# Inspection Report

**Property Address:**  
92635 Commercial Ave  
San Luis Obispo, CA 93401

| <b>Date:</b> 7/17/2025 | <b>Time:</b> 12:00 PM | <b>Report ID:</b><br>92635Commercial |

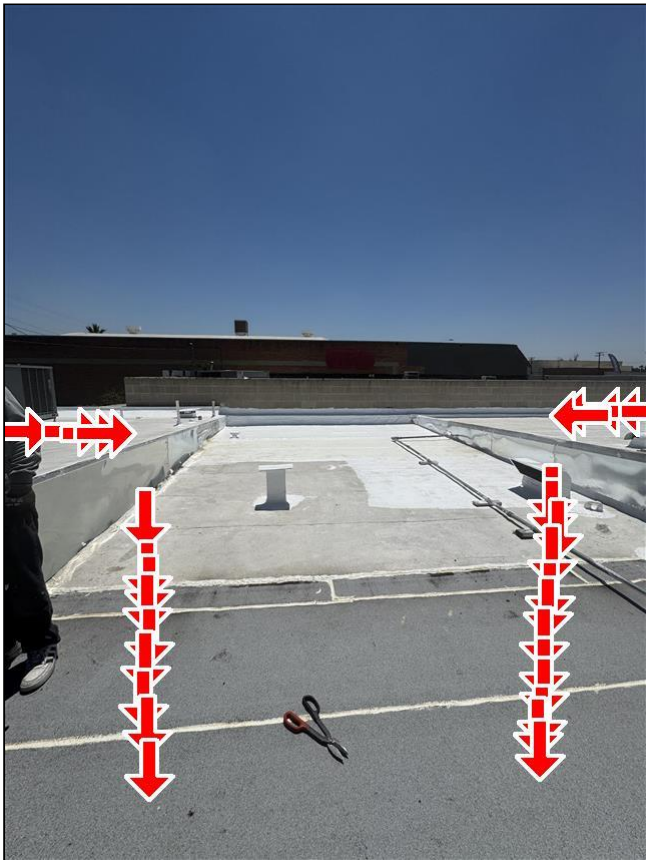
1.1 Item 1 (Picture) Path of Roof Water To Front

Most of my commentary pertains to what is already in the inspection. The main points of the inspections are related to the roofing which is currently undergoing major repair and rebuilding in the overhang section. As will be mentioned, my conversation with the roofer clarified that the owner will not be paying for the gutters that are needed to be replaced in the front. To give context, the roof is slanted to drain the water in the front of the building where the water will likely pool without proper drainage installed after the repairs. I highly recommend that this issue is brought up with the seller prior to purchase. Even after

repairs, without proper drainage, the roof could collapse under the weight of pooled water. More will be mentioned pertaining to the roof in the main report.

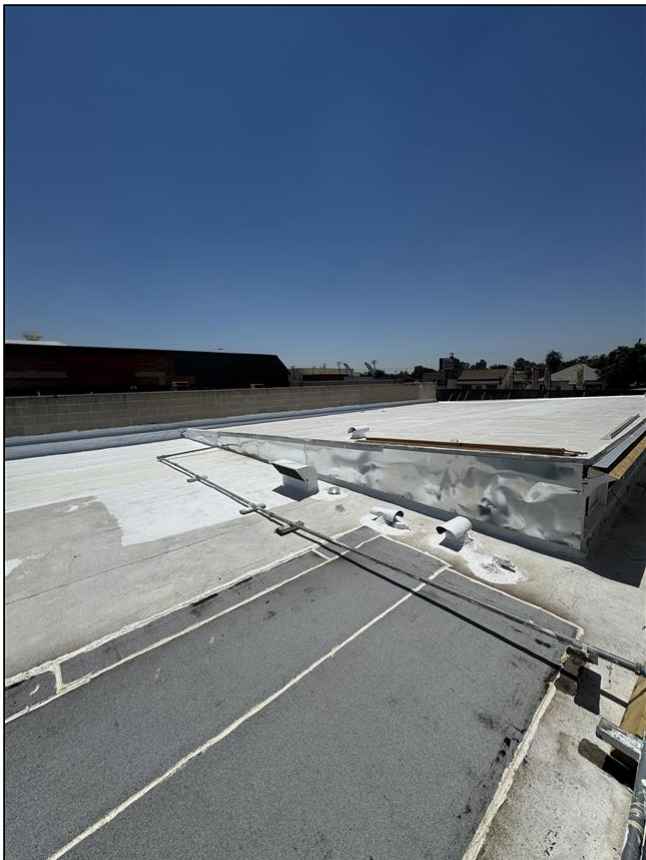
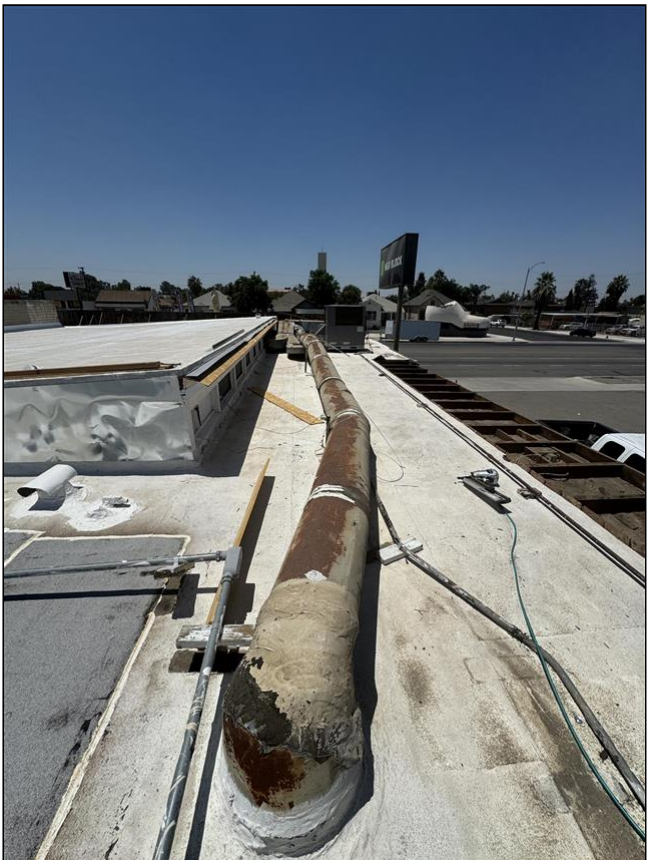
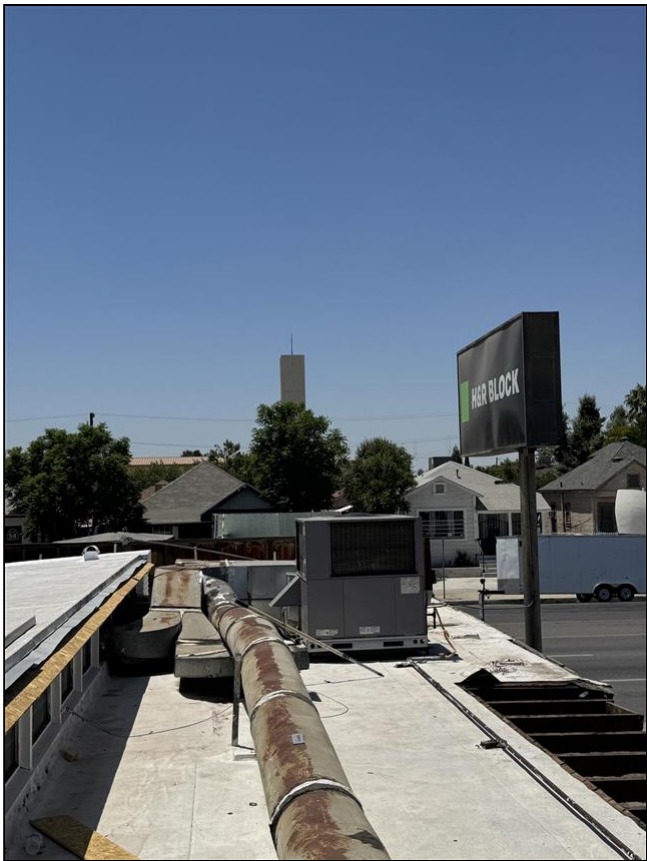
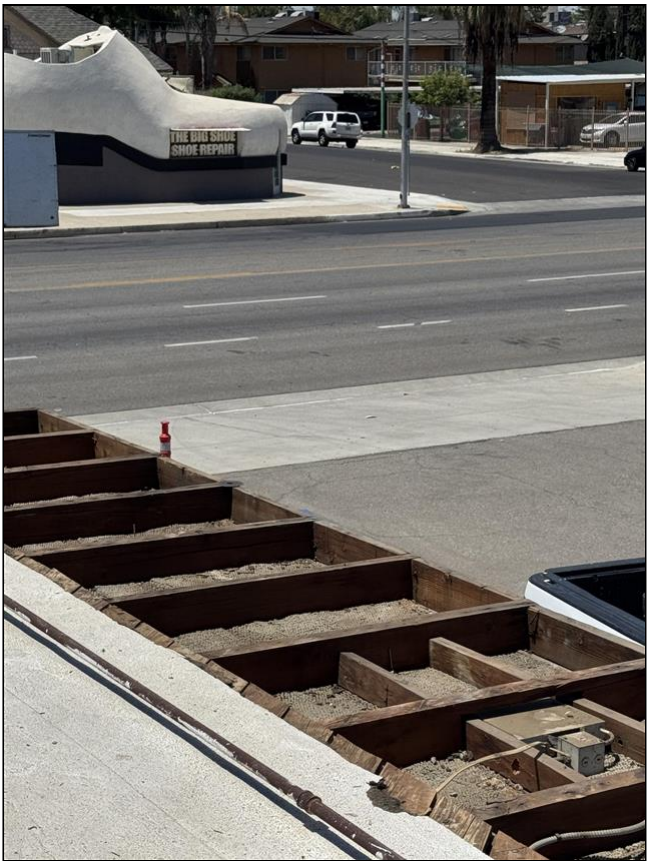
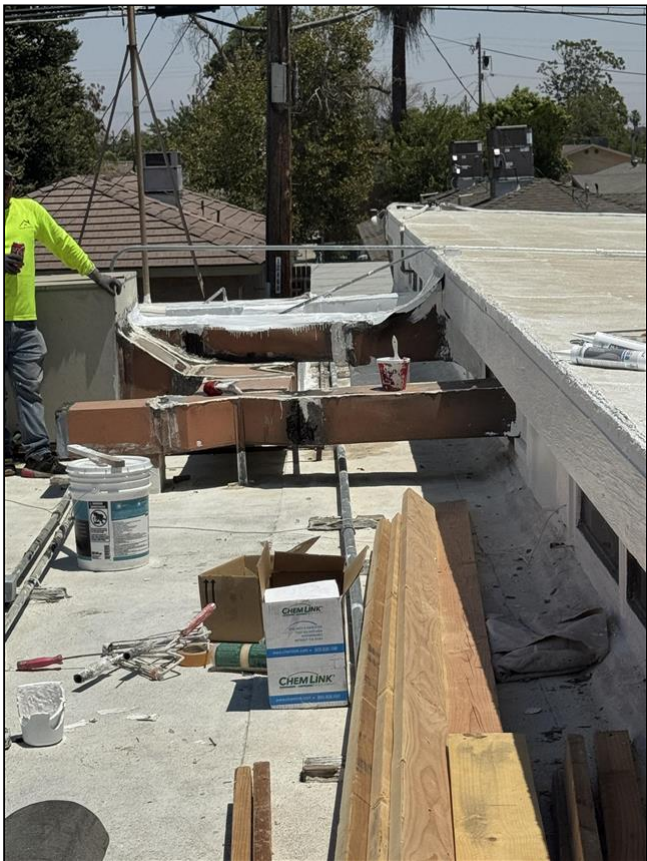
**Inspected-** The roof appears to be in good condition as it was just recently sealed by roofers that were also performing major repairs on the front overhang of the building. The roof is covered with sheet asphalt fiberglass material that is common to commercial flat roofs.

- The overhang repairs being performed will remove old rafter wood and extend the overhang with new wood and a front facing wall facade. Prior to the repairs the end of the old rafter wood was deteriorated leading to the slumping of the old overhang.

-The roofers will not be fixing or repairing the facade facing the street which has wood that is old and damaged by weathering. It is possible to repaint the wood to last longer, but left as is , the facade will eventually lose structural integrity and begin to fall apart. It is recommended to discuss this with the seller and if needed, contact the current (or another) roofer to repair/replace that wood and paint it for protection.

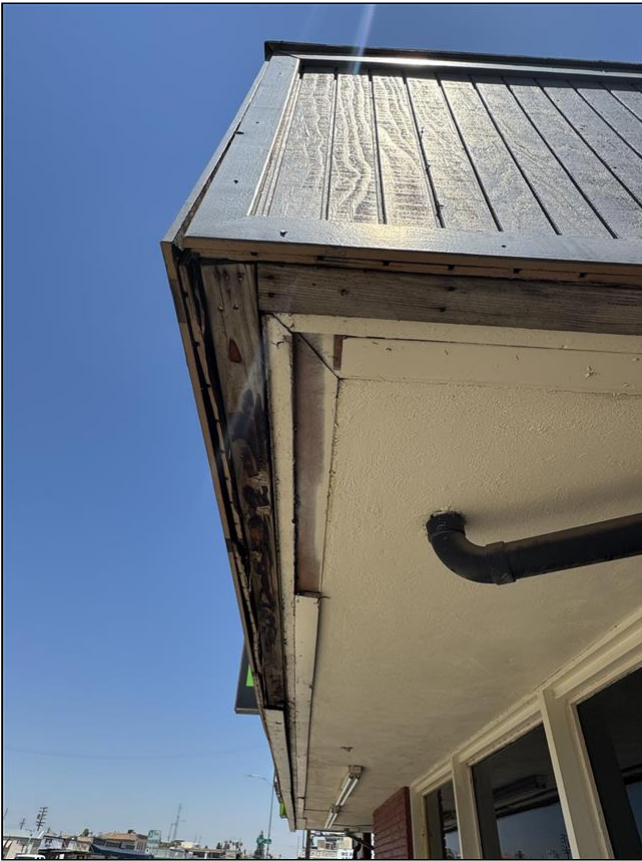
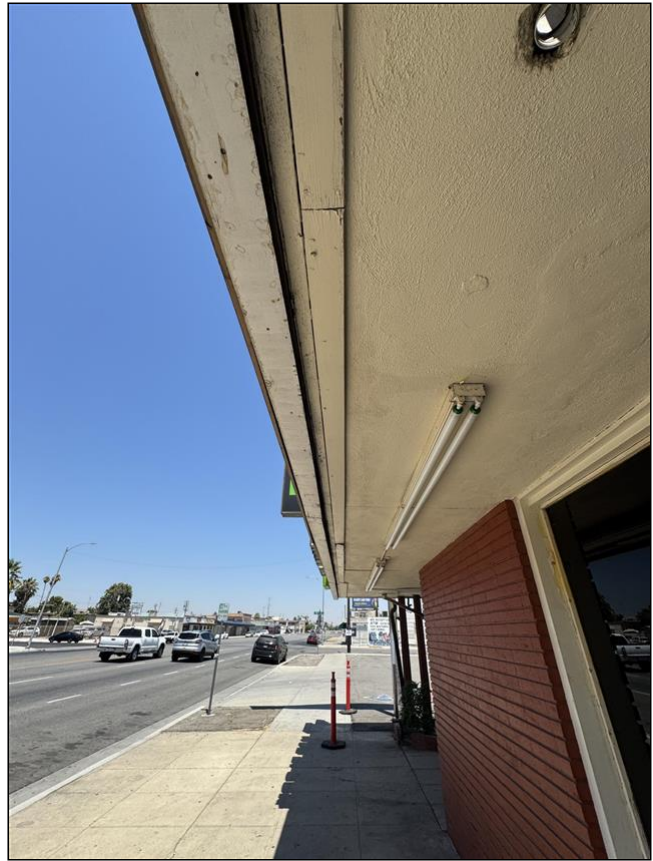
**Inspected-** It is my impression from the conversation with the roofer that only the front overhang and facade on the building are being repaired. Other recommended work was declined by the owner/seller. Unfortunately some of the recommended work will still need to be done. As mentioned in my commentary, the roofer indicated that despite the removal of the front gutters, the work plan does not include the installation of a drainage system to collect all of the water that will pool in front of the facade. He indicated that such an installation would cost a few thousand dollars more. The roof as a whole is directing water to the front of the building. This additional work by a professional contractor is urgently recommended to avoid water damage to the new overhang and roof.

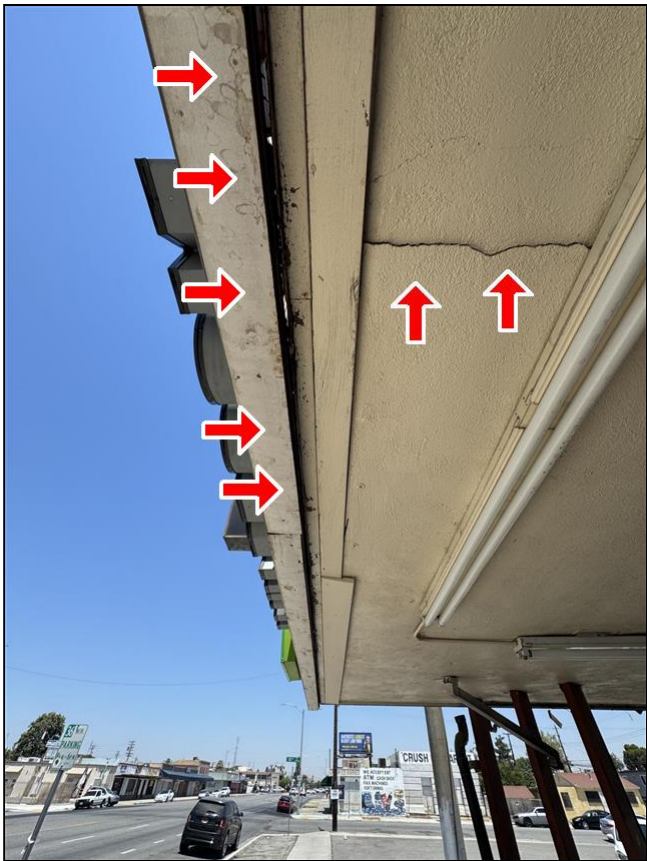
-On the side facing the street, the facade that I assume will remain is separating from the roof. Also, there is a crack that developed in the stucco in the overhang several feet from the front corner. I recommend a having a general contractor survey the entire facade and possible replacement. The crack should also be looked at to determine whether major repair is required.

2.2 Item 3 (Picture) Crack and Separation

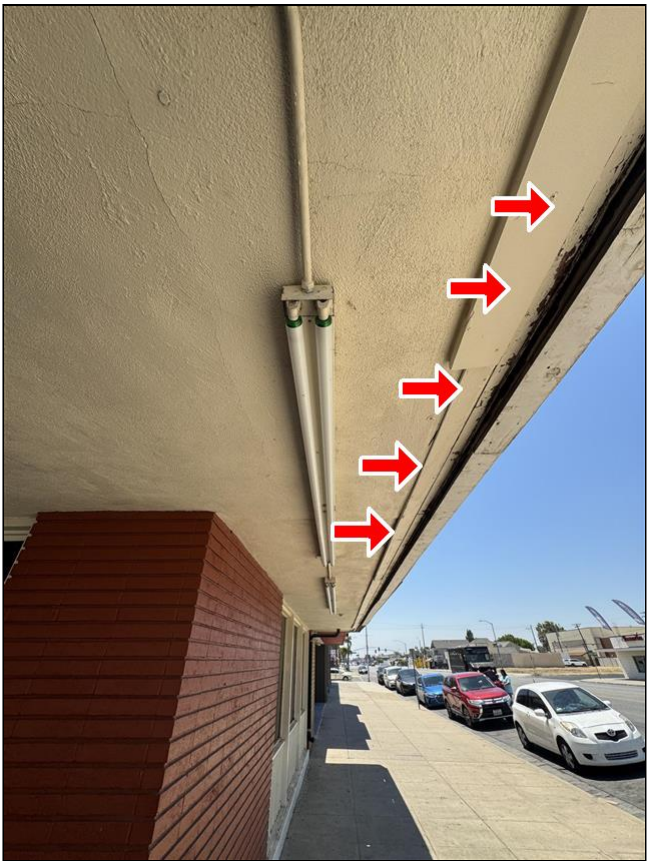
2.2 Item 4 (Picture) Separation

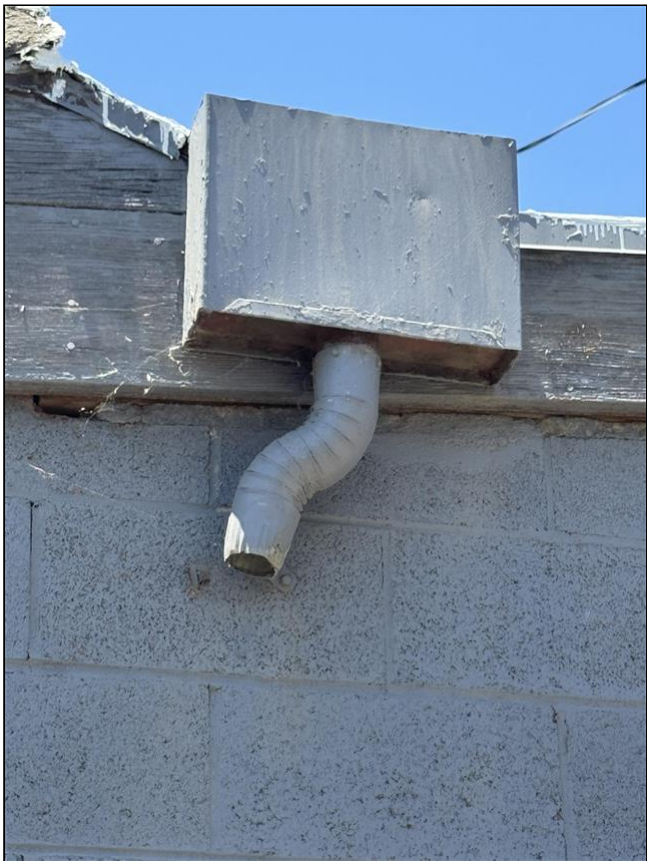
-There is an incomplete drain on the alley side of the roof. It is recommended to have the drain completed to the ground for efficient and non damaging drainage.

2.2 Item 5 (Picture) Incomplete Drainage

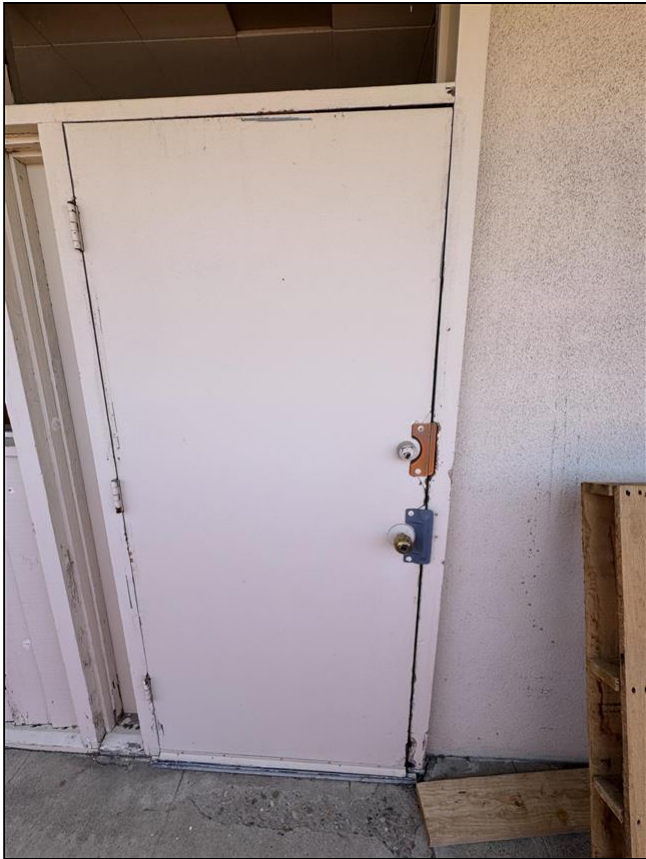
3.1 Item 1 (Picture) Door 2

**Inspected-** All of the doors are in good working order, but the front facing door facing the street has been temporarily screwed shut to avoid people entering through that door. Minor areas should be touched up with paint or repainted due to wear.

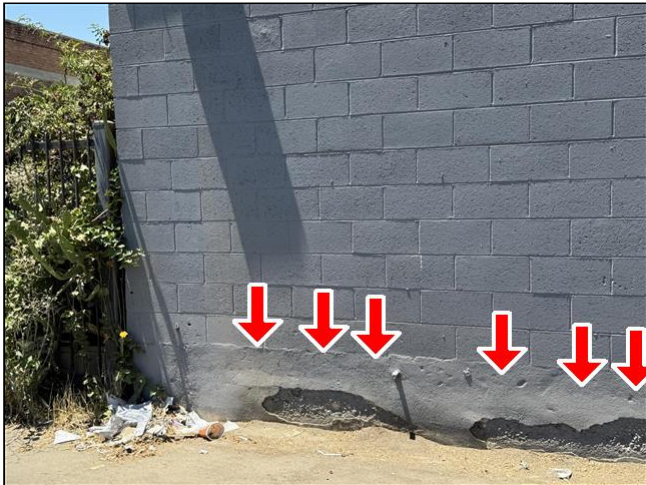
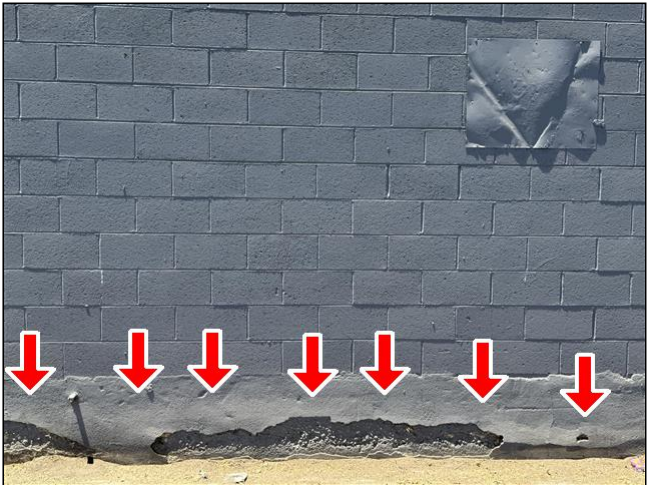
**Inspected-** the base of the wall on the alley side is in need of repair and repainting to avoid further environmental damage to the wall. It is recommended to have a masonry contractor make the repairs.

3.2 Item 1 (Picture) Damaged Masonry

3.2 Item 2 (Picture) Damaged Masonry 2

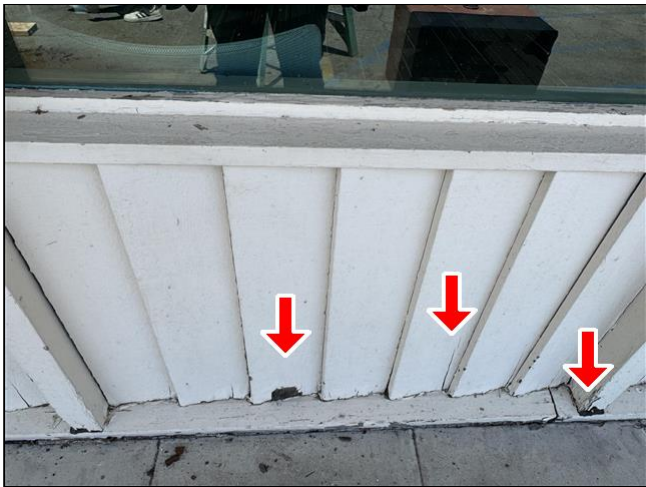
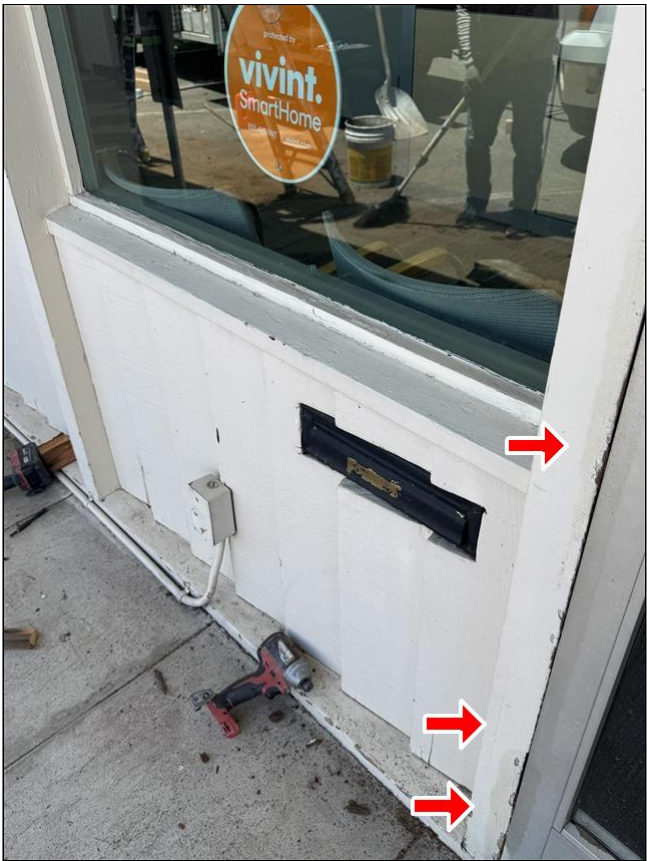
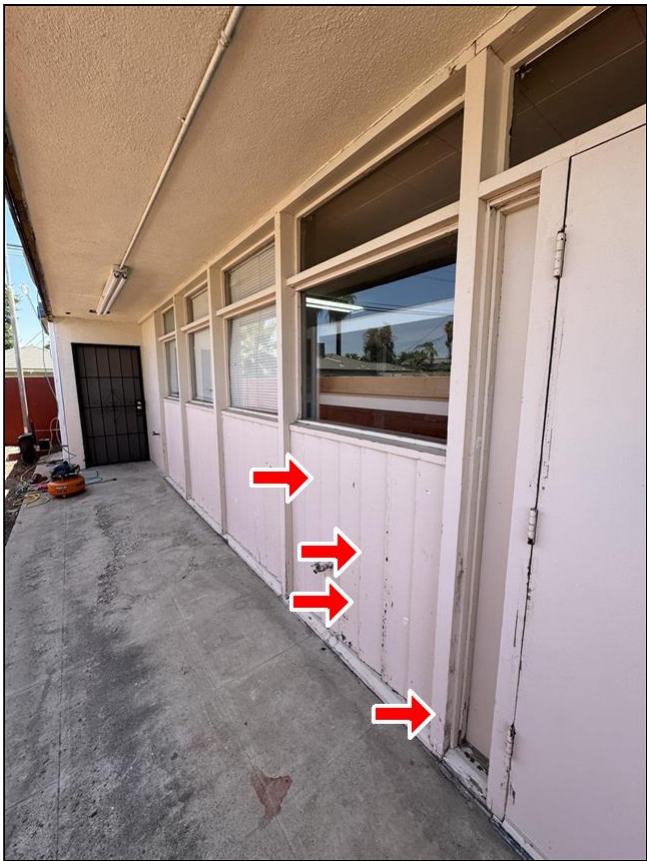
- On the wood portion of the siding around the front exterior, there are several areas that should be repainted or touched up to prevent environmental damage.

3.2 Item 3 (Picture) Siding Chipping

3.2 Item 4 (Picture) Siding Chipping 2

3.2 Item 5 (Picture) Siding Chipping 3

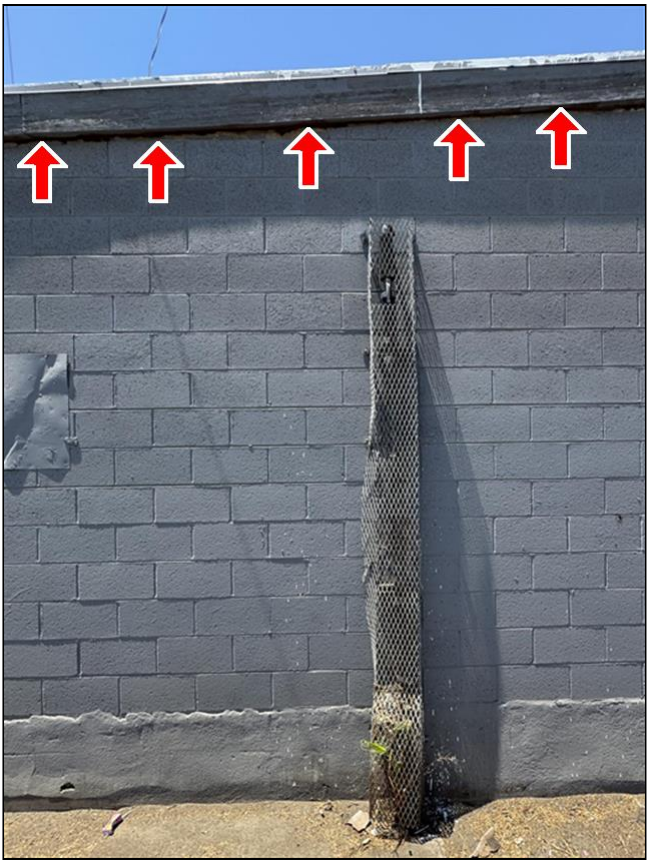
- On both the alley side and areas presumably not being repaired by the seller there is some wood fascia that is old and needs to be replaced and repainted. It is recommended to have all of that wood replaced since it is warped.

3.2 Item 6 (Picture) Old Wood Fascia

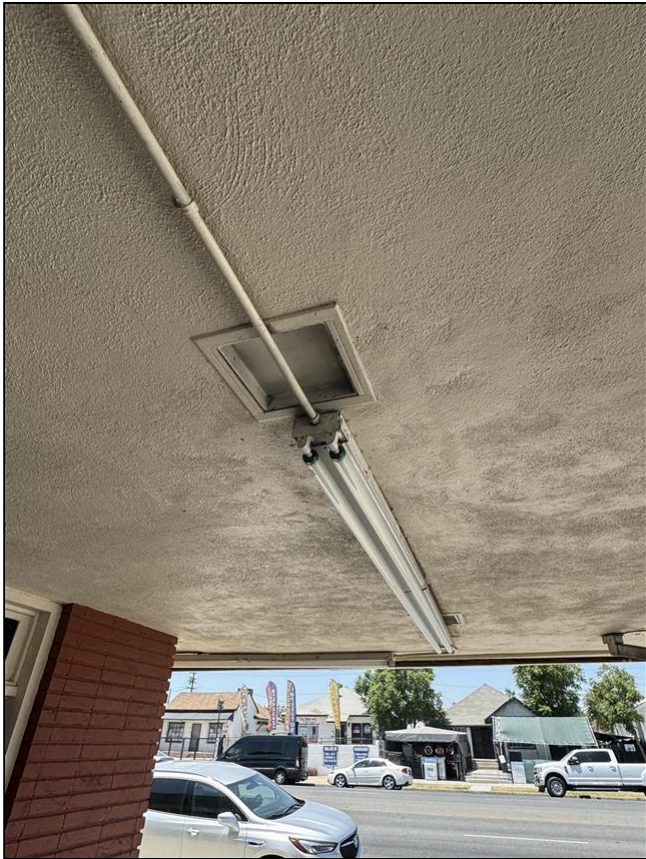
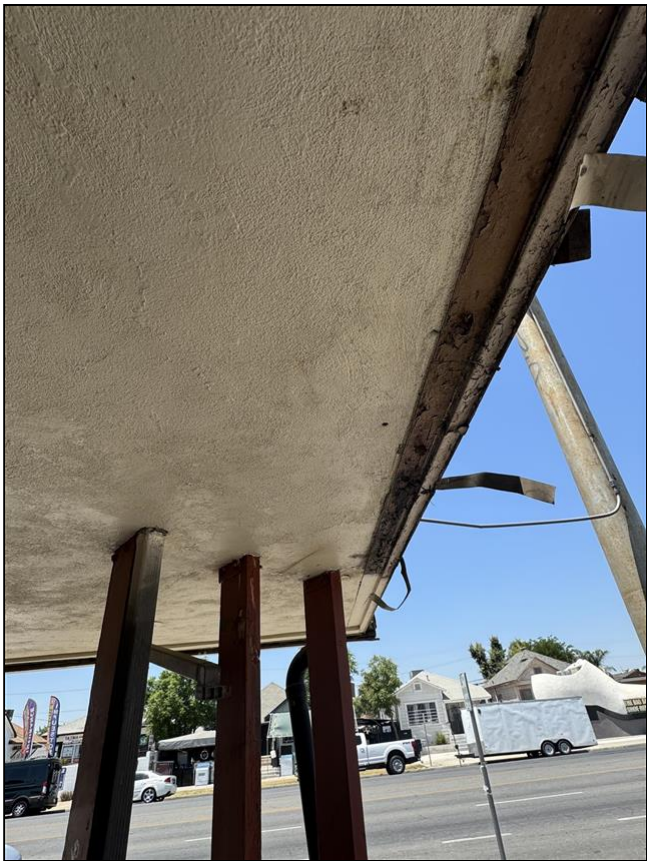
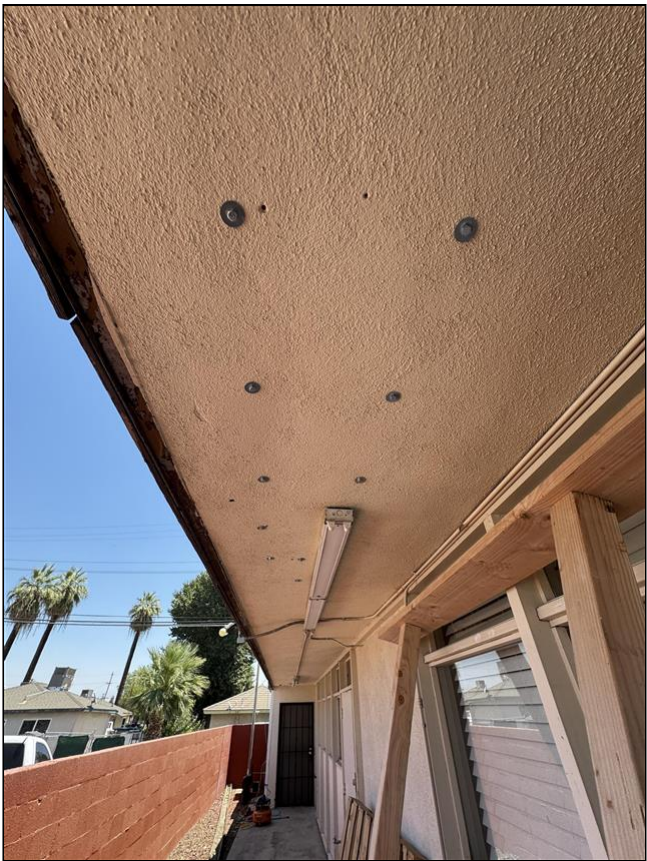
**Inspected-** As mentioned in Section 2.2, there is a large crack in the front overhang that should be assessed and repaired. However, the currently exposed overhang stucco is in relatively good condition and additional work will determine its final condition.

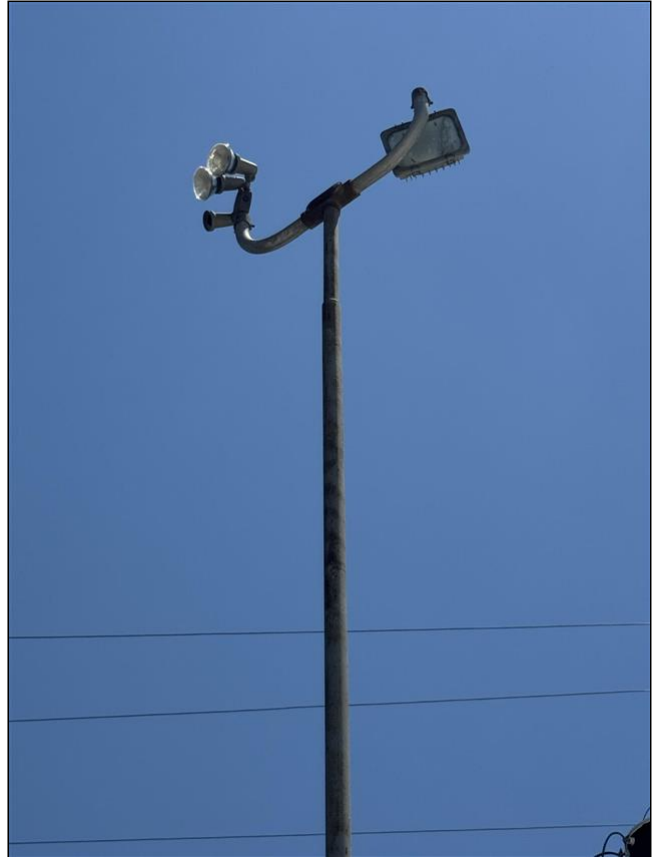
-According to Michelle, the tallest lights on a pole on the side of the front building do not work. However, the lights on the shorter pole do work. It is recommended to remove or repair those lights that aren't working.

3.6 Item 2 (Picture) Non Working Lights

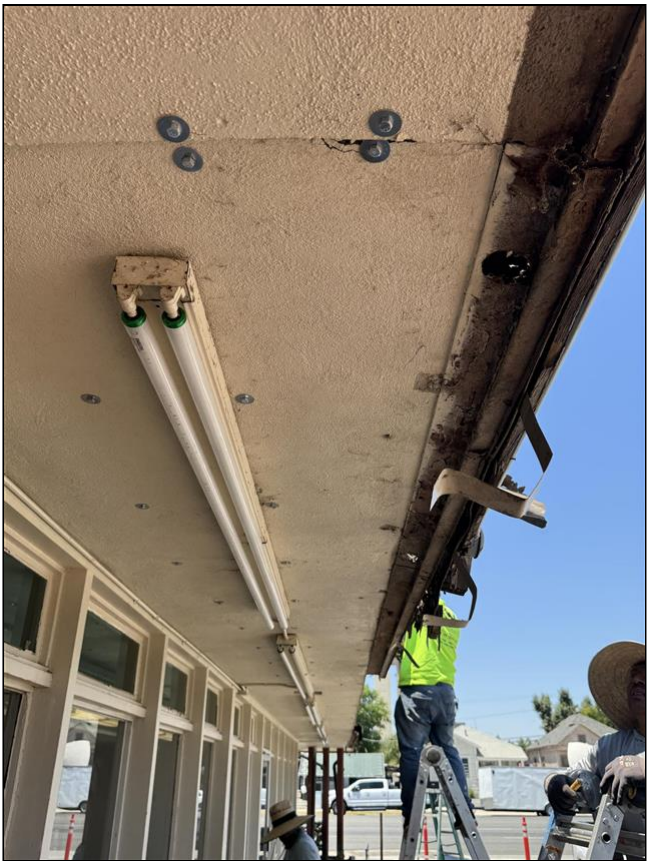
3.6 Item 4 (Picture) Lights 3

- There are several fluorescent lights under the overhang, now being repaired, that are burnt out and need to be replaced. The ballasts seem to be in working order though for the lights that are working in that row.

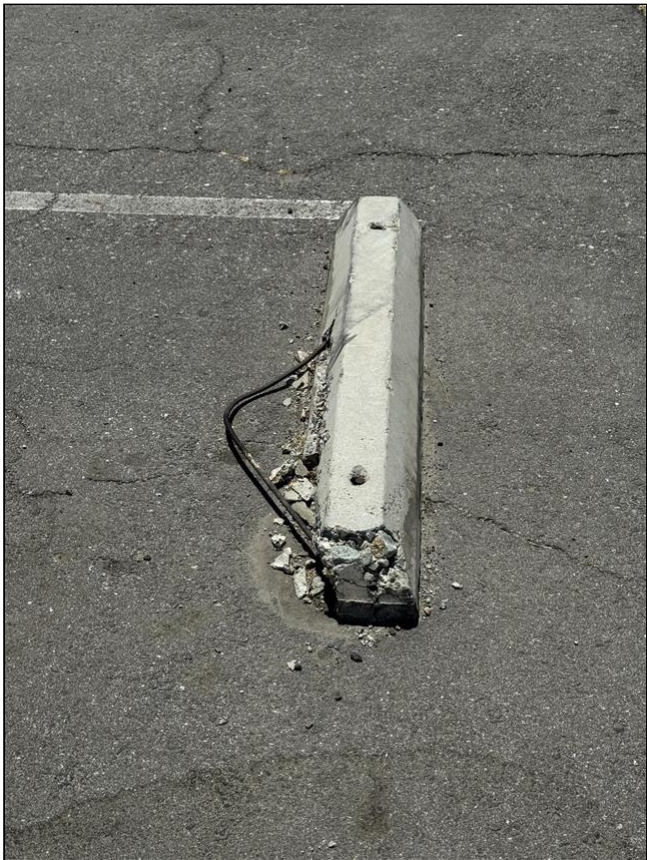
**Inspected-** The lot appears to be in generally good condition with only minor cracks in the asphalt throughout. There is a broken parking block and others that or chipped that should be repaired or replaced. The parking lines in the lot should be repainted as they are now fairly faded.

4.0 Item 1 (Picture) Broken Parking Block

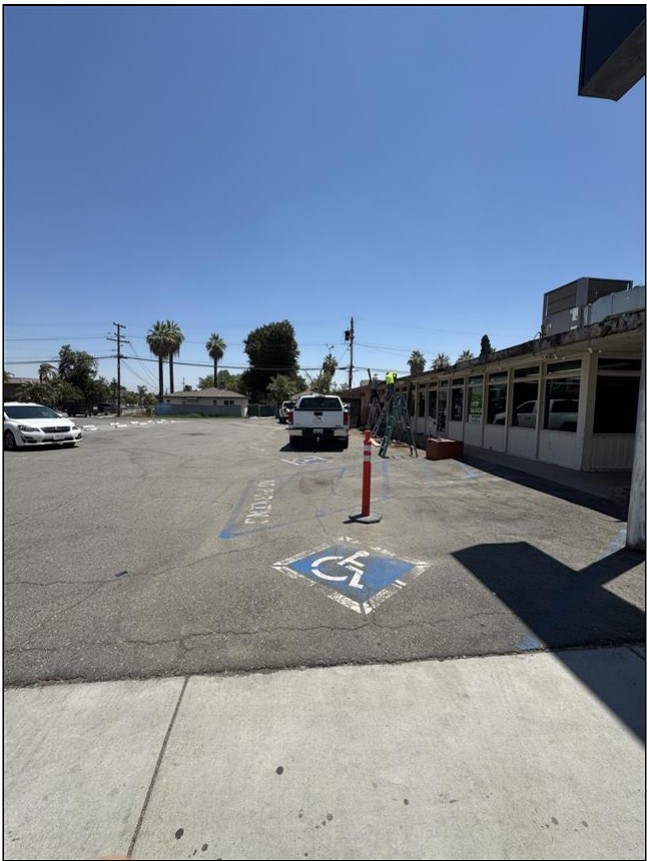
4.0 Item 4 (Picture) Faded Handicap

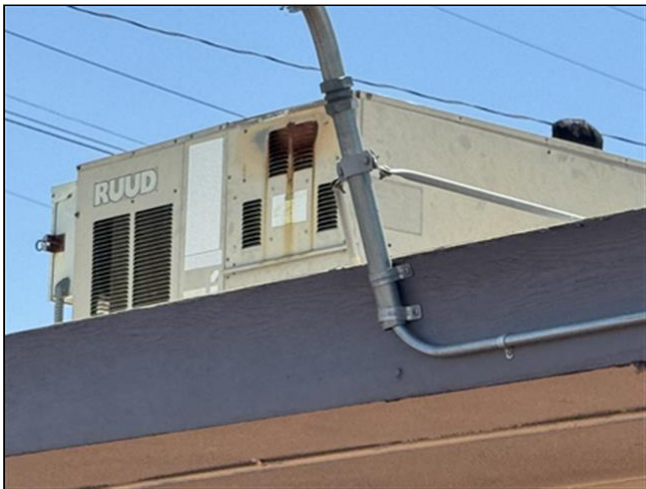
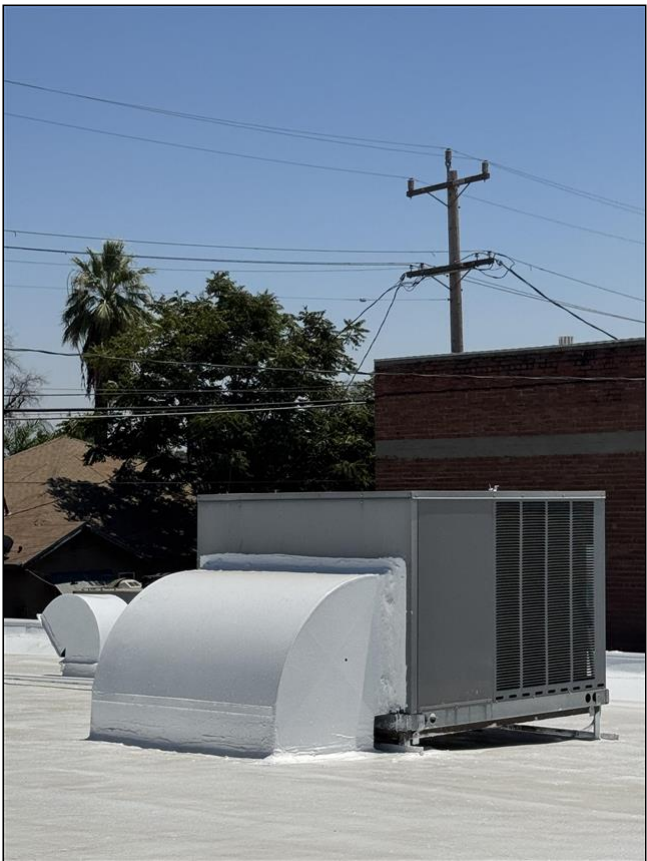
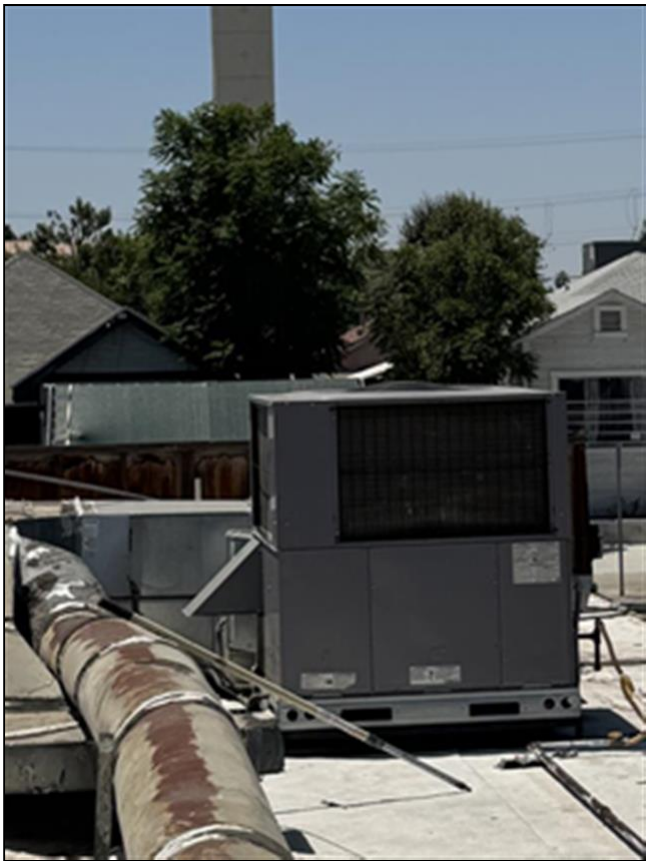
**Inspected-** As mentioned in my commentary, only 2 of the HVAC Units were working at the time of inspection. Those two units were only servicing the front office areas, the bathrooms, and the middle room used for storage. Fortunately both were working well and along with their thermostats were tested for efficiency. It is recommended to have an HVAC technician determine if the other 2 units can be fixed, and if not, they should be replaced.

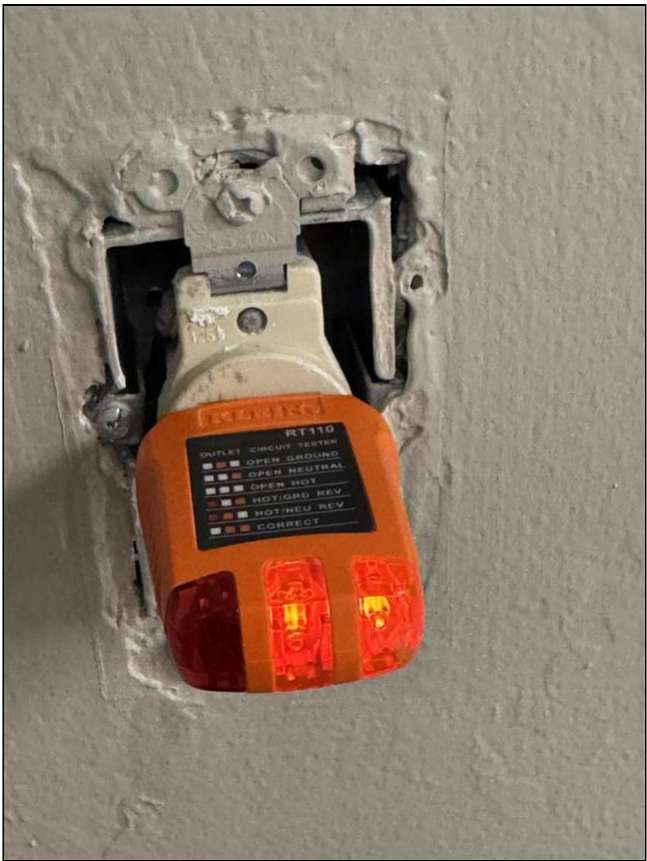
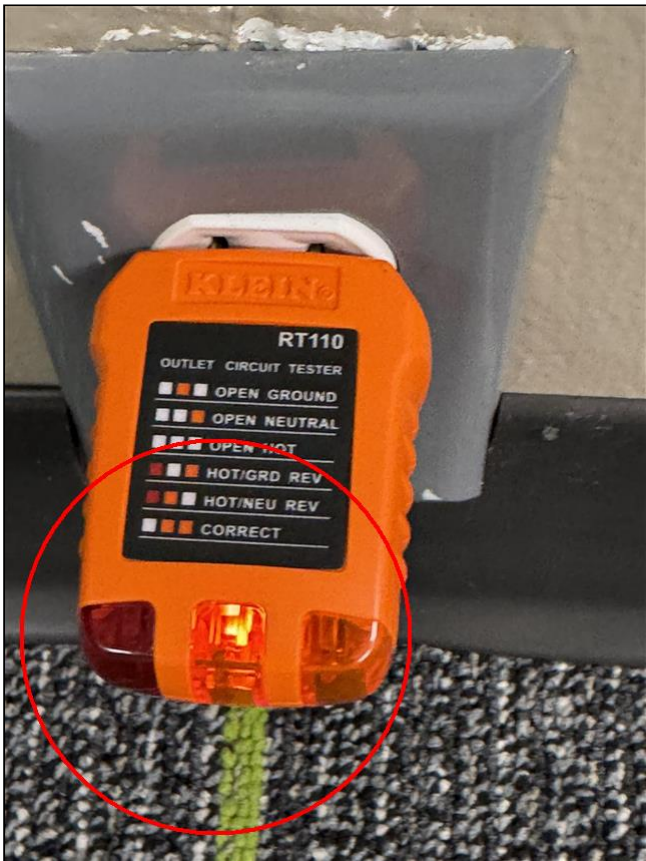
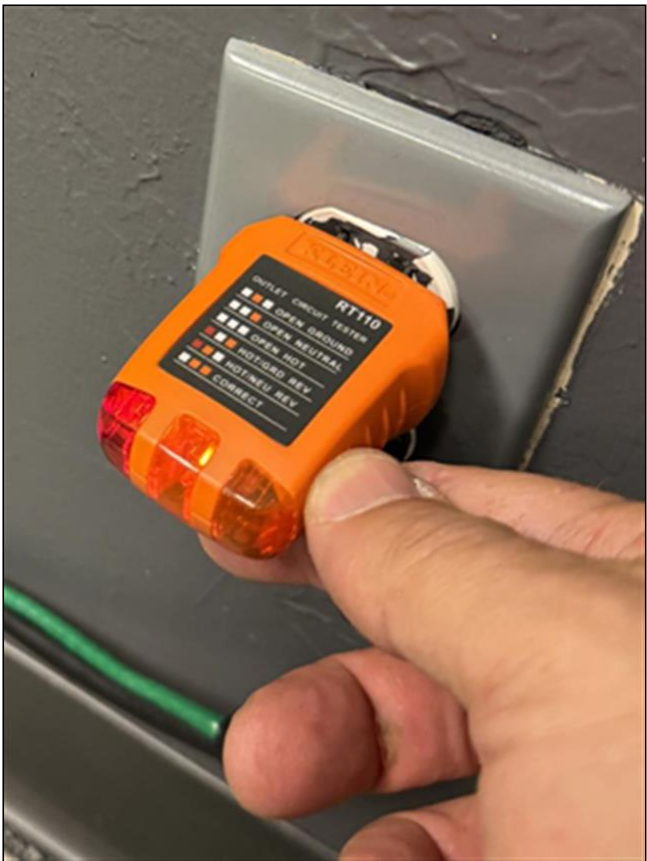
-Receptacles were tested throughout the building and there were 2-3 receptacles on the wall opposite the screen in the media room that did not work. Close to the screen, below it was a receptacle that was very loose and not properly grounded and nearby was a receptacle that was missing its plate. It is recommended to have a licensed electrician survey the non-operable receptacles and repair the loose receptacle and plateless one.

6.0 Item 8 (Picture) Media Missing Plate

6.0 Item 9 (Picture) Media Loose Bad Ground

6.0 Item 10 (Picture) Media Loose Bad Ground  
2

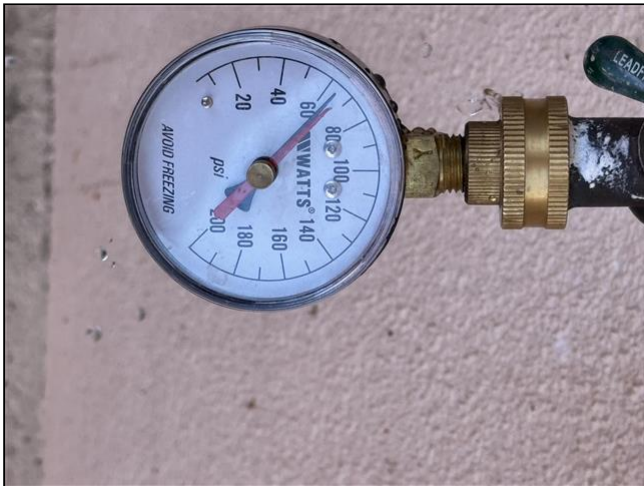
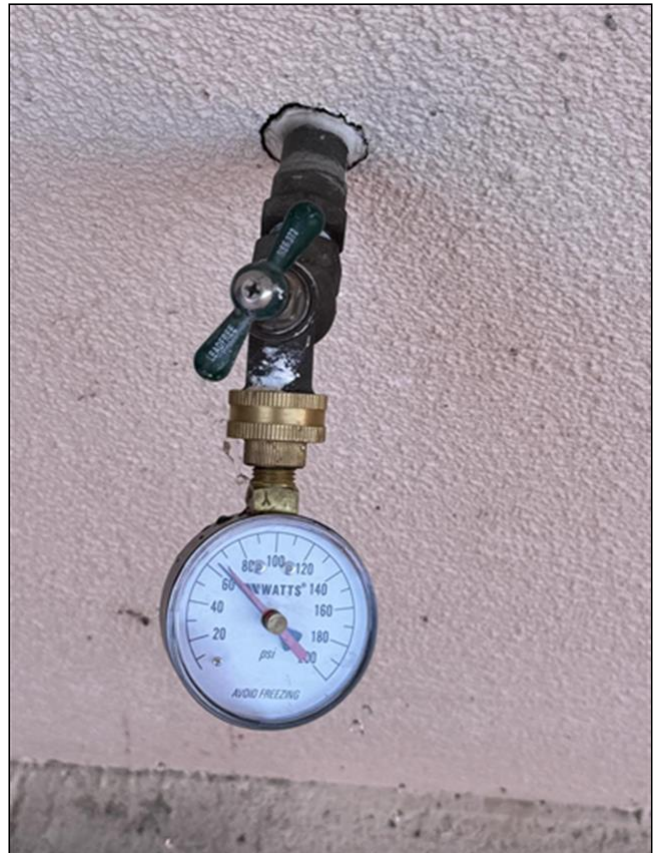
**Inspected-** The bathroom sinks were both functional without leaks and the toilets were also functional. The water pressure tested at 65 psi which is slightly low but better for older pipes as those found in this building. There was a small electrical water heater that supplied the break room and bathroom sinks and it appeared to be in good working condition.

7.0 Item 1 (Picture) 65 PSI-1

7.0 Item 2 (Picture) 65 PSI-2

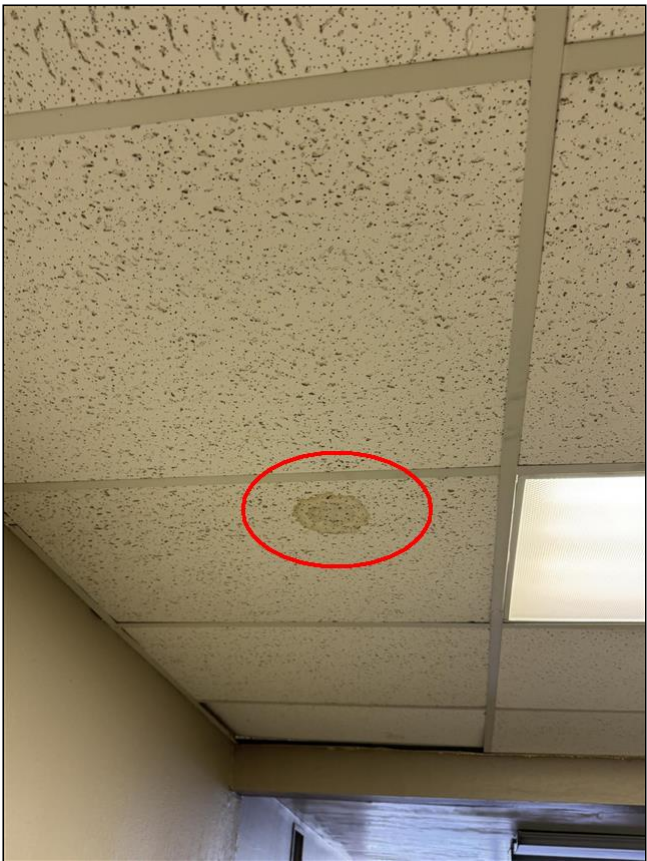
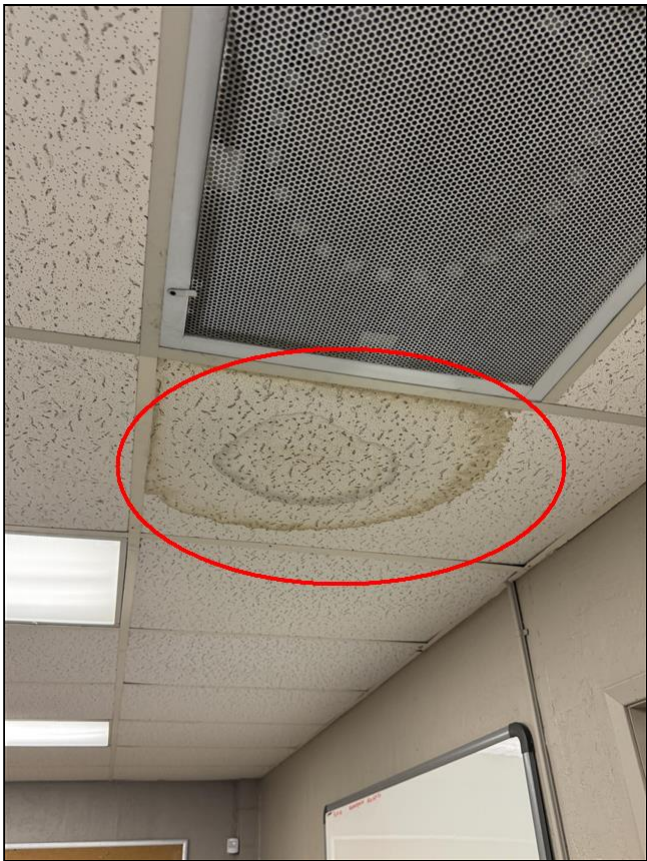
**Inspected-** The ceilings are generally in good condition, but as mentioned, there were a few roof leaks in the past that have now been addressed by the owner/seller in the current repairs. Those leaks were in the rear conference room and the rear hallway storage room. The roof is being entirely re-sealed and unless a pipe were to burst, there shouldn't be any additional leaks in the near future.

8.1 Item 6 (Picture) Small Leak CR

8.1 Item 7 (Picture) Larger Leak CR

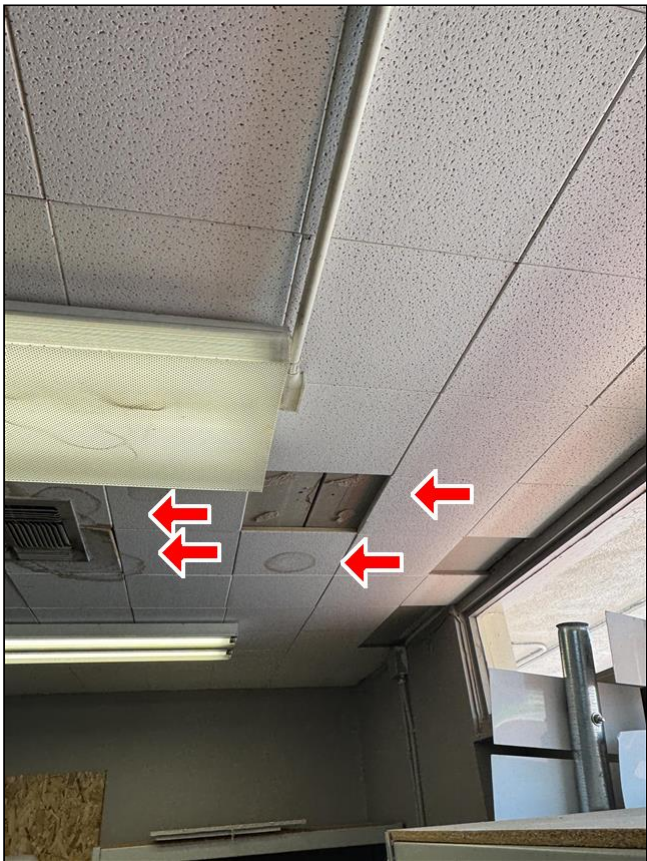
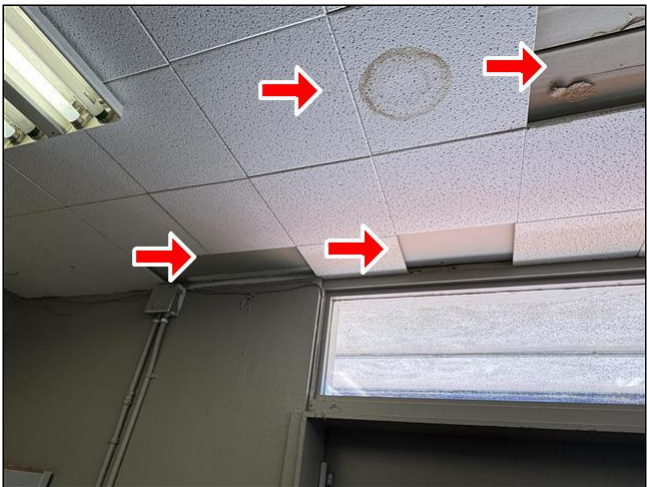
-There are a few missing tiles in the storage room mentioned and also some slightly buckled tiles in the conference room

8.1 Item 9 (Picture) Missing Tiles and Leaks Storage

8.1 Item 10 (Picture) Small Leak 2 Storage

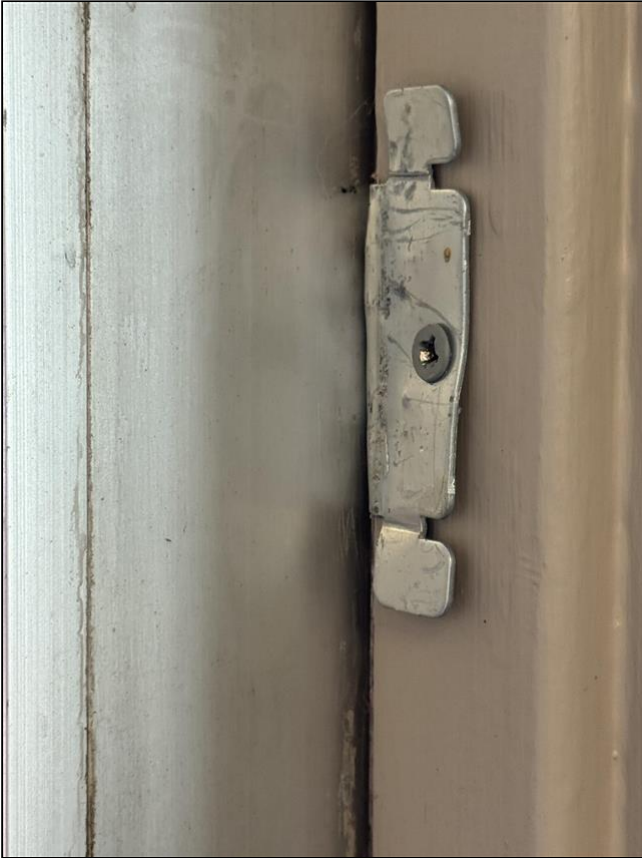
**NI-** All of the doors were in good working order, but the front side door facing the street was screwed shut and should be released and repaired if necessary. I could not inspect this door due to its state at the time of inspection.

8.4 Item 1 (Picture) Front Door Screwed Shut

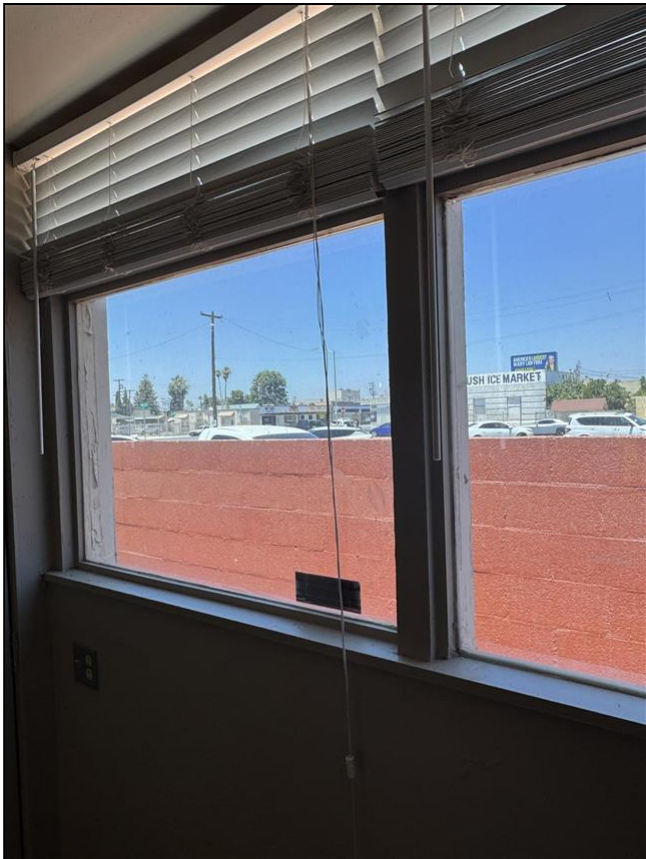
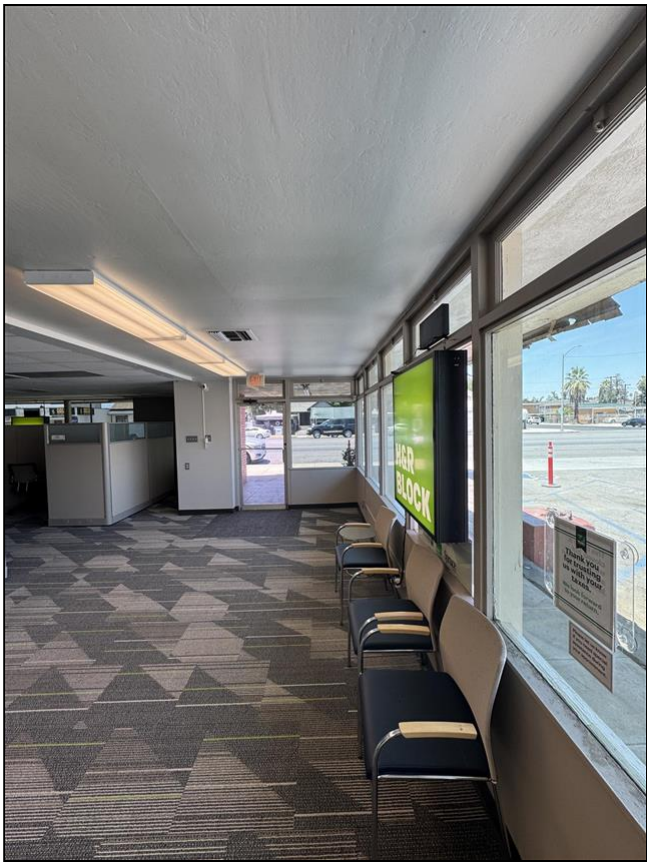
**Inspected-** The glass in the windows were in very good condition, but some of the windows were loose and are in need of re sealing to avoid drafts and improve HVAC efficiency.
