# Inspection Report

**Joe and Rebecca Blow**

**Property Address:**  
1234 Anywhere Paso  
Paso Robles, CA 93446

**Blue Oak Home and Commercial Inspections**

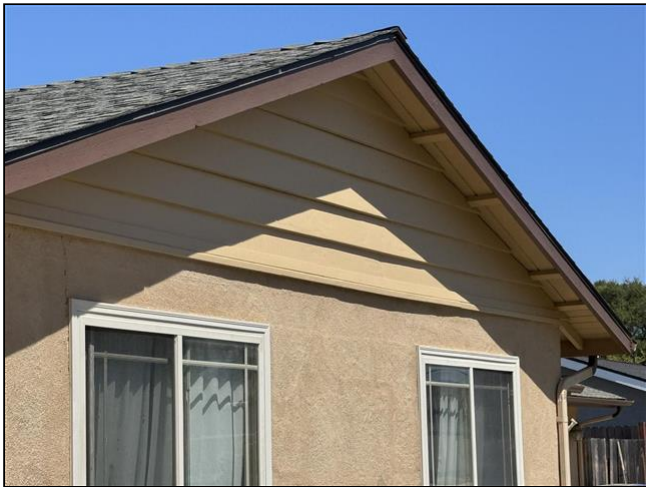
1.0 Item 1 (Picture) Eaves, Soffits, Trim 1

-The inspector observed few deficiencies in the condition of the roof structure exterior. There was a minor crack in one outer soffit board and a board that had about a half inch of separation from the exterior roofing underside. Both of those should be repaired or secured by a licensed contractor to prevent moisture, pests, or deterioration.

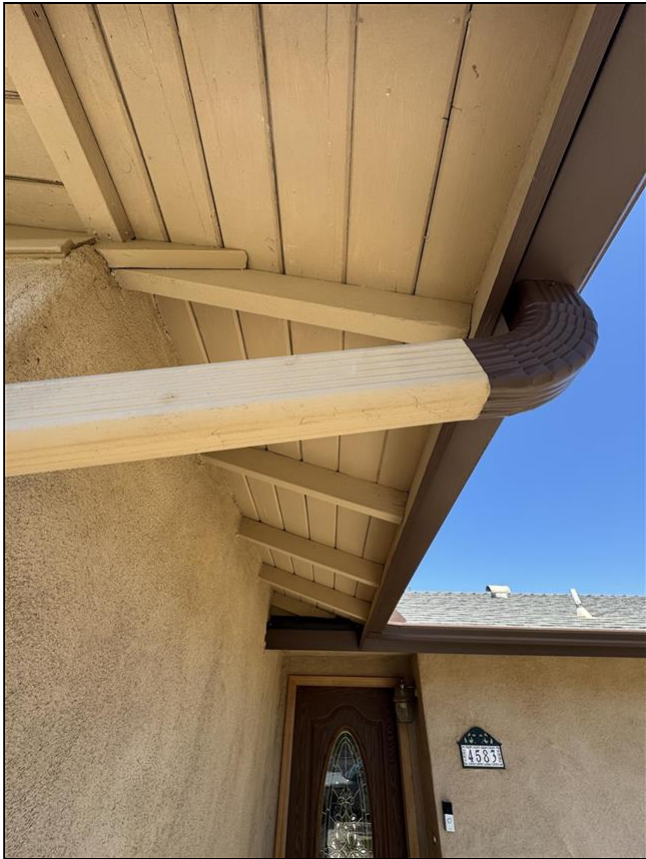
1.2 Item 1 (Picture) Downspout and Gutter

- In general, the gutters and downspouts are all in good condition. It was noticed the gutters had about a half an inch of dirt in them and should be pressure washed to prevent clogging in the future. There was one gutter where the end was slightly bent upward, but still functional. Also, a few of the downspout connections were loose and should be re tightened and resealed as needed to prevent any leaks. Finally there are a few downspouts where the metal is bent at the bottom. It is recommended to either replace these for esthetic purposes and clog prevention, or bend them back to more open for discharge.

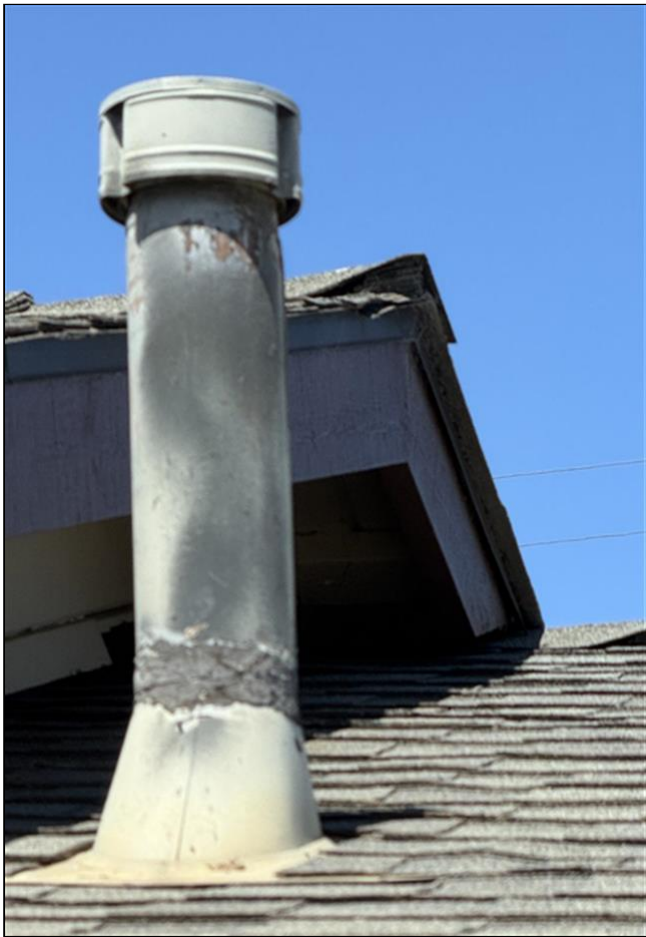
1.3 Item 1 (Picture) Vent 1

-Combustion vents on the roof showed general moderate corrosion. Nonetheless, they were generally in good condition. It is recommended to replace the vents when roof shingle replacement occurs, or paint over the vents to further preserve them.

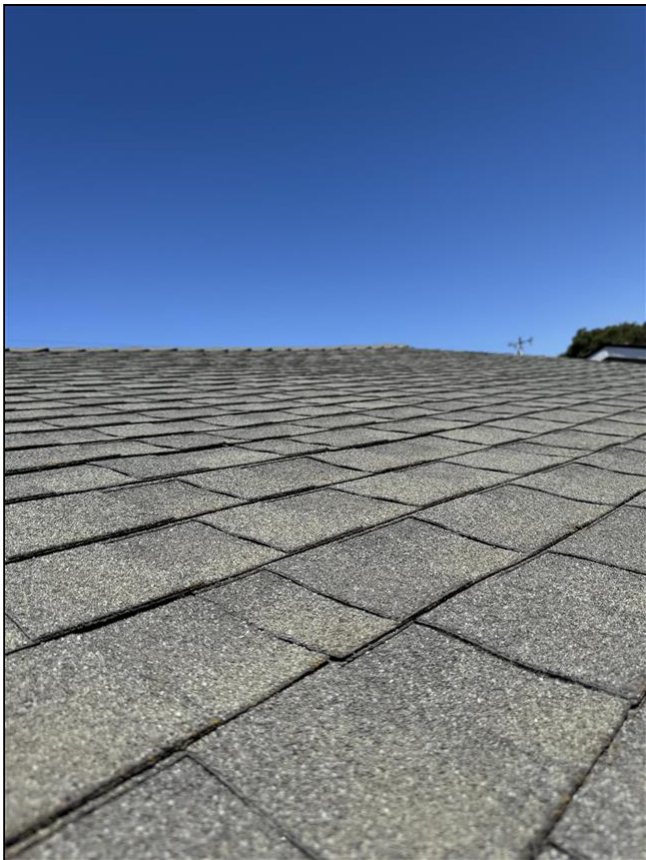
1.4 Item 1 (Picture) Shingles 1

-At the time of the inspection, the Inspector observed few deficiencies in the installation of the asphalt composition shingles covering this roof. The roof overall was fairly straight with few bumps or ripples, but the main thing noted was that the roof was probably more than half its useful age considering the visual appearance and the noted fact that the seller had not replaced any shingles since she bought the house 18 years ago. It is recommended to replace the roof as soon as possible within 5-10 years and monitor closely for weather damage or leaks in the attic. No signs of leaks were discovered at the time of inspection.

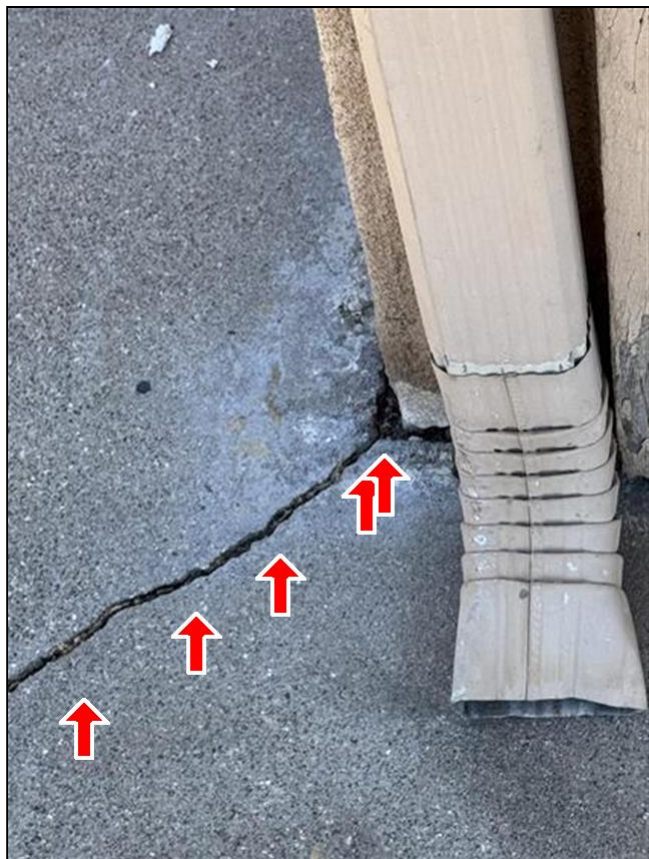
2.2 Item 3 (Picture) Large Crack

- The walkways were in very good condition at the time of inspection with few cracks. However, there is one large crack that should be filled next to the rear downspout. It is recommended to fill the crack or have a licensed contractor perform the work to prevent moisture intrusion into the foundation at the corner of the house.

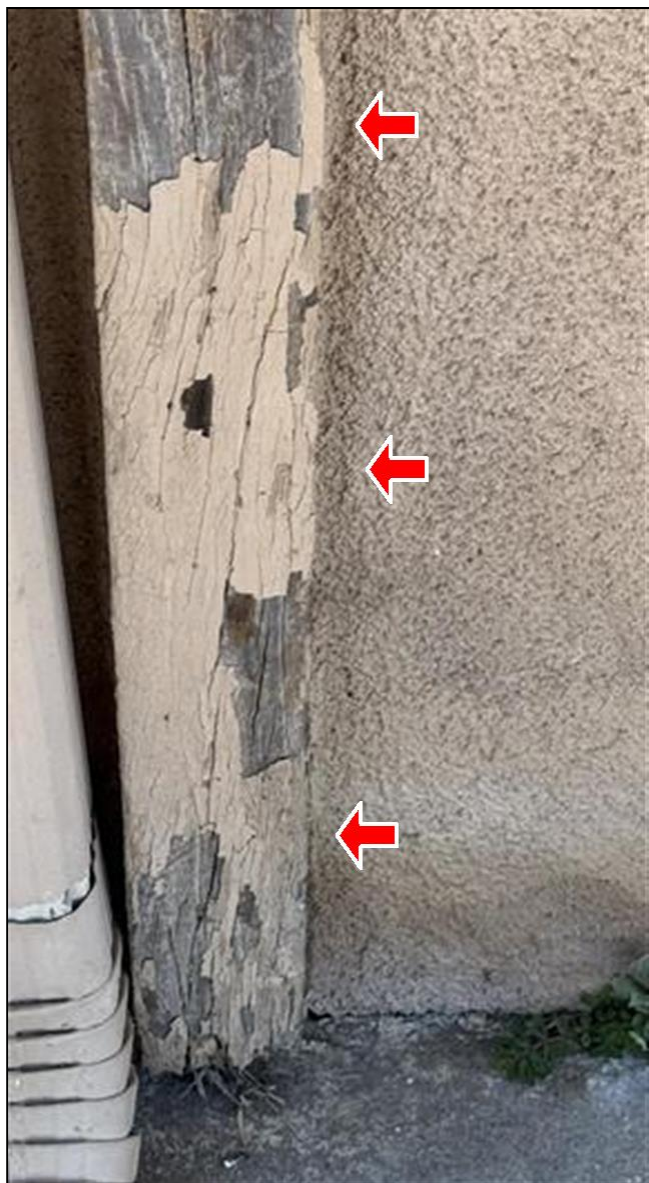
2.3 Item 1 (Picture) Older Wood Trim

-At the time of the inspection, the Inspector observed few deficiencies in the condition of the trim. the vast majority of the exterior trim was recently painted with some wood likely replaced. However, near the downspout in the rear, there was a piece of wood trim that should be replaced and repainted as it is old enough and damaged to be a concern for moisture and pest intrusion.

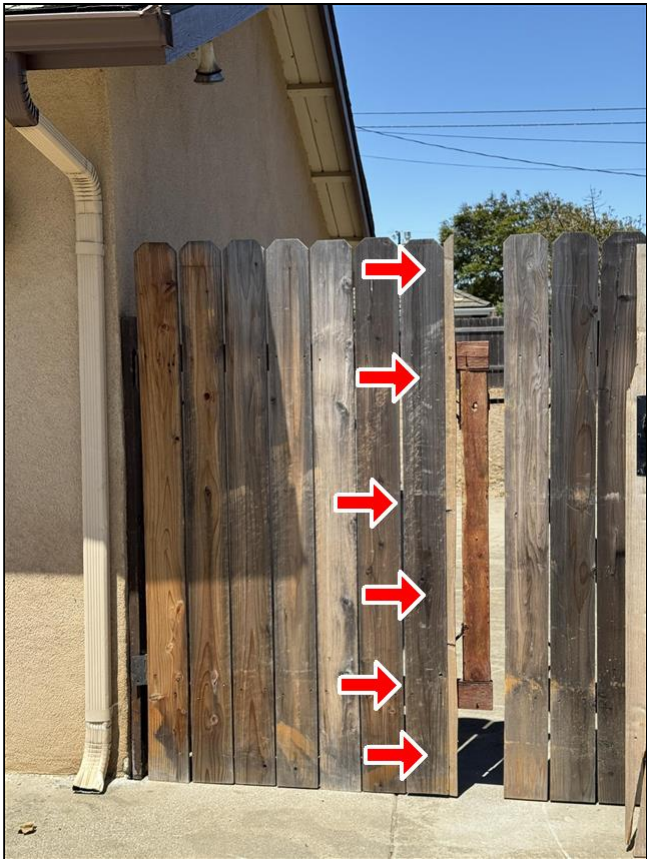
2.7 Item 1 (Picture) Front Gate Right

-The fences and gate were older but generally in good condition. The front fence is in need of repair as one piece of wood was split and separated from the gate. Though the fences appeared to be in good condition at the time of inspection, it is highly recommended to have a termite inspector survey the entire

fence system. Also, the fences can be further preserved by painting or staining them. Finally, all plant material should be removed from any fences as plants promote moisture retention and pest infiltration.

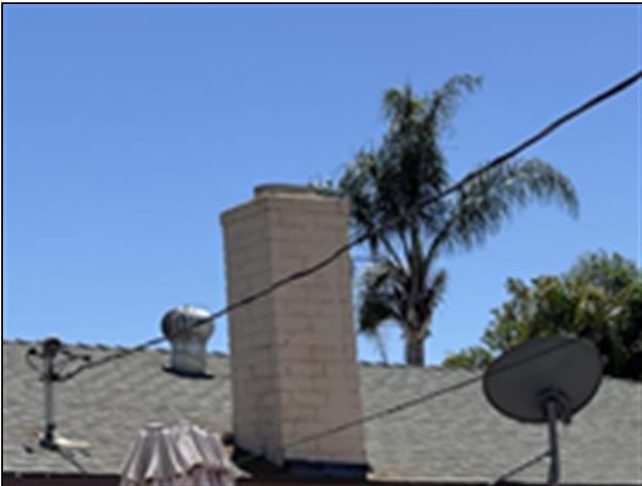
2.8 Item 1 (Picture) Chimney

-At the time of the inspection, the Inspector observed no deficiencies in the condition of the brick masonry chimney. However, it was noted that the chimney did not have a spark arrestor. It is recommended to have an arrestor installed if the fireplace is intended for future use.

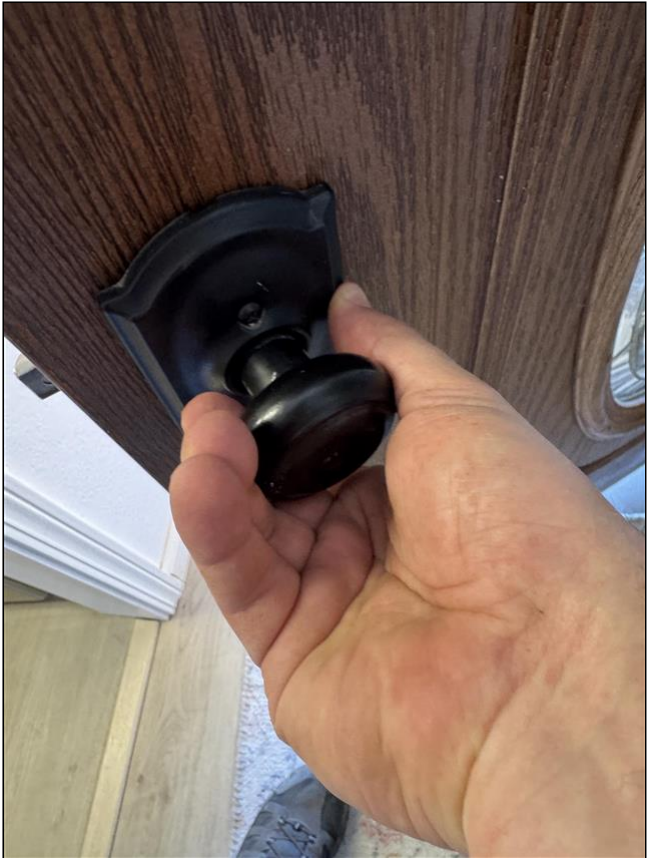
3.0 Item 2 (Picture) Loose Door Handle

-At the time of the inspection, the Inspector observed few deficiencies in the condition of door exteriors. However, the front doorknob assembly seemed a little loose. It is recommended to tighten as needed.

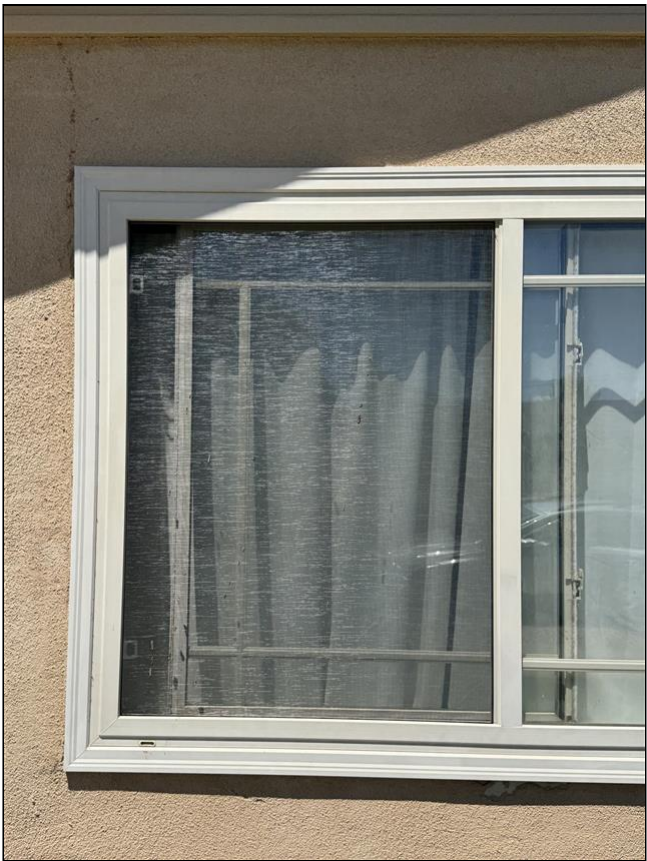
3.1 Item 4 (Picture) Windows 4- Deteriorated Screen

-The Inspector observed no deficiencies in the condition of window exteriors at the time of the inspection. However, the screens are old and showing signs of deterioration. It is recommended to replace the screens as needed.

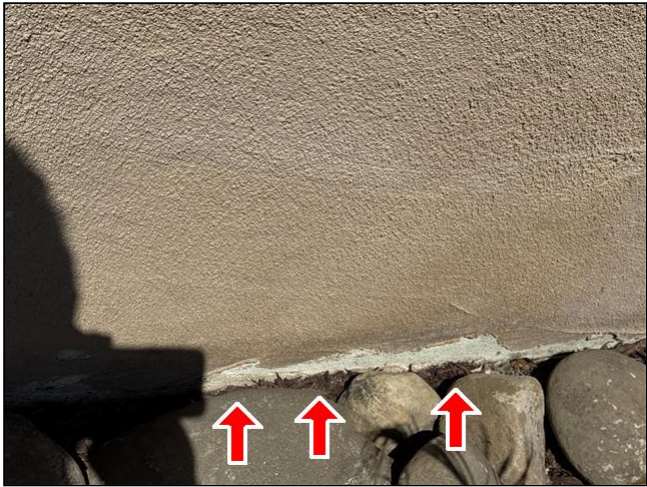
3.3 Item 1 (Picture) Paint Damage

-Minor cracking and/or buckling of stucco and paint chipping visible at floor levels due to moisture and other weathering. The stucco exterior wall covering appeared to be adequately protecting the home at the time of the inspection. however, it is recommended to have the stucco patched as needed and repainted by a licensed contractor and regularly monitored to prevent moisture intrusion into the slab foundation.

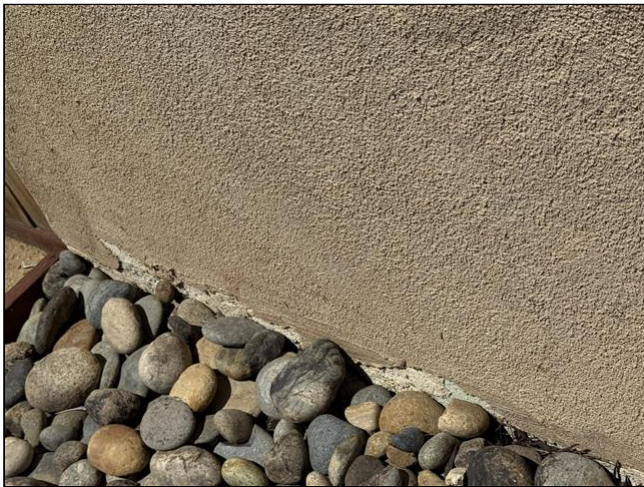
4.0 Item 1 (Picture) Bottom of Front Wall

-At the time of the inspection, the Inspector observed few deficiencies in the condition of the visible portions of the concrete basement floor slab. Notable exceptions will be listed in this report. Most of the slab was not directly visible due to floor coverings.

-As recommended in section 3.2, the bottom of the exterior wall should be protected with paint and patching as needed to protect the foundation. Reducing moisture to the area will lessen chipping and other weathering as observed.

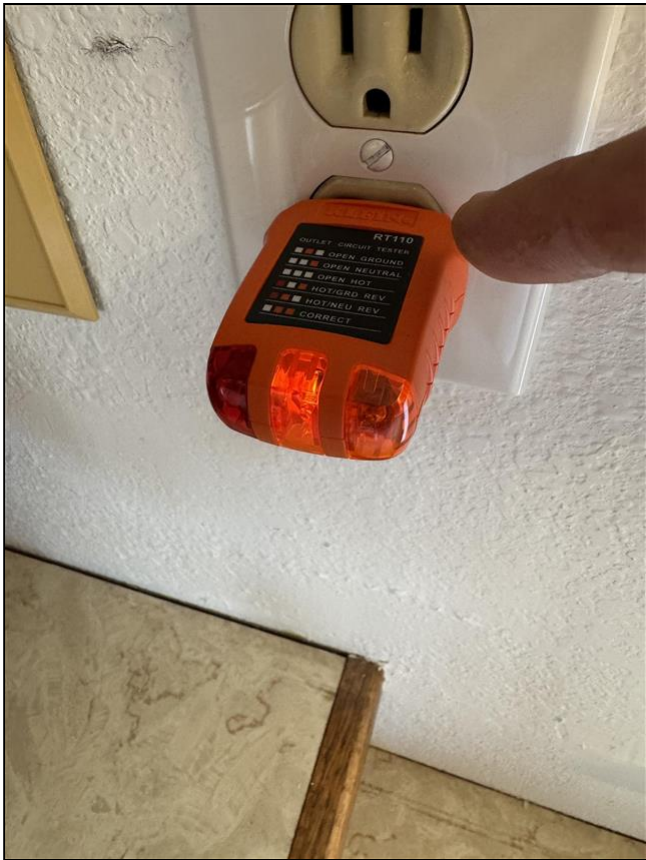
6.4 Item 1 (Picture) Corner Kitchen Receptacle

- A representative number of standard receptacle outlets were tested in each room of the house and only 3 deficiencies were found. 1)The corner back receptacle in the kitchen was not working which should be rewired by a licensed electrician if not related to a switch. 2) The entertainment room had a receptacle that is functional but pulling out of the wall. Please have serviced as well. 3) The front bedroom had an old receptacle with no ground and it was also loose. Please have serviced also.

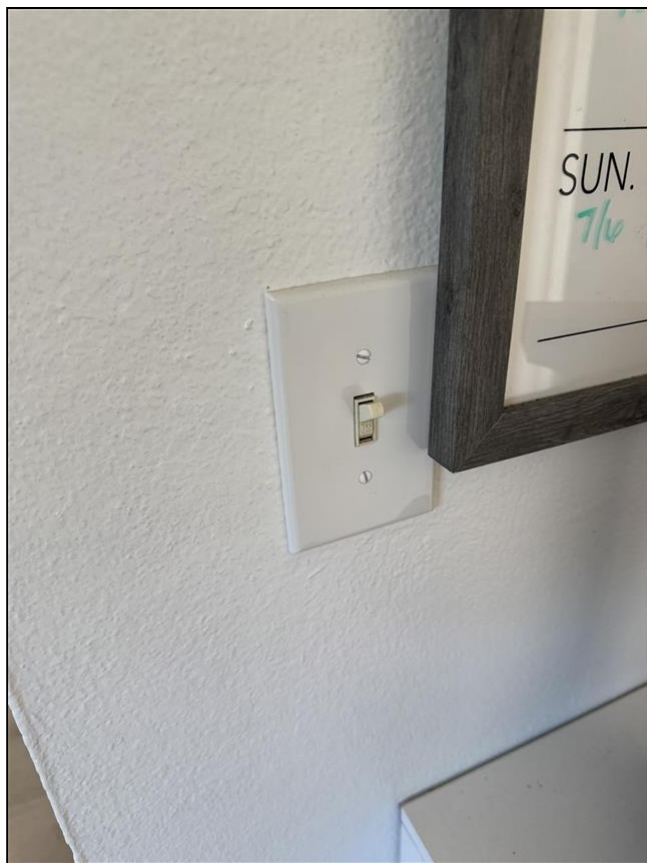
6.6 Item 1 (Picture) Non-Functioning Switch

- The inspector found few deficiencies in the switches that were available for inspection in each room and living area. However, the switch in the main entryway before the living room was not functioning. The switch may be associated with an outlet, but that will require further investigation. All outlets in the living room were functioning at the time of inspection.

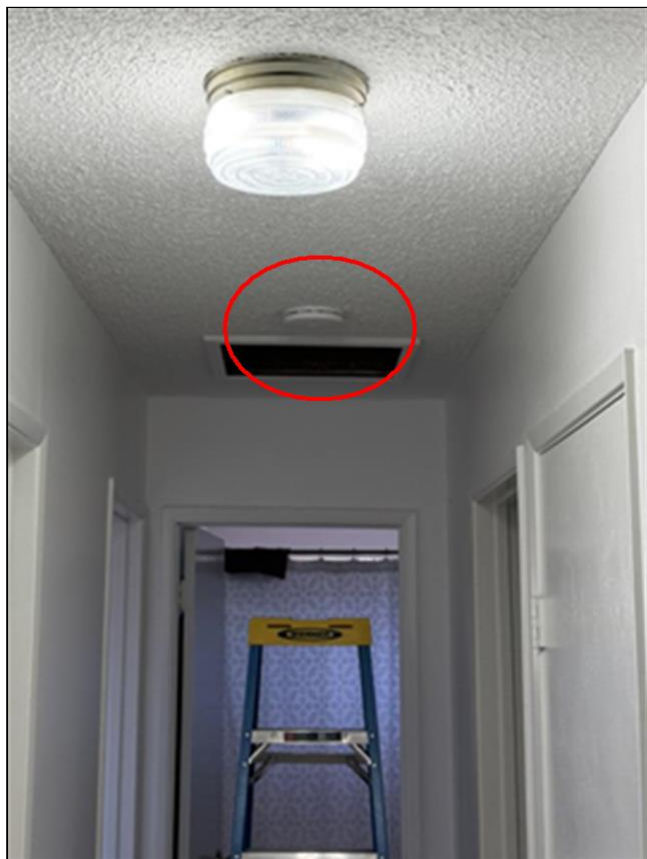
6.8 Item 1 (Picture) Hallway Smoke Detector

- The only smoke detector found was in the hallway and it was functioning at the time of inspection. However, there were no other smoke detectors present in the rooms. By CA state law, a smoke detector should be placed in each bedroom and living space. They should be placed ideally above the bedroom doors. Smoke Detectors should be installed prior to the sale of all homes and may be called out by the appraiser.

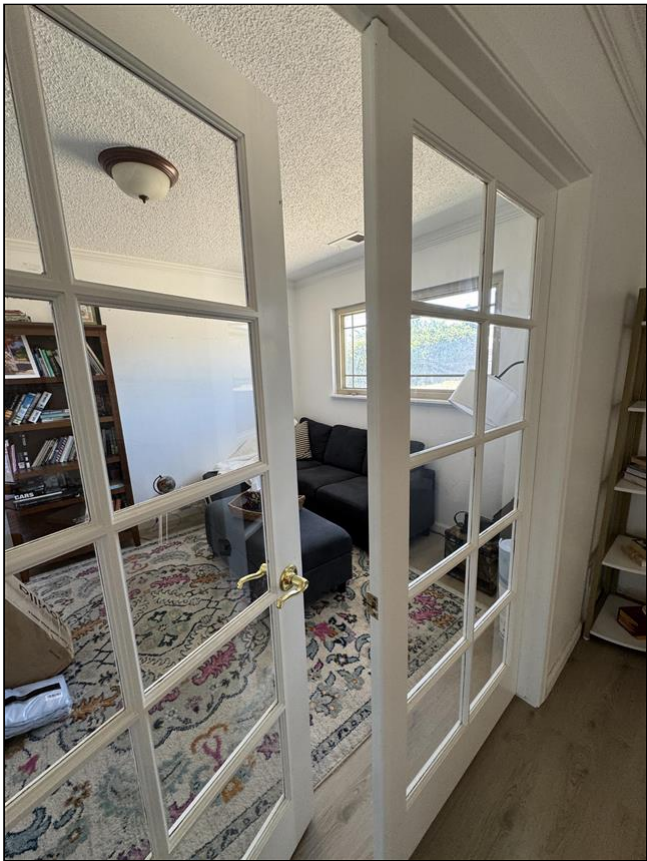
8.4 Item 1 (Picture) Wobbly Doors

- The interior door to the entertainment area are out of alignment and cannot be closed properly. Also, when they are closed, there is only an upper latch and no lower latch to stabilize the door. It is recommended to have a licensed contractor install a new latch and re-align the doors to close properly.
- The patio door is in good working order.

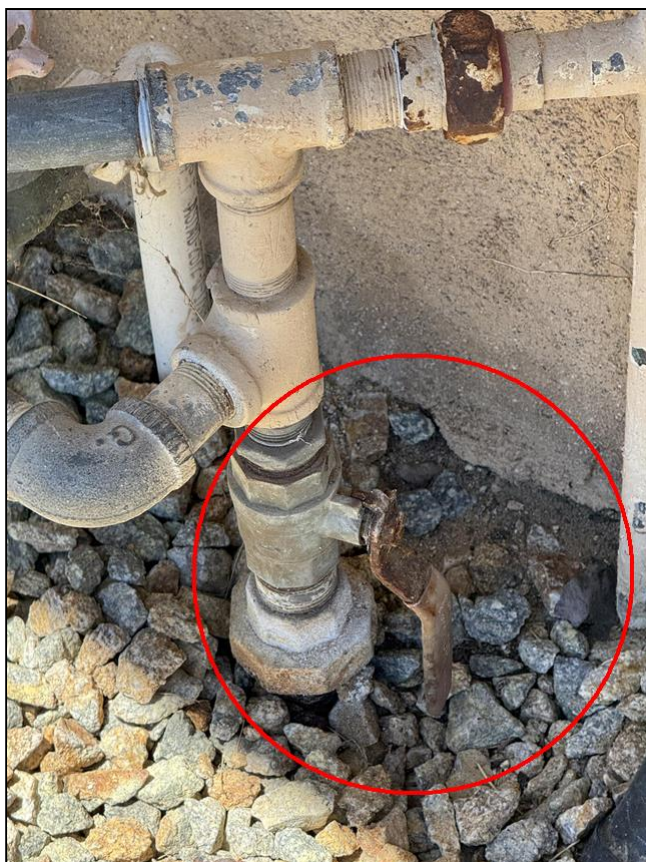
9.0 Item 1 (Picture) Water Shutoff Valve

- The water shutoff valve was operable at the time of inspection, but it is recommended to treat or replace the rust corrosion on and around the valve and then repaint it to reduce corrosion from moisture.

-The front water pressure measured at 90psi, however that is most likely because a pressure regulator was not present (or found). Though 90psi is not prohibitively high, a recommended range is 70-80psi to preserve the pipes over time. Nonetheless, a regulator may be installed for added assurance and reduced pressure fluctuations if that is a problem. Please refer to a licensed plumber for further information.

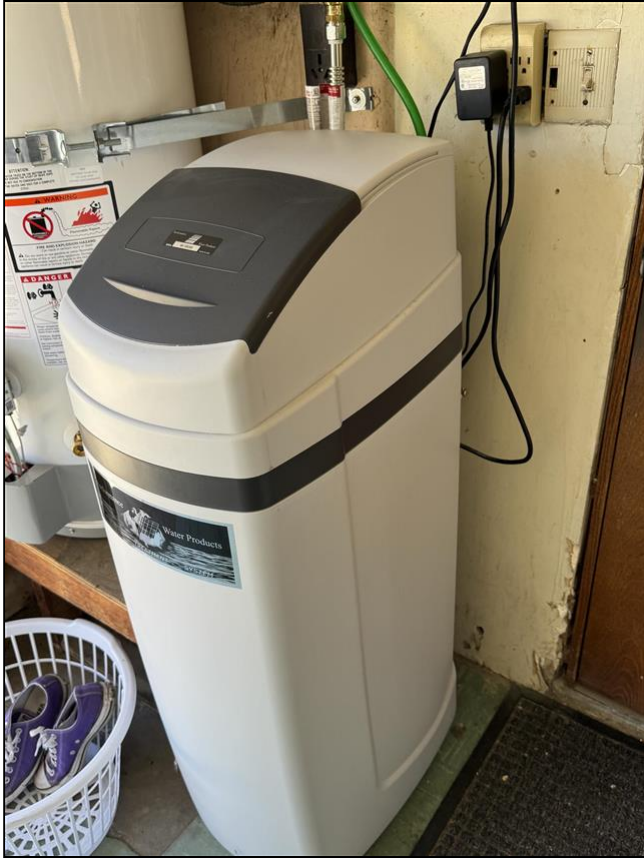
9.2 Item 1 (Picture) Water softener

- A water softener was present at the time of inspection. However, it is beyond the scope of the inspector to inspect these systems. It is recommended to refer to the owners manual if present or contact the manufacturer for more information.

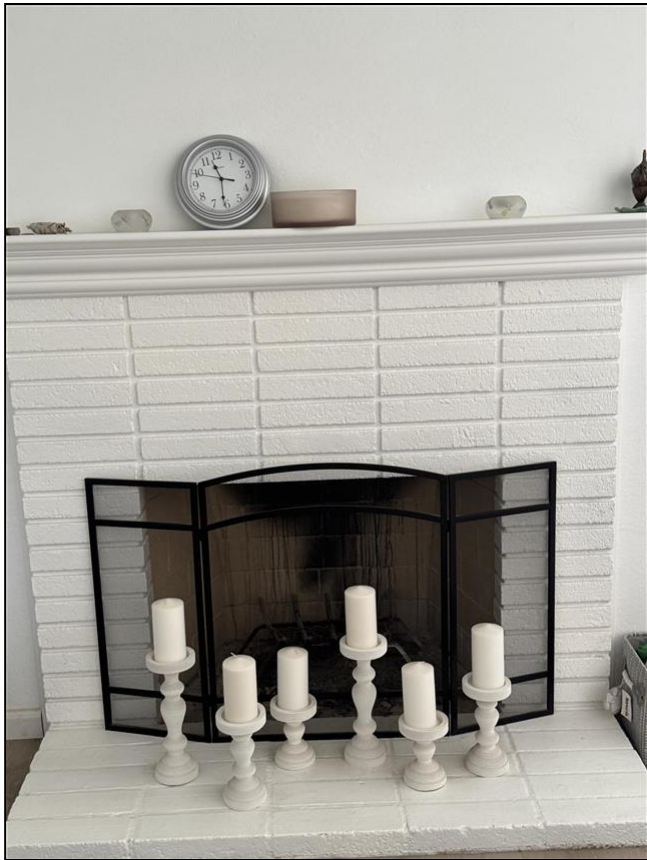
10.3 Item 1 (Picture) Wood Fireplace

-The home contained a wood-burning fireplace located in the main floor family room. It is recommended to have a fireplace professional inspect the operability of the flu and cleanliness of the fireplace before starting a fire. Making these determinations is beyond the scope of a home inspector due to the hazard and liability if not done properly. In addition, an inquiry on the placement of a spark arrestor should be discussed.

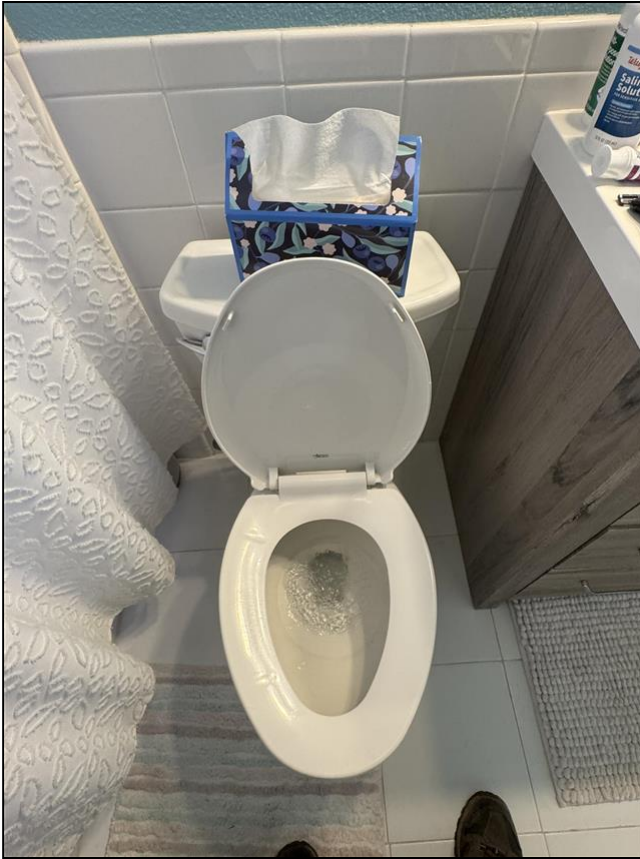
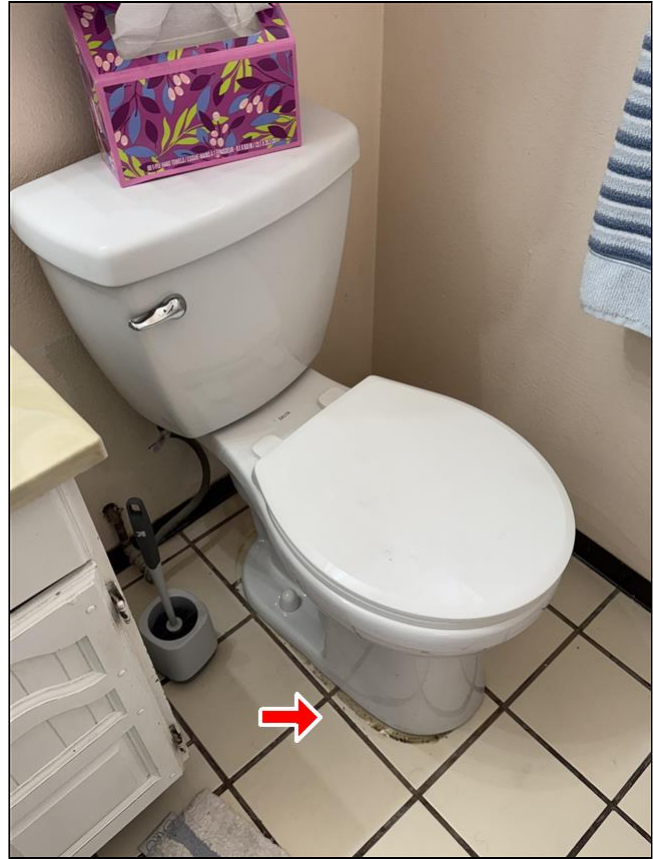
-The hallway toilet was in good condition , but the master bathroom toilet must be re-seated or tightened by a qualified plumber as it is very loose and could be dangerous.
