# Inspection Report

**Property Address:**  
92635 Commercial Ave  
San Luis Obispo, CA 93401

| <b>Date:</b> 7/17/2025 | <b>Time:</b> 12:00 PM | <b>Report ID:</b><br>92635Commercial |

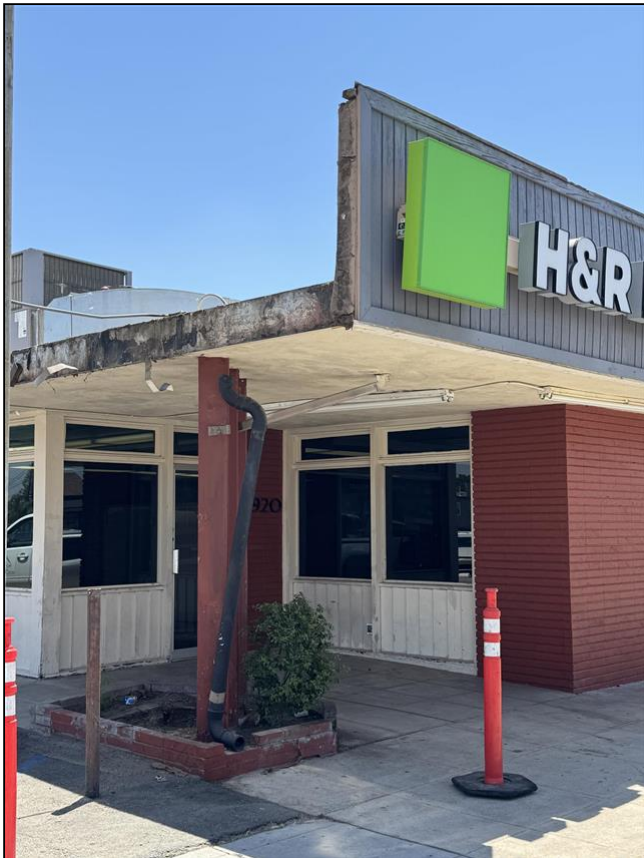
1.0 Item 1 (Picture) Front Corner

Most of my commentary pertains to what is already in the inspection. The main points of the inspections are related to the roofing which is currently undergoing major repair and rebuilding in the overhang section. As will be mentioned, my conversation with the roofer clarified that the owner will not be paying for the gutters that are needed to be replaced in the front. To give context, the roof is slanted to drain the water in the front of the building where the water will likely pool without proper drainage installed after the repairs. I highly recommend that this issue is brought up with the seller prior to purchase. Even after

repairs, without proper drainage, the roof could collapse under the weight of pooled water. More will be mentioned pertaining to the roof in the main report.

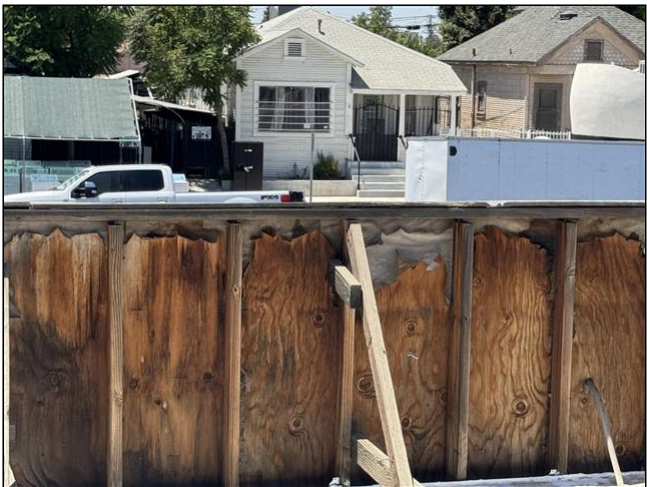
2.0 Item 6 (Picture) Street Facing Facade

-The roofers will not be fixing or repairing the facade facing the street which has wood that is old and damaged by weathering. It is possible to repaint the wood to last longer, but left as is , the facade will eventually lose structural integrity and begin to fall apart. It is recommended to discuss this with the seller and if needed, contact the current (or another) roofer to repair/replace that wood and paint it for protection.

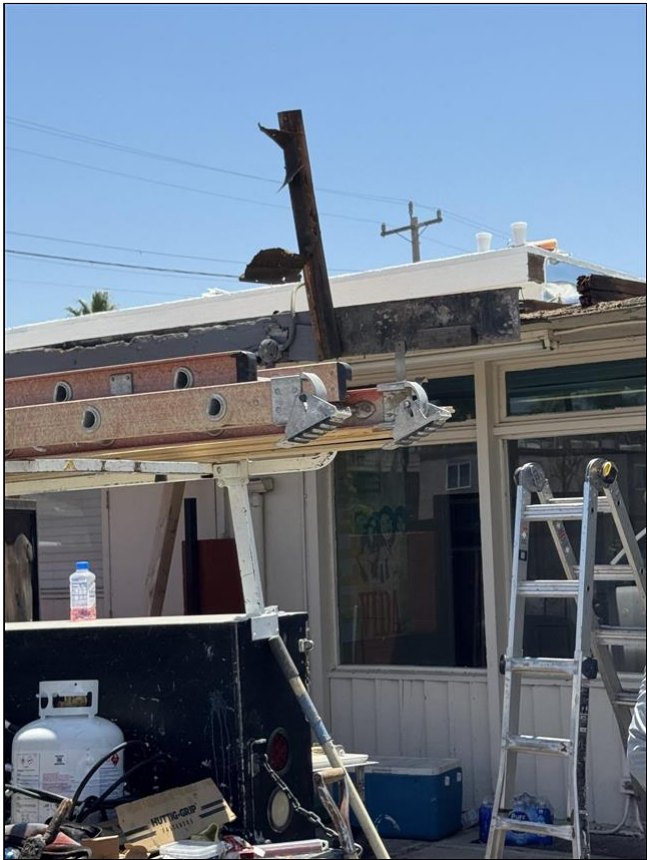
3.0 Item 1 (Picture) Roof and Overhang Work

- The overhang repairs being performed will remove old rafter wood and extend the overhang with new wood and a front facing wall facade. Prior to the repairs the end of the old rafter wood was deteriorated leading to the slumping of the old overhang.

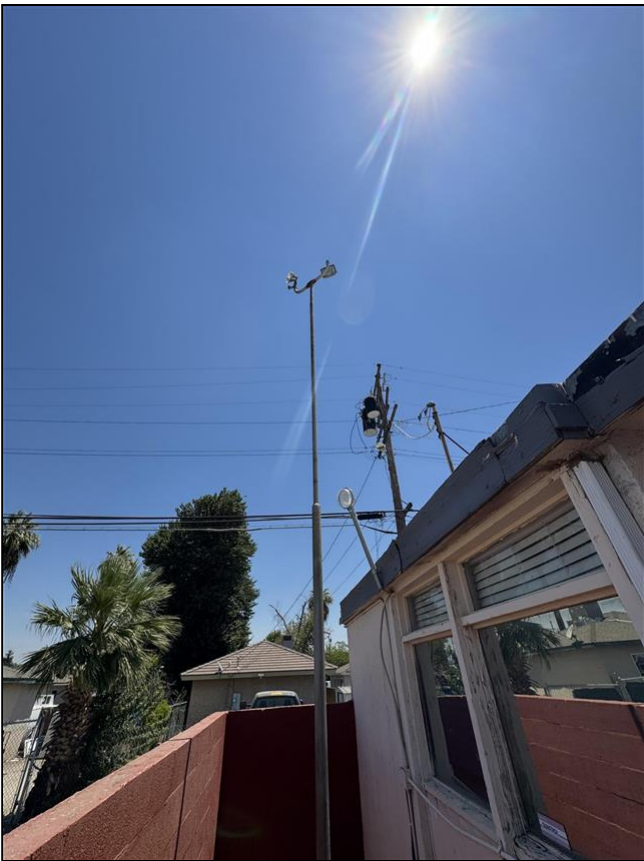
3.6 Item 3 (Picture) Lights

- There are several fluorescent lights under the overhang, now being repaired, that are burnt out and need to be replaced. The ballasts seem to be in working order though for the lights that are working in that row.

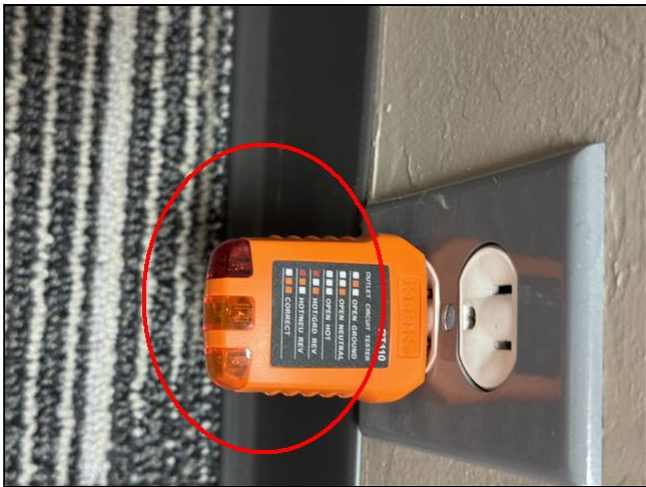
6.0 Item 7 (Picture) End Media Room Test

-Receptacles were tested throughout the building and there were 2-3 receptacles on the wall opposite the screen in the media room that did not work. Close to the screen, below it was a receptacle that was very loose and not properly grounded and nearby was a receptacle that was missing its plate. It is recommended to have a licensed electrician survey the non-operable receptacles and repair the loose receptacle and plateless one.

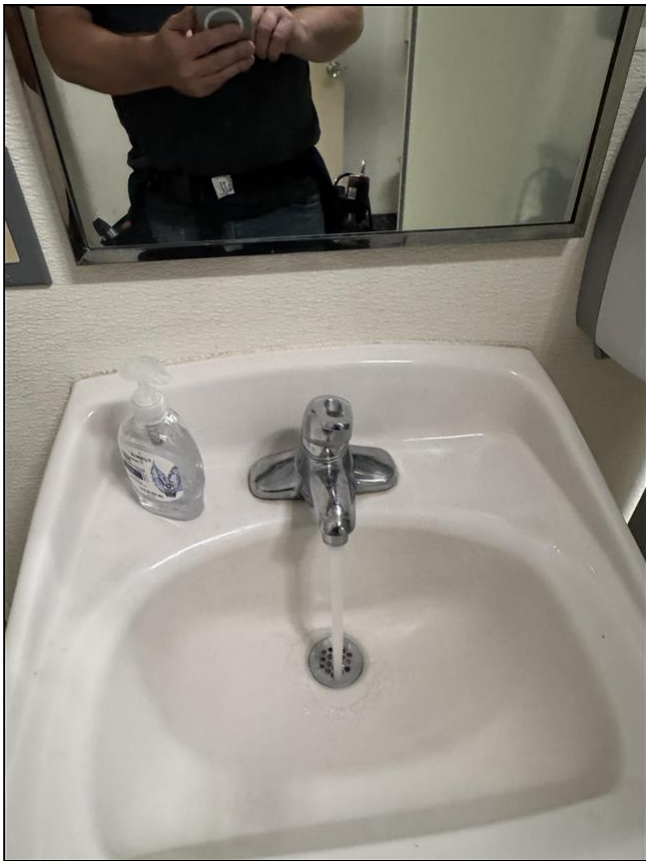
7.0 Item 3 (Picture) Sink

**Inspected-** The bathroom sinks were both functional without leaks and the toilets were also functional. The water pressure tested at 65 psi which is slightly low but better for older pipes as those found in this building. There was a small electrical water heater that supplied the break room and bathroom sinks and it appeared to be in good working condition.

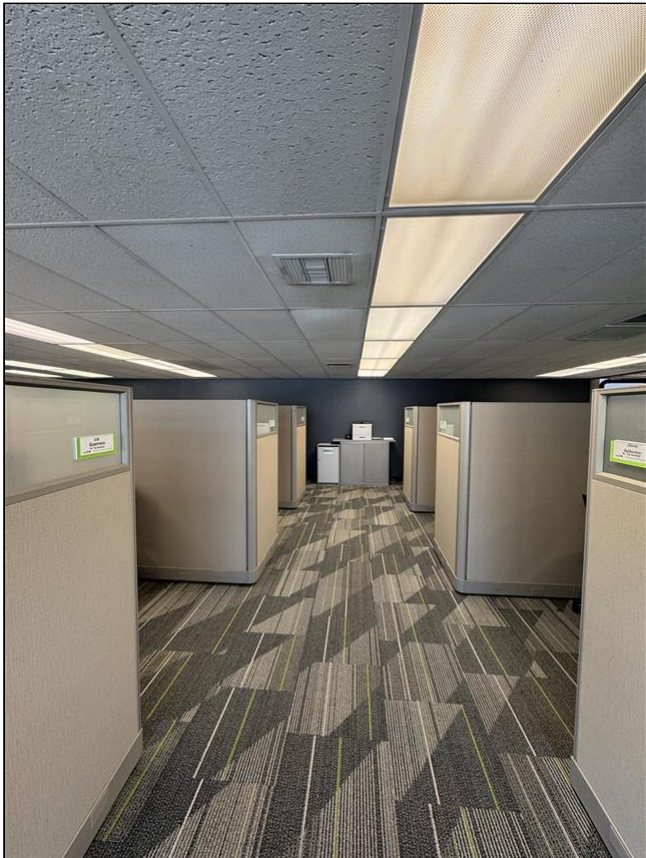
8.1 Item 1 (Picture) Front Ceilings

**Inspected-** The ceilings are generally in good condition, but as mentioned, there were a few roof leaks in the past that have now been addressed by the owner/seller in the current repairs. Those leaks were in the rear conference room and the rear hallway storage room. The roof is being entirely re-sealed and unless a pipe were to burst, there shouldn't be any additional leaks in the near future.

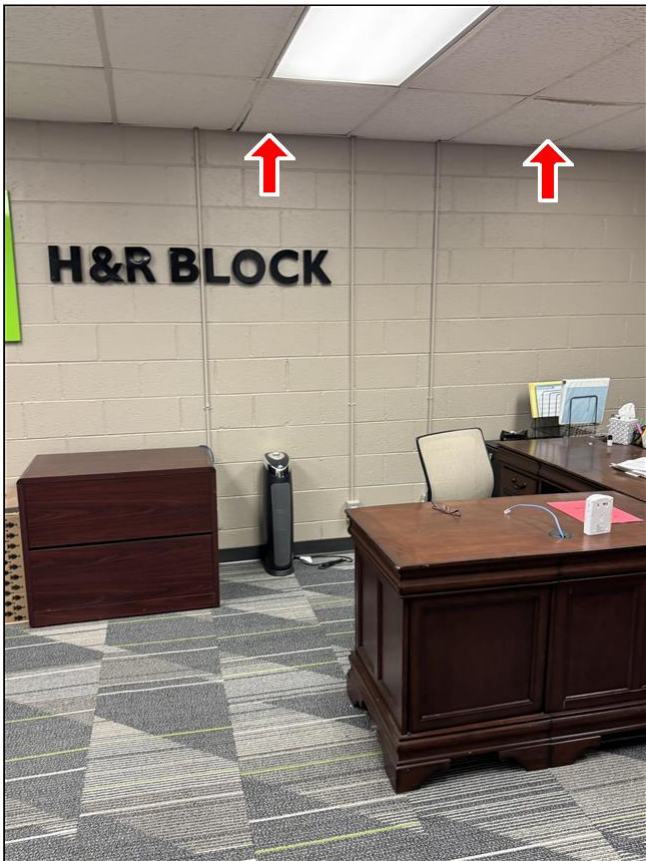
-There are a few missing tiles in the storage room mentioned and also some slightly buckled tiles in the conference room

8.1 Item 5 (Picture) Conference Room Ceiling Buckling

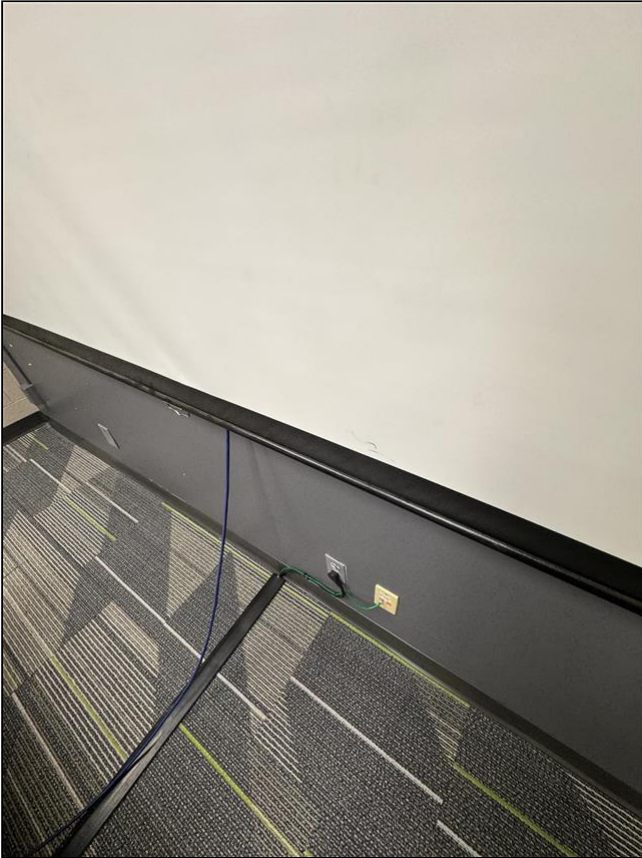
8.2 Item 1 (Picture) Walls 1

**Inspected-** The walls were in good condition at the time of inspection.

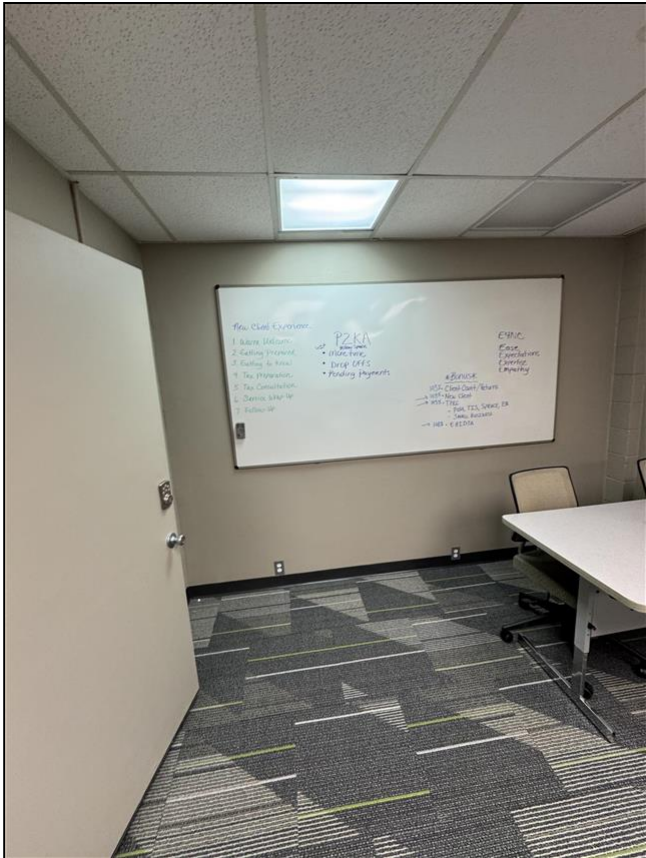
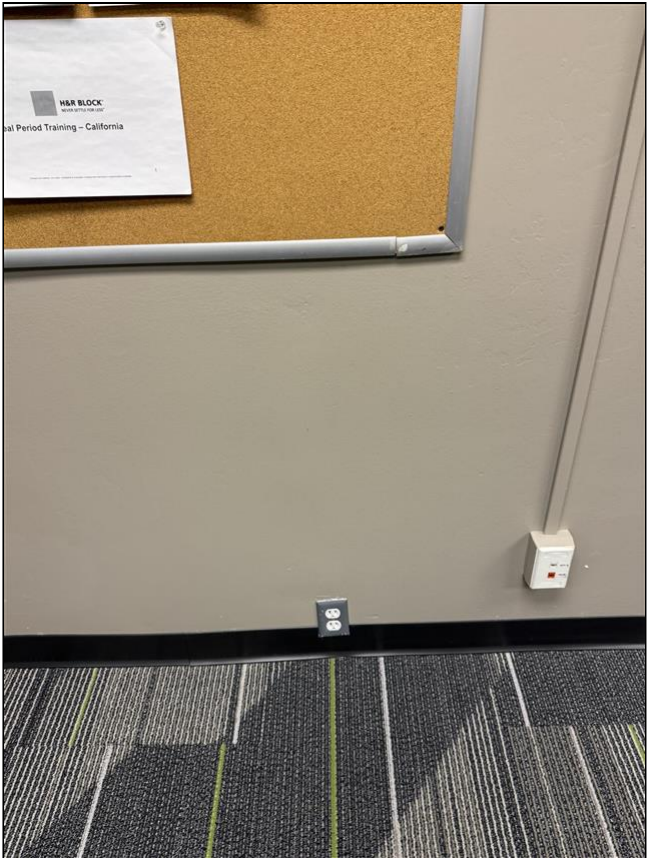
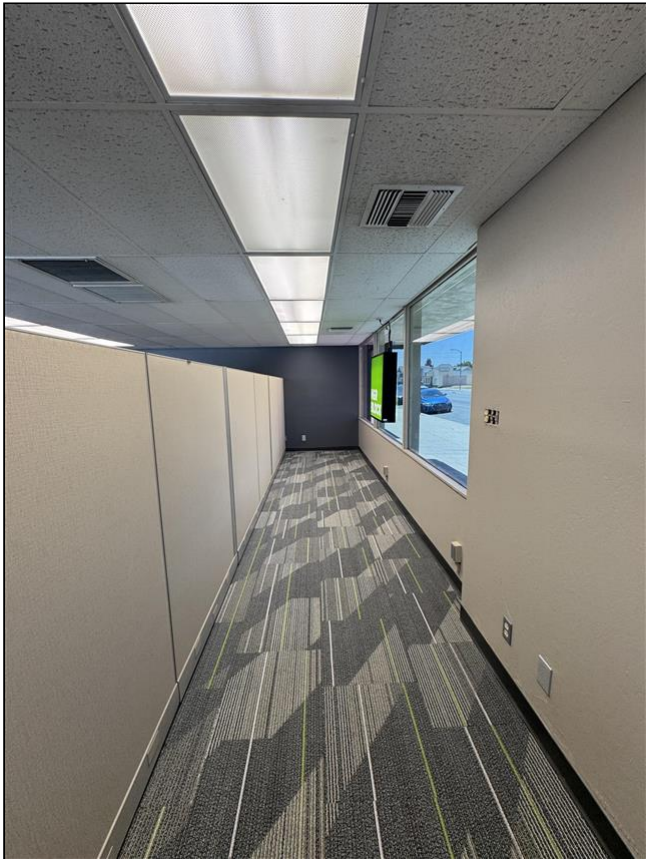
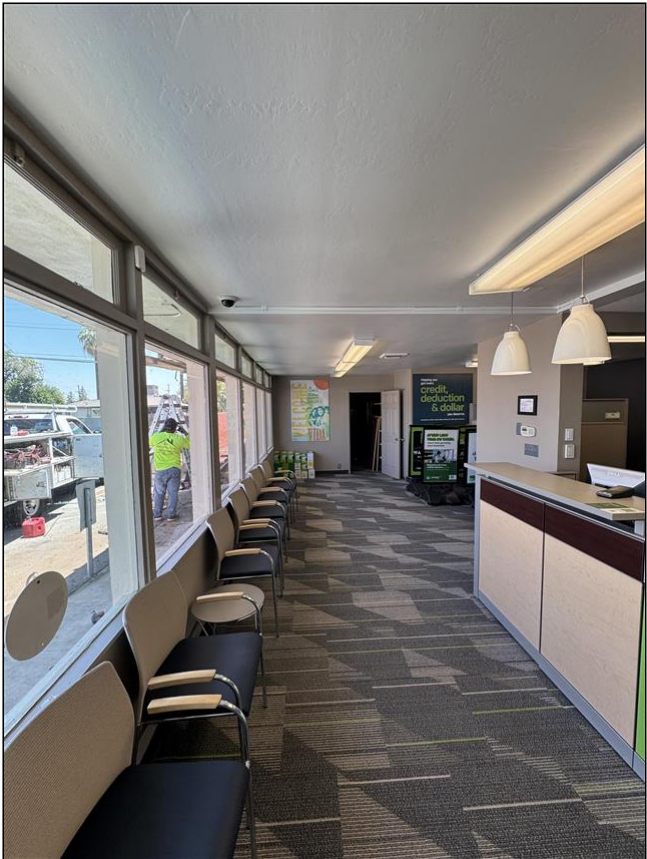
**Inspected-** The floors and trim were in good condition at the time of inspection

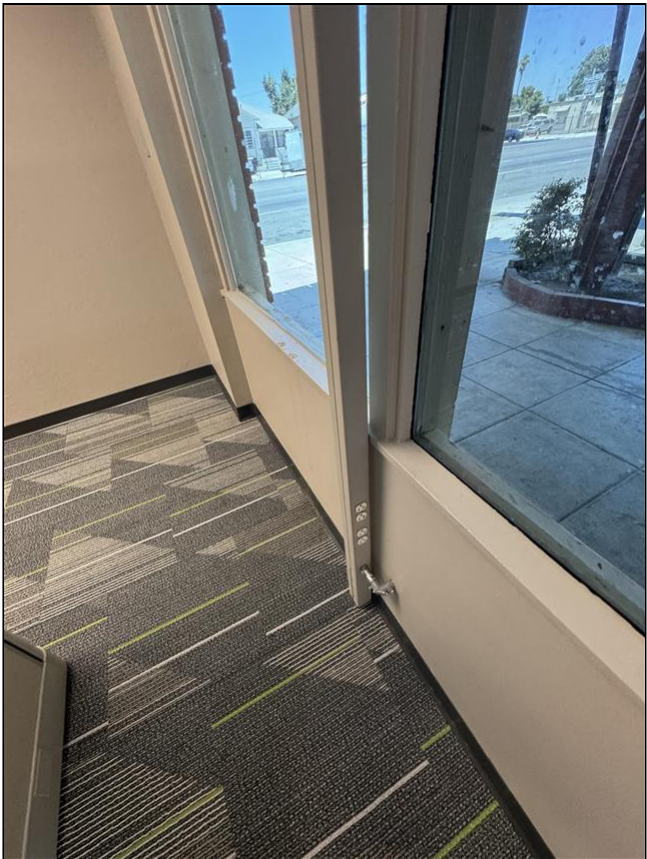
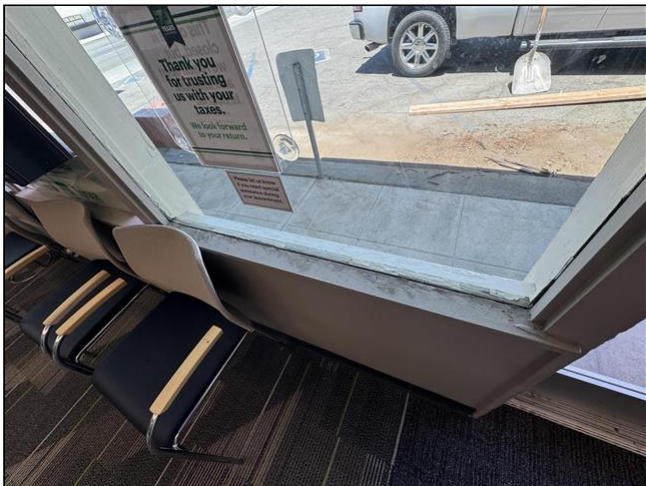
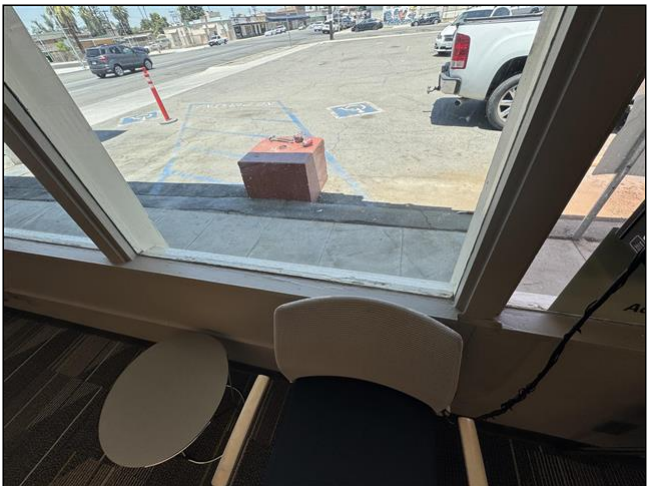
**Inspected-** The glass in the windows were in very good condition, but some of the windows were loose and are in need of re sealing to avoid drafts and improve HVAC efficiency.
