# Inspection Report

**Joe and Rebecca Blow**

**Property Address:**  
1234 Anywhere Paso  
Paso Robles, CA 93446

**Blue Oak Home and Commercial Inspections**

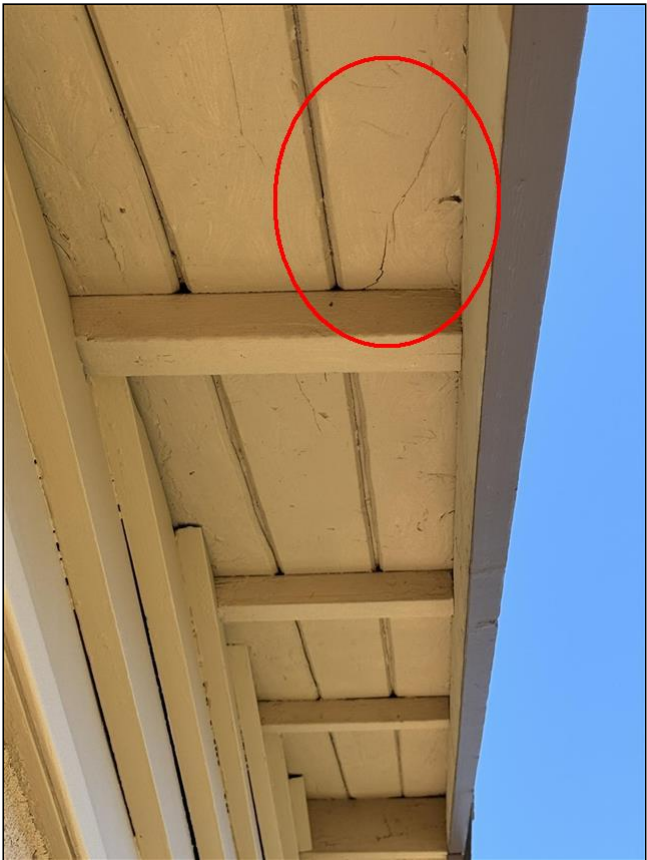
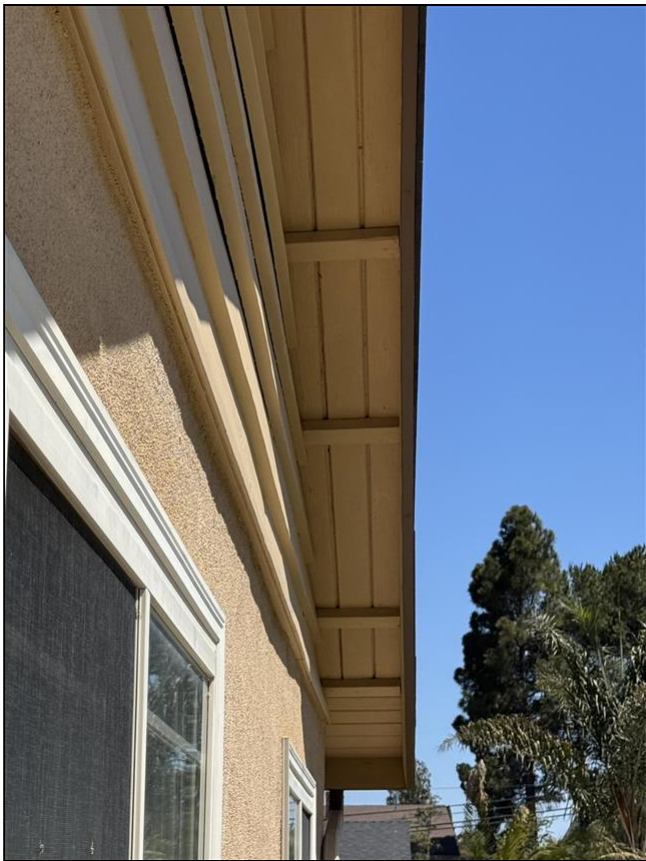
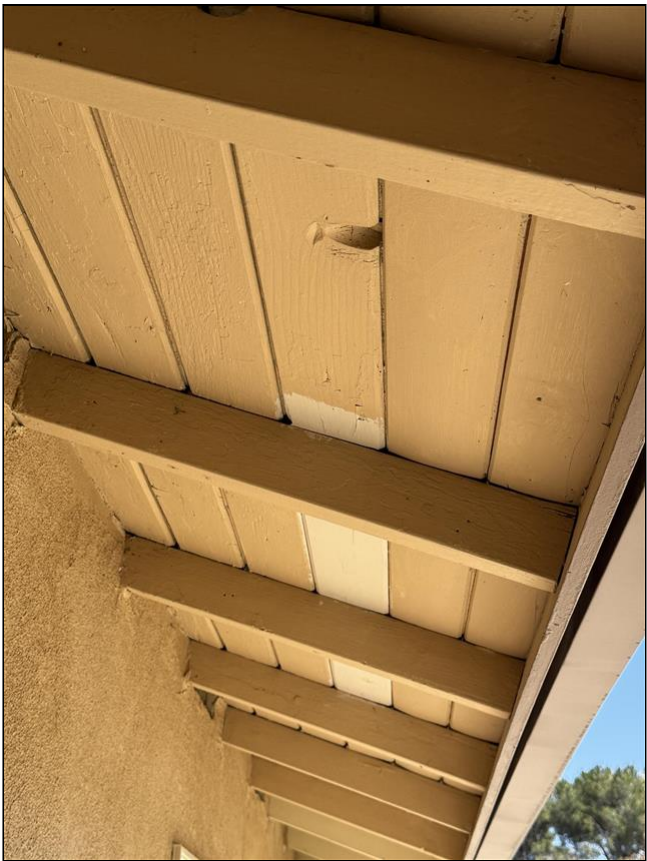
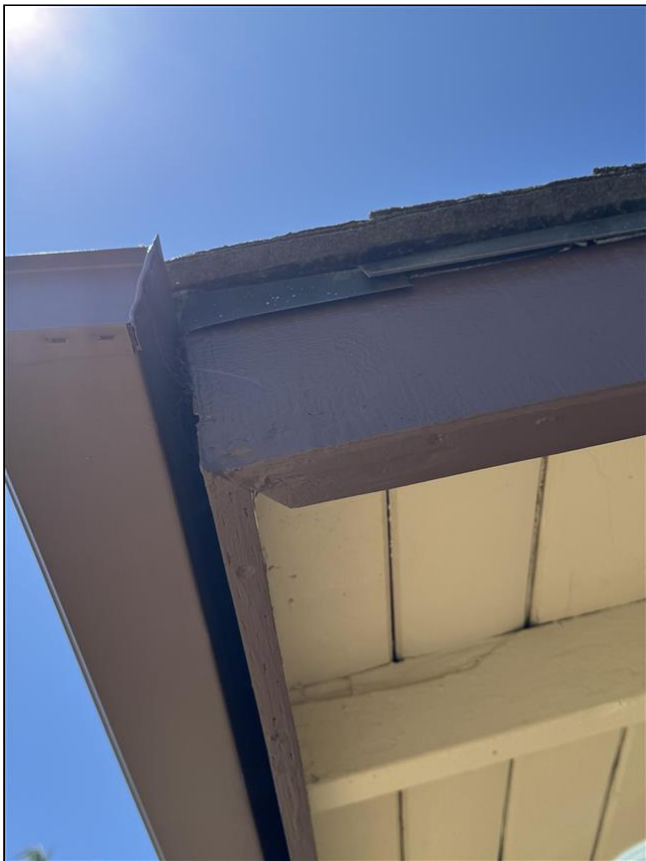
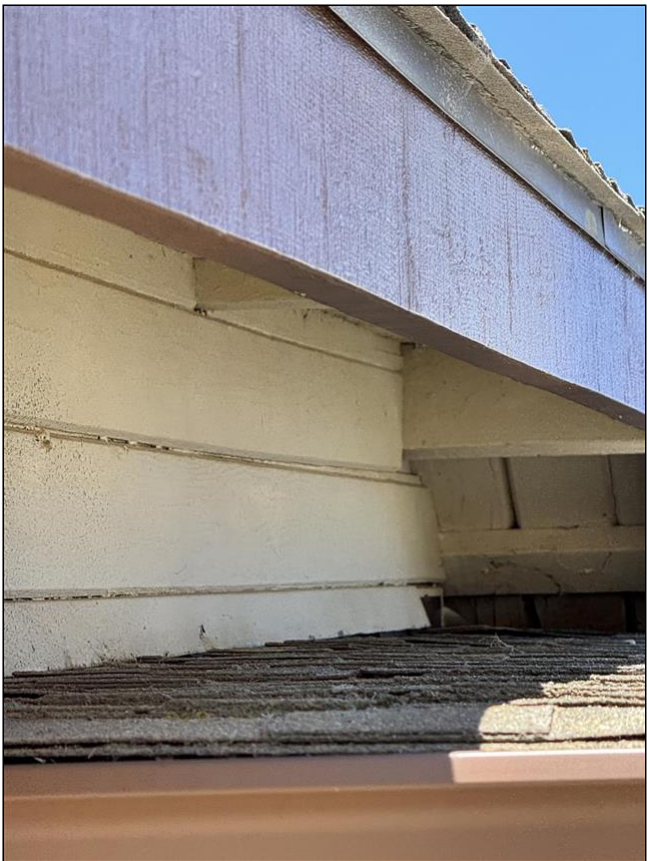
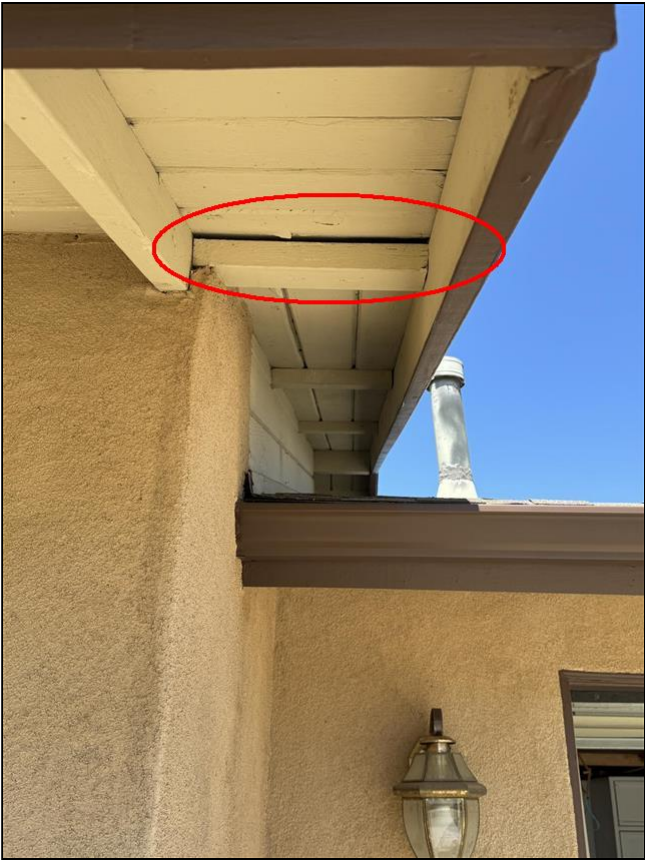
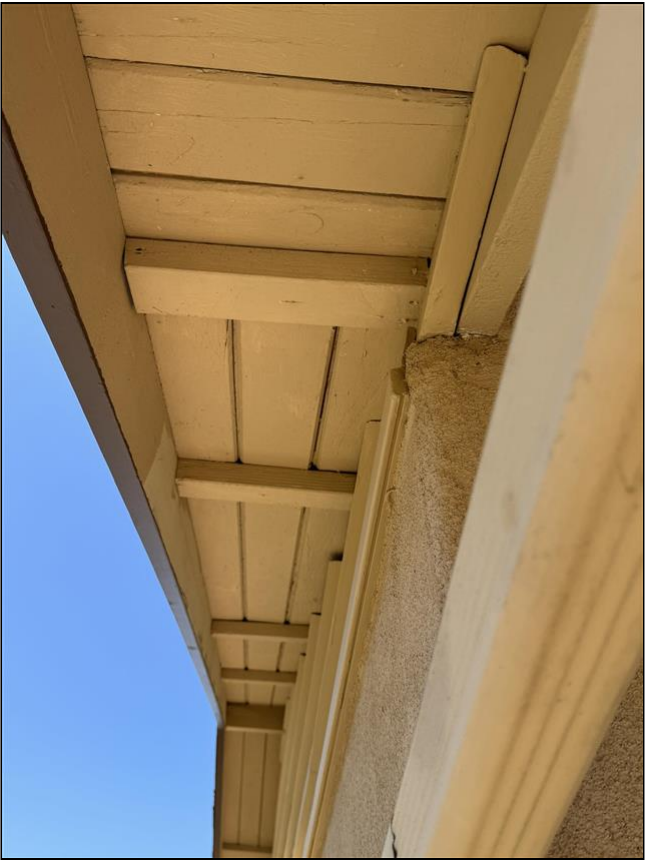
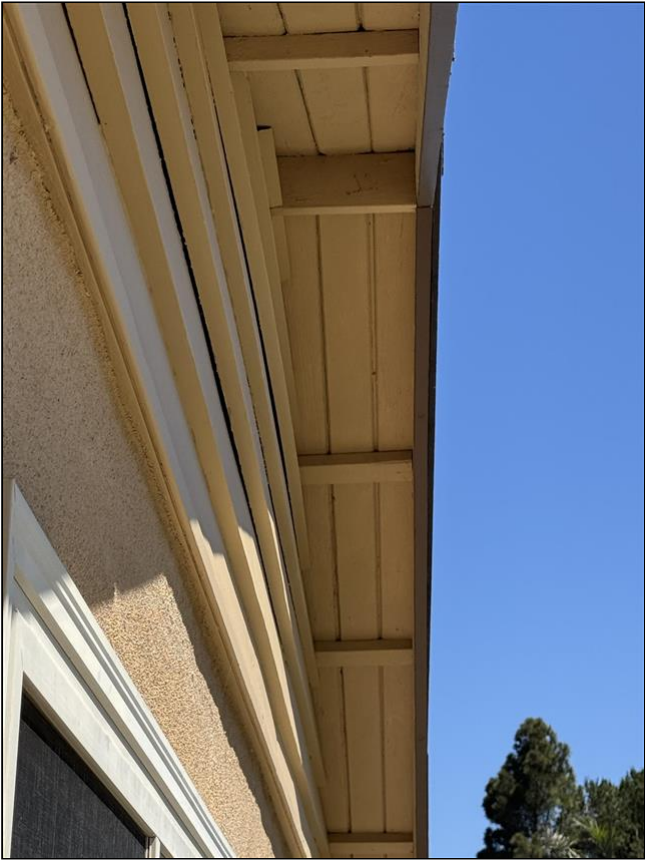
-The inspector observed few deficiencies in the condition of the roof structure exterior. There was a minor crack in one outer soffit board and a board that had about a half inch of separation from the exterior roofing underside. Both of those should be repaired or secured by a licensed contractor to prevent moisture, pests, or deterioration.

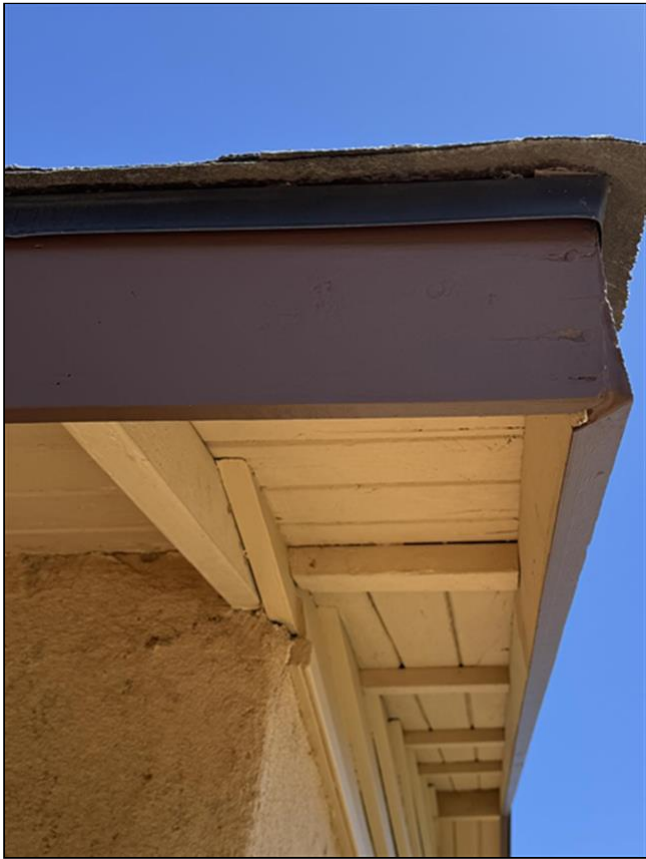
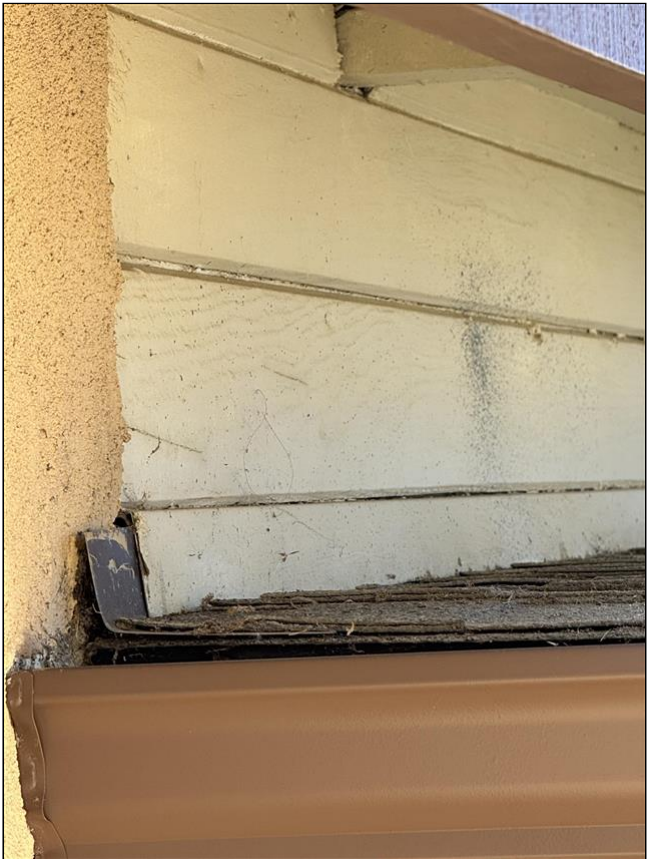
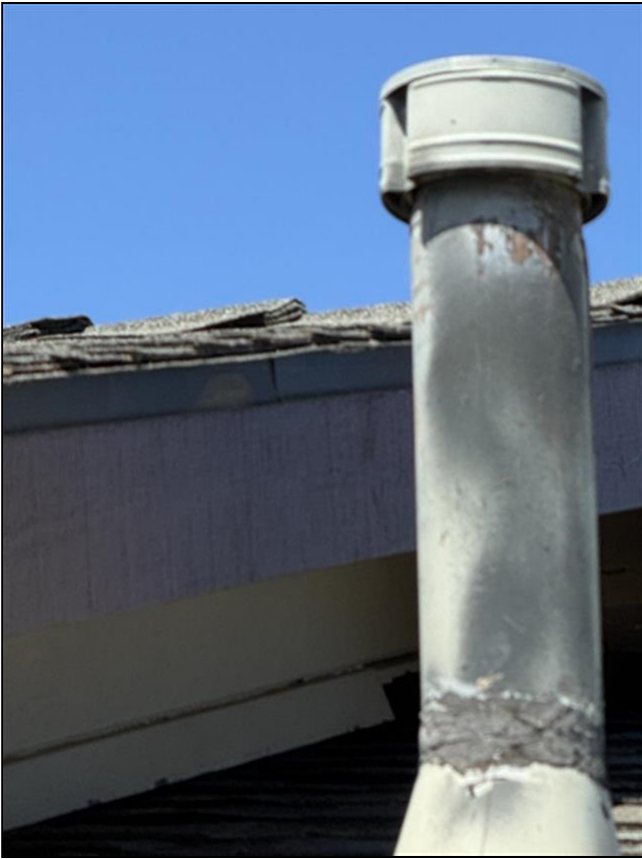
-The inspector observed few deficiencies when inspecting roof flashing.

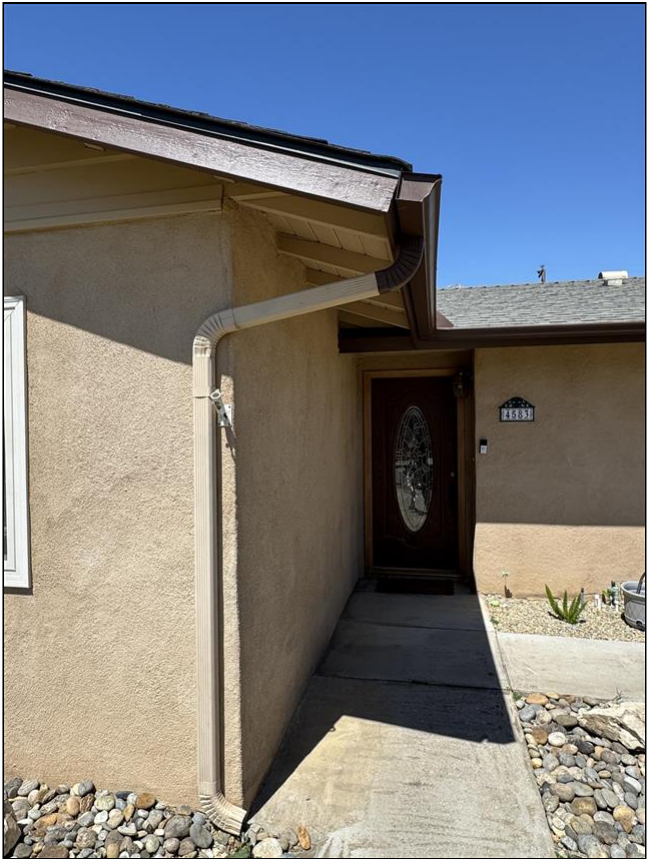
1.2 Item 2 (Picture) Downspout

- In general, the gutters and downspouts are all in good condition. It was noticed the gutters had about a half an inch of dirt in them and should be pressure washed to prevent clogging in the future. There was one gutter where the end was slightly bent upward, but still functional. Also, a few of the downspout connections were loose and should be re tightened and resealed as needed to prevent any leaks. Finally there are a few downspouts where the metal is bent at the bottom. It is recommended to either replace these for esthetic purposes and clog prevention, or bend them back to more open for discharge.

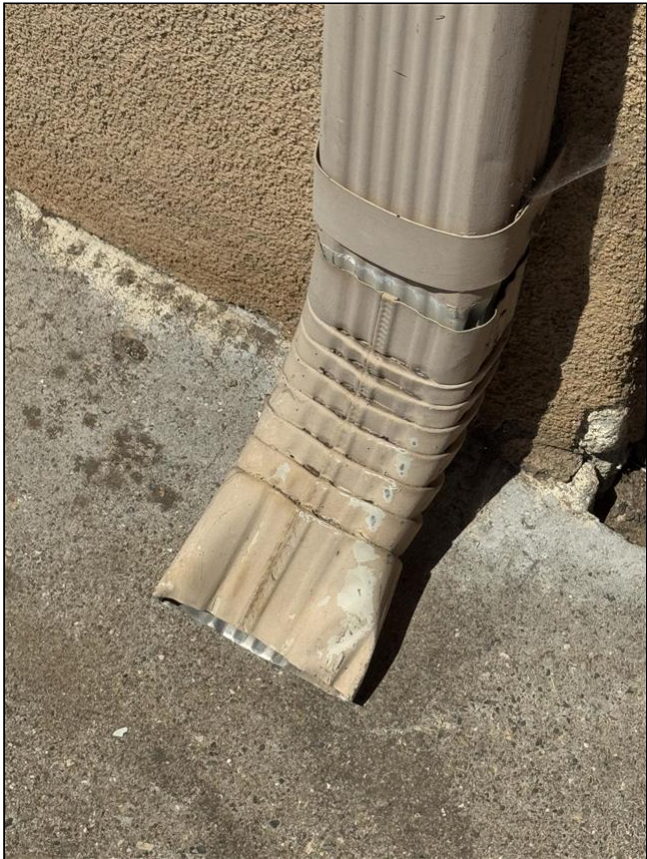
1.2 Item 5 (Picture) Bent Downspout

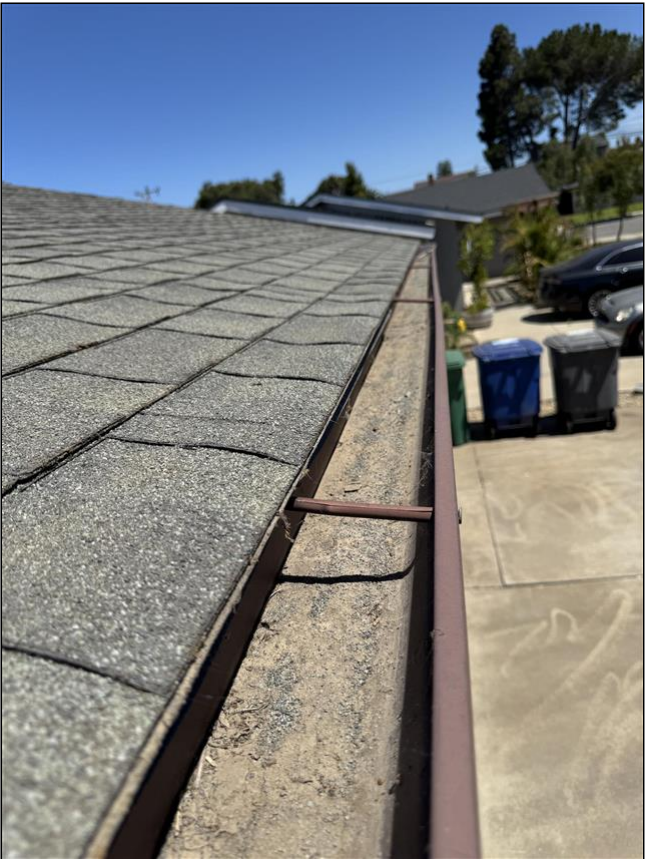
1.2 Item 6 (Picture) Dirty Gutter

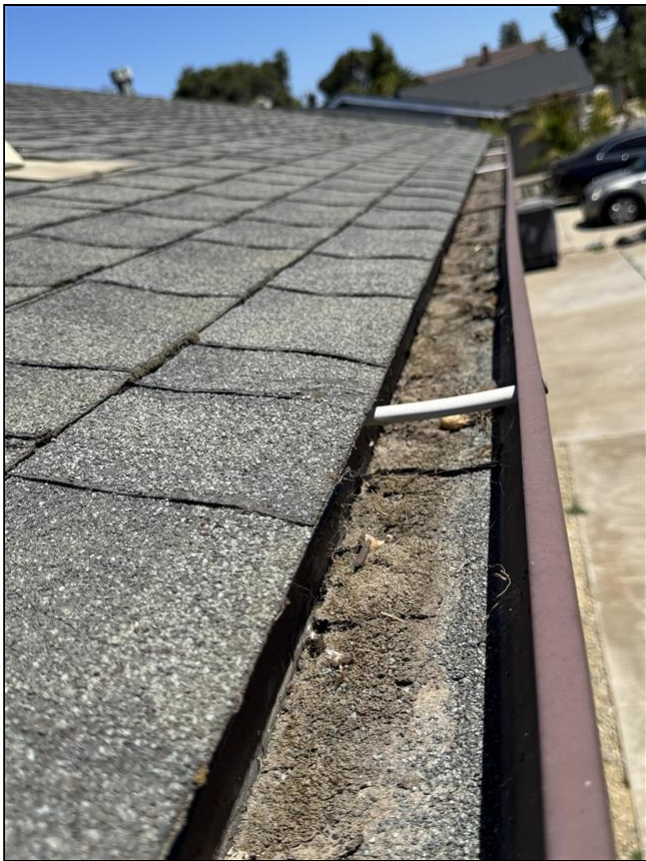
1.2 Item 7 (Picture) Dirty Gutter 2

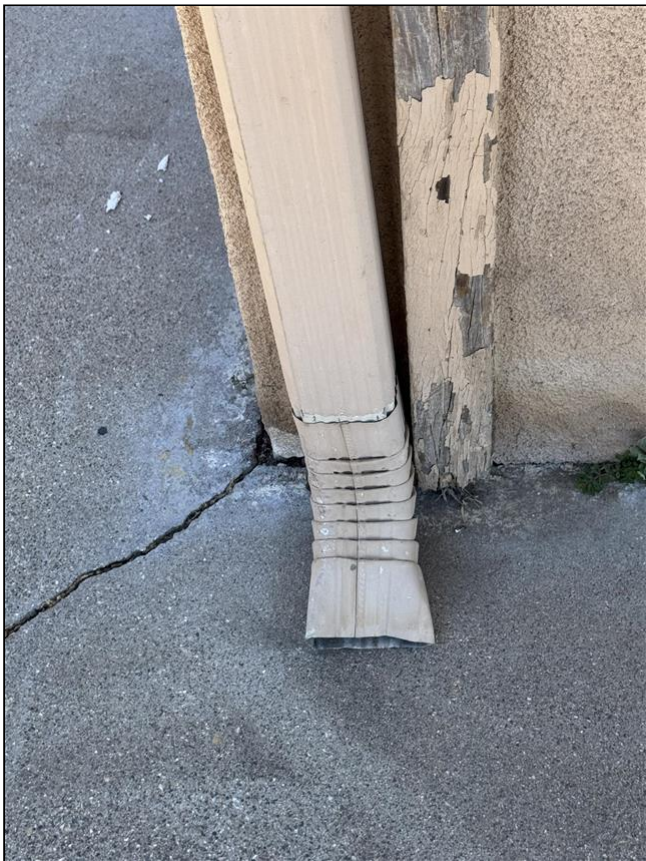
1.2 Item 9 (Picture) Bent Downspout 2

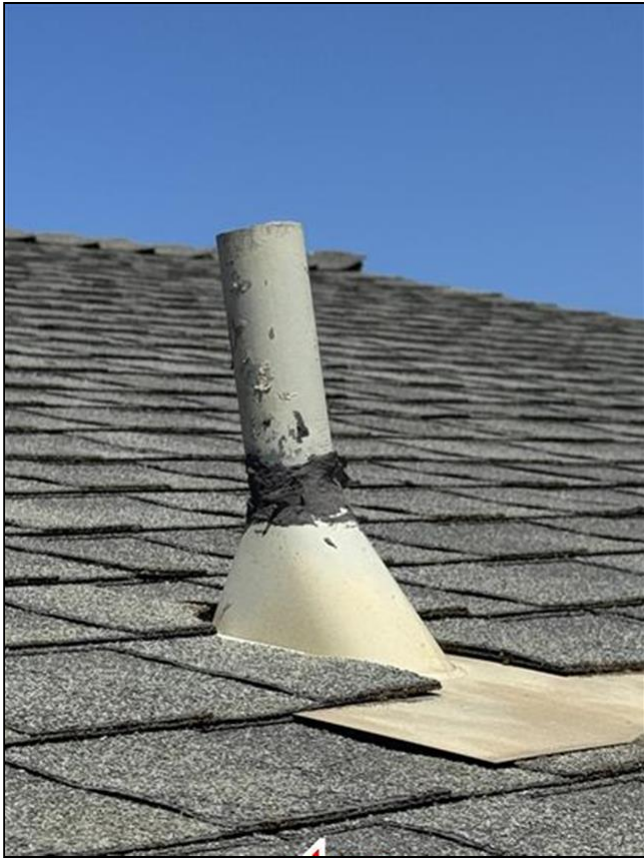
1.3 Item 3 (Picture) Vent 3

-Combustion vents on the roof showed general moderate corrosion. Nonetheless, they were generally in good condition. It is recommended to replace the vents when roof shingle replacement occurs, or paint over the vents to further preserve them.

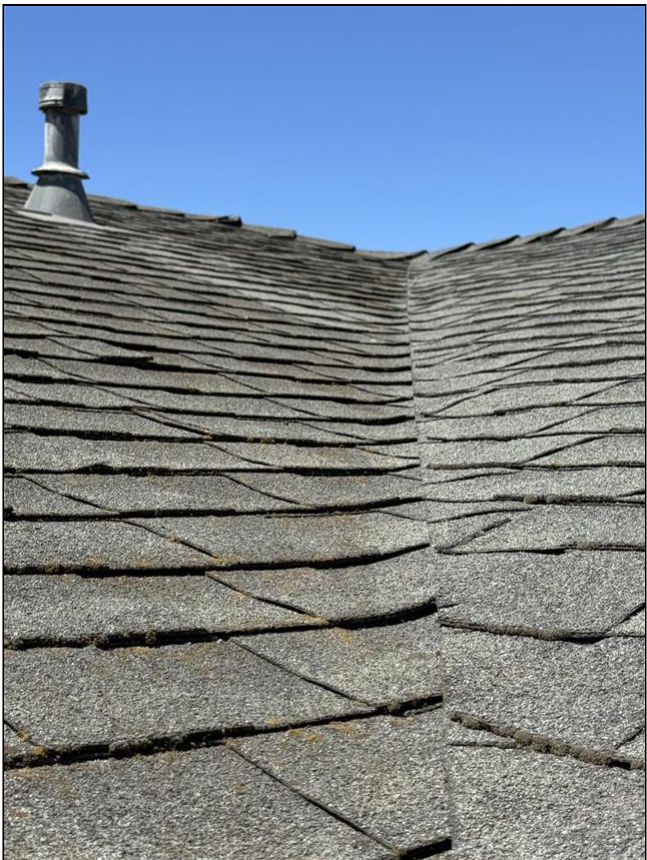
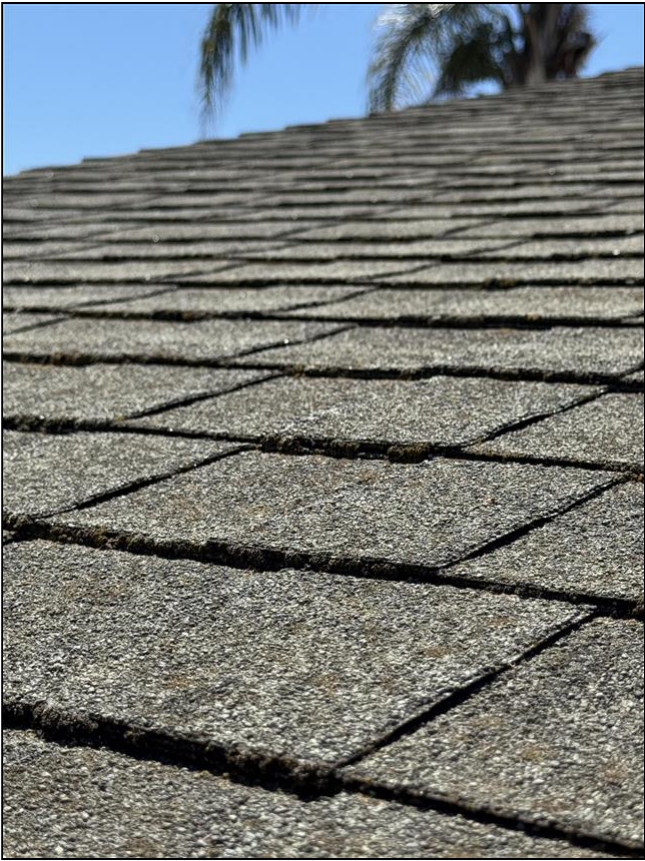
-At the time of the inspection, the Inspector observed few deficiencies in the installation of the asphalt composition shingles covering this roof. The roof overall was fairly straight with few bumps or ripples, but the main thing noted was that the roof was probably more than half its useful age considering the visual appearance and the noted fact that the seller had not replaced any shingles since she bought the house 18 years ago. It is recommended to replace the roof as soon as possible within 5-10 years and monitor closely for weather damage or leaks in the attic. No signs of leaks were discovered at the time of inspection.

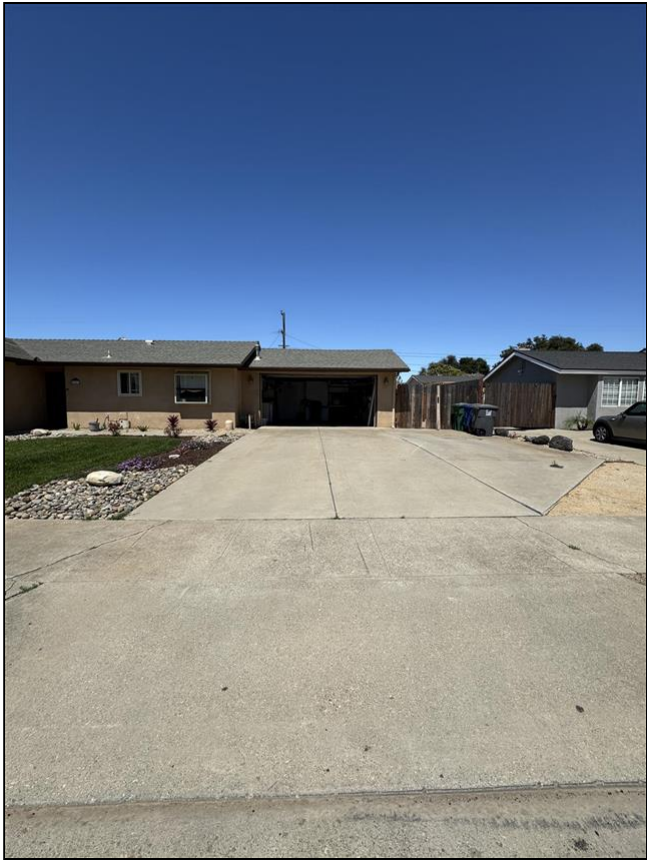
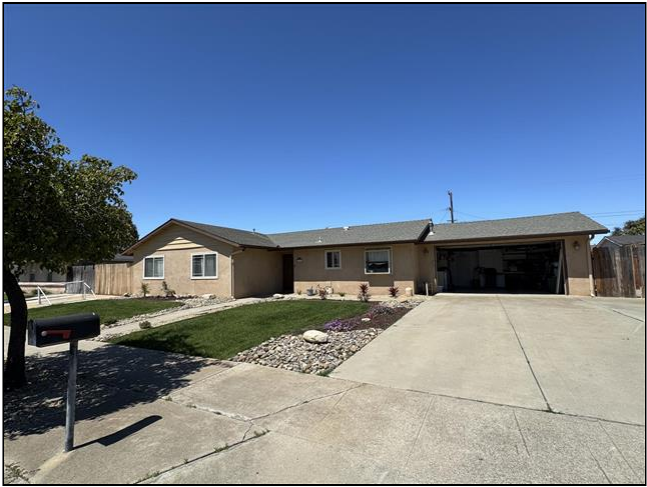
-The Inspector observed no deficiencies the driveway condition at the time of the inspection.

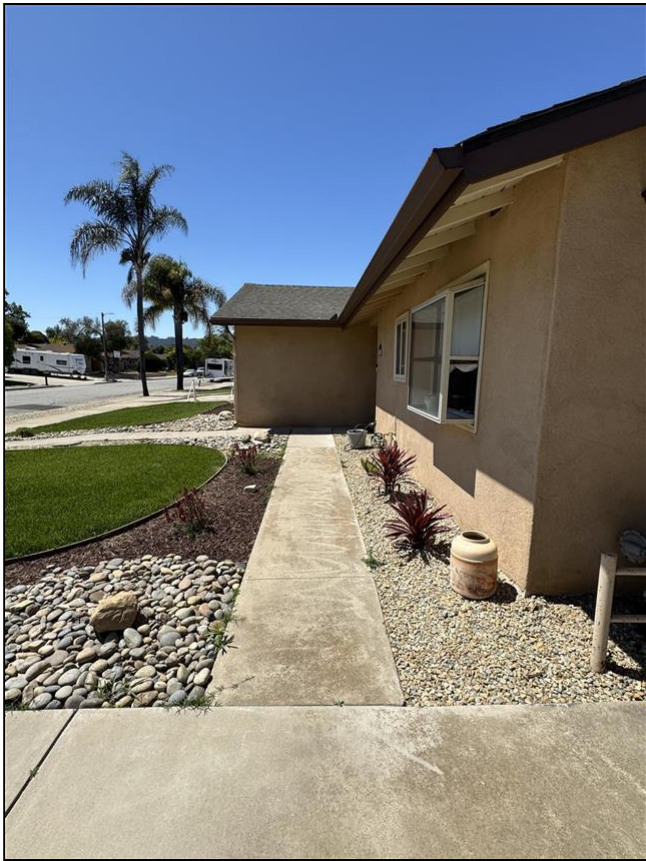
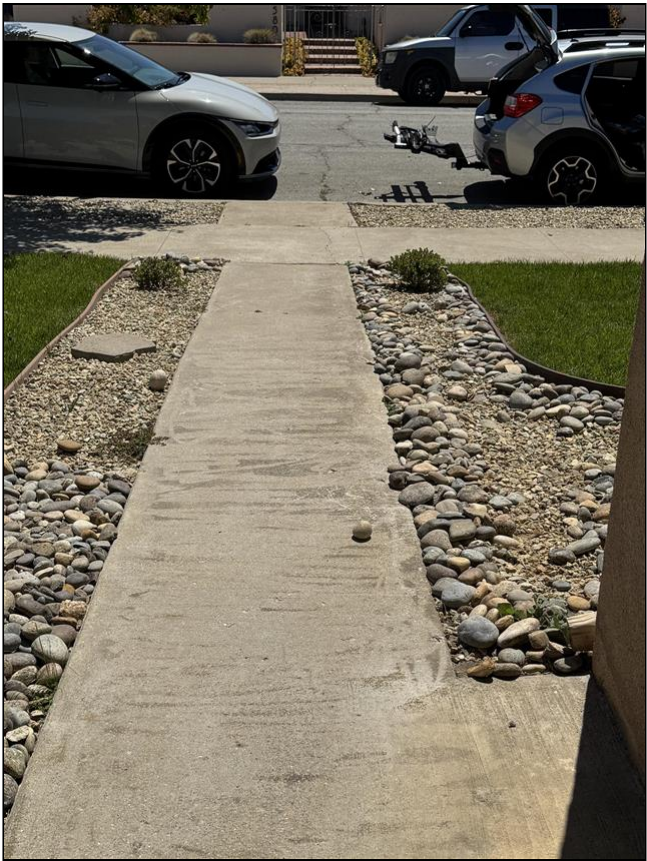
- The walkways were in very good condition at the time of inspection with few cracks. However, there is one large crack that should be filled next to the rear downspout. It is recommended to fill the crack or have a licensed contractor perform the work to prevent moisture intrusion into the foundation at the corner of the house.

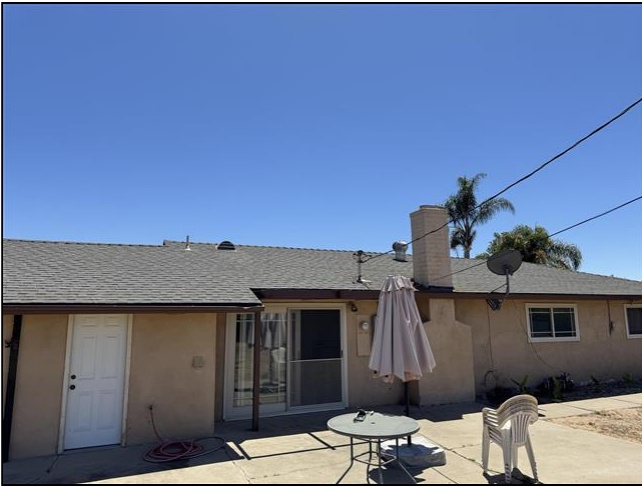
2.5 Item 1 (Picture) Rear Patio

-The Inspector observed no deficiencies in the condition of this patio at the time of the inspection.

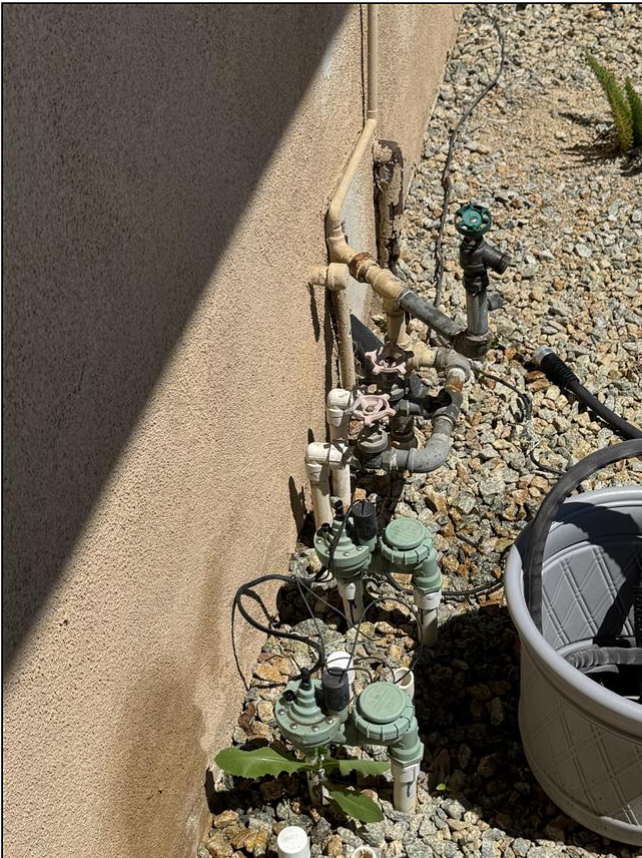
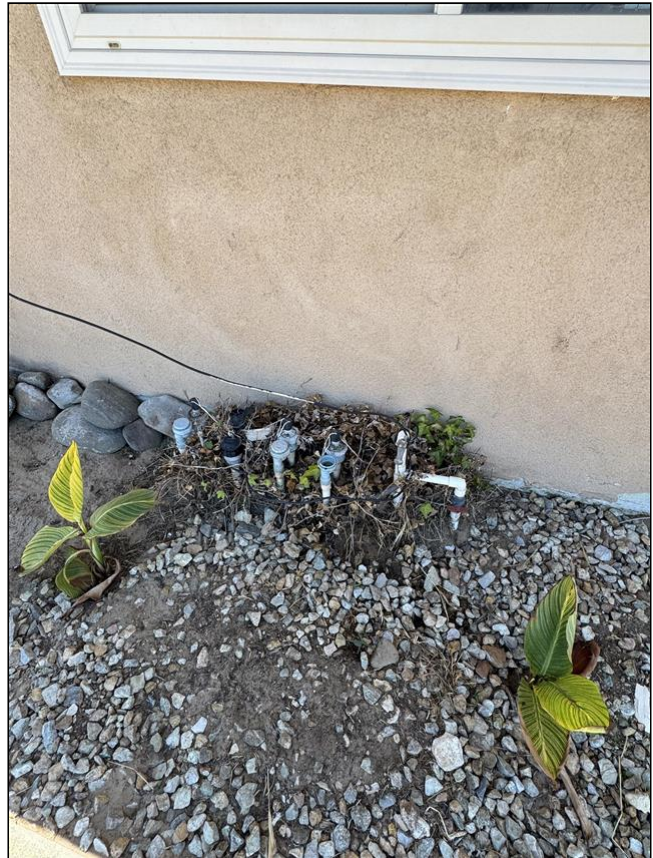
-The home was equipped with a landscape irrigation system. Inspection of irrigation systems lies beyond the scope of the General Home Inspection and the Inspector did not inspect the system. You may wish to have this system inspected by a qualified irrigation or landscape contractor before the expiration of your Inspection Objection Deadline.

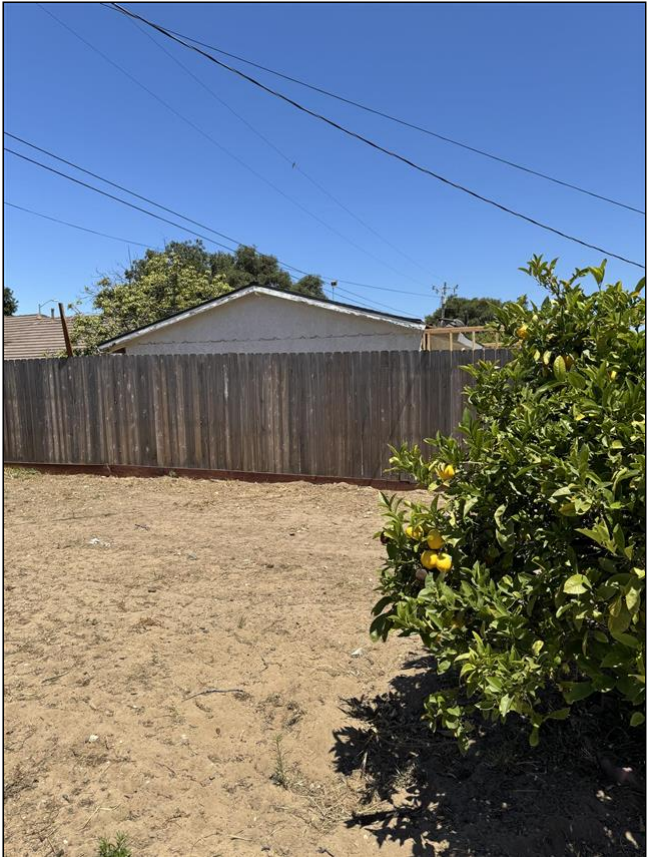
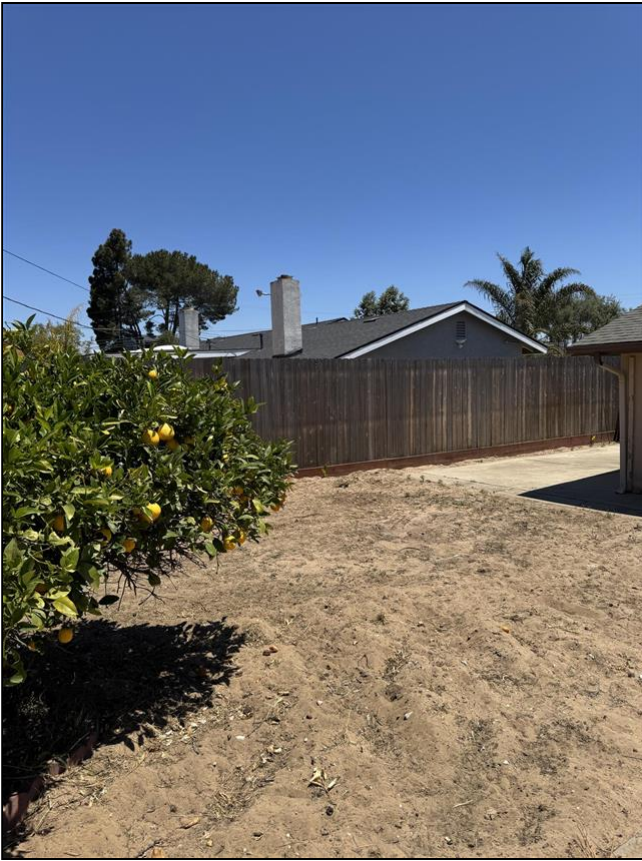
-The fences and gate were older but generally in good condition. The front fence is in need of repair as one piece of wood was split and separated from the gate. Though the fences appeared to be in good condition at the time of inspection, it is highly recommended to have a termite inspector survey the entire

2.7 Item 4 (Picture) Rear Fences 2

2.7 Item 5 (Picture) Rear Fences 3

fence system. Also, the fences can be further preserved by painting or staining them. Finally, all plant material should be removed from any fences as plants promote moisture retention and pest infiltration.

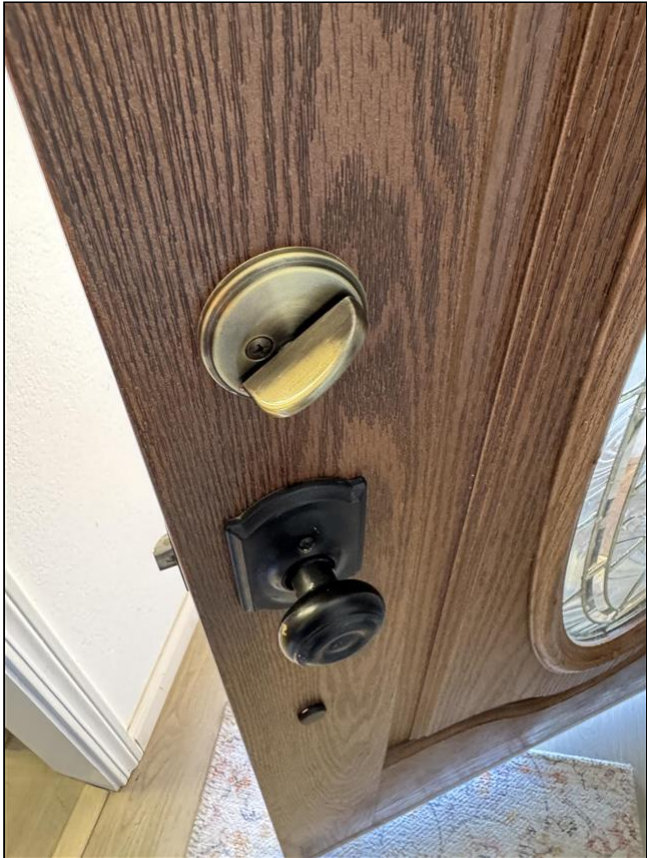
-At the time of the inspection, the Inspector observed few deficiencies in the condition of door exteriors. However, the front doorknob assembly seemed a little loose. It is recommended to tighten as needed.

3.0 Item 1 (Picture) Front Door 2

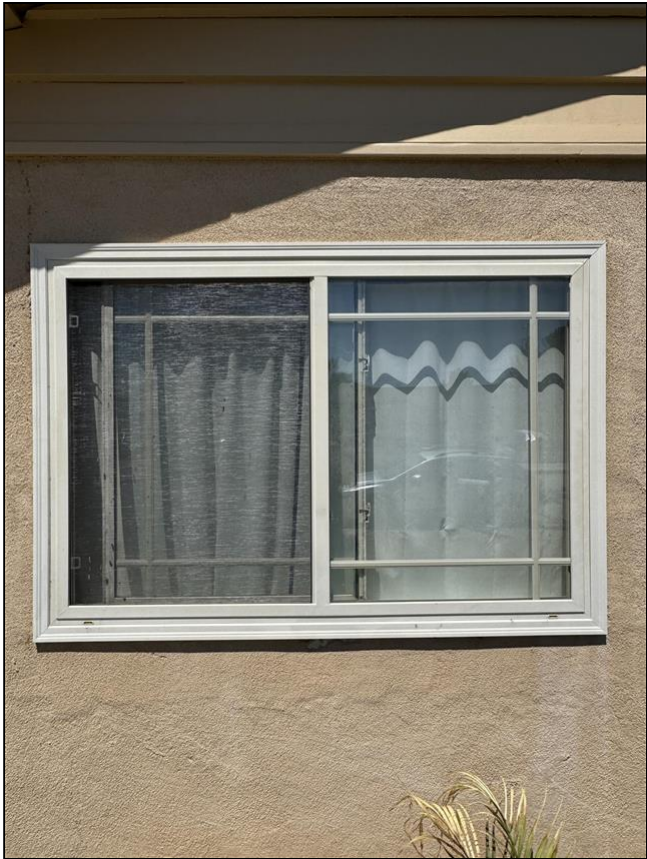
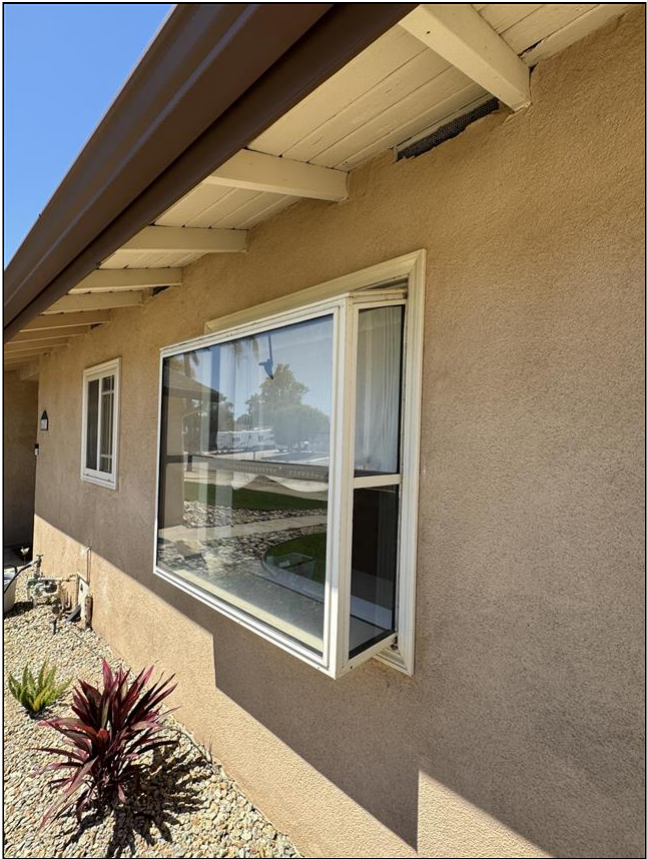
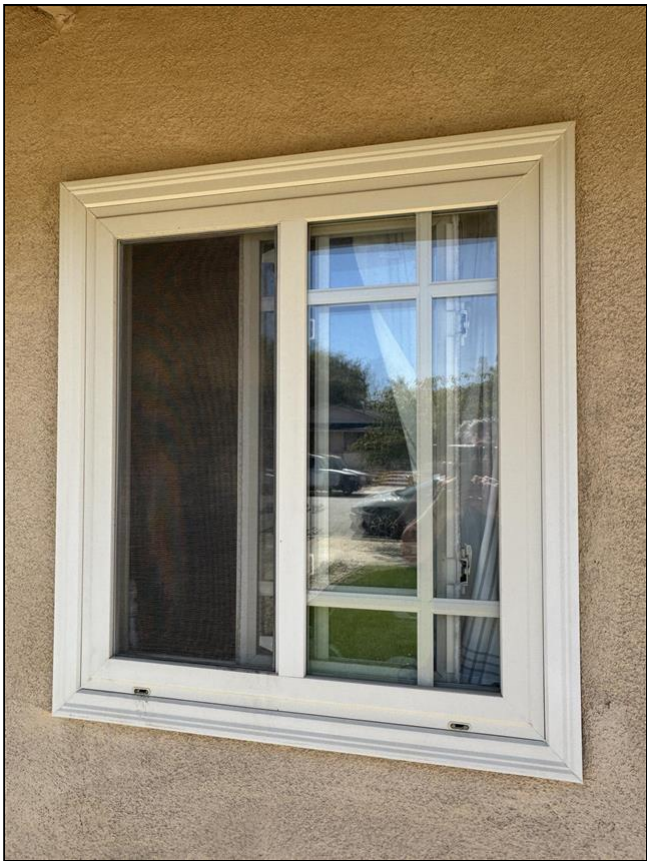
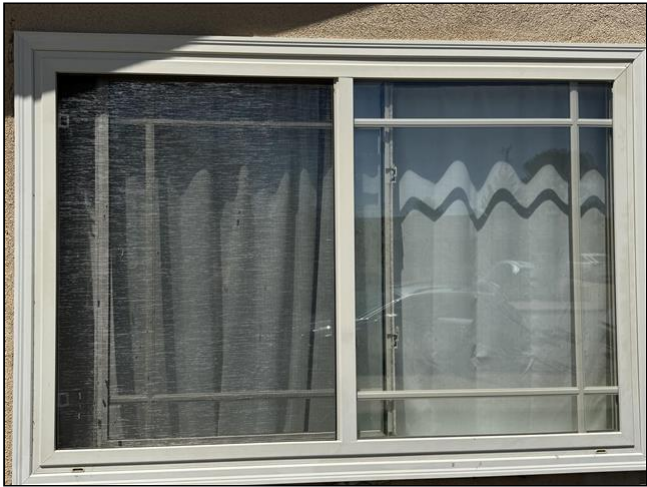
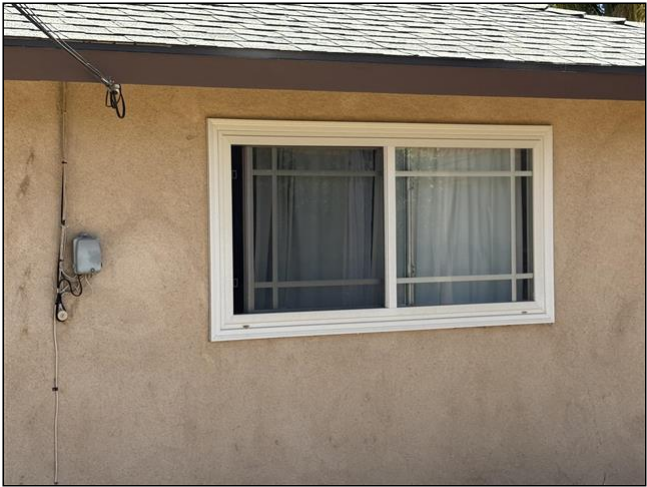
-The Inspector observed no deficiencies in the condition of window exteriors at the time of the inspection. However, the screens are old and showing signs of deterioration. It is recommended to replace the screens as needed.

3.1 Item 1 (Picture) Windows 1

3.1 Item 2 (Picture) Windows 2

3.1 Item 3 (Picture) Windows 3

3.1 Item 5 (Picture) Windows 5

3.1 Item 6 (Picture) Windows 6

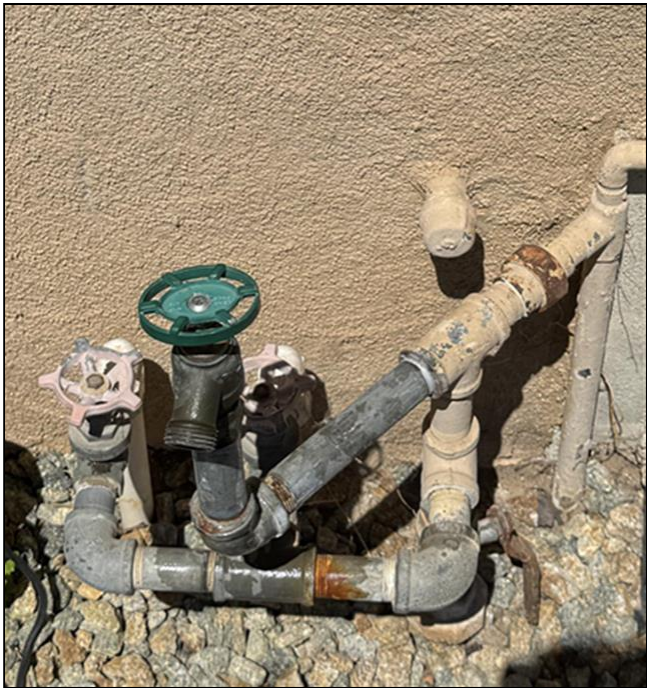
3.2 Item 1 (Picture)

-The Inspector observed no deficiencies in the condition of outer wall penetrations at the time of the inspection.

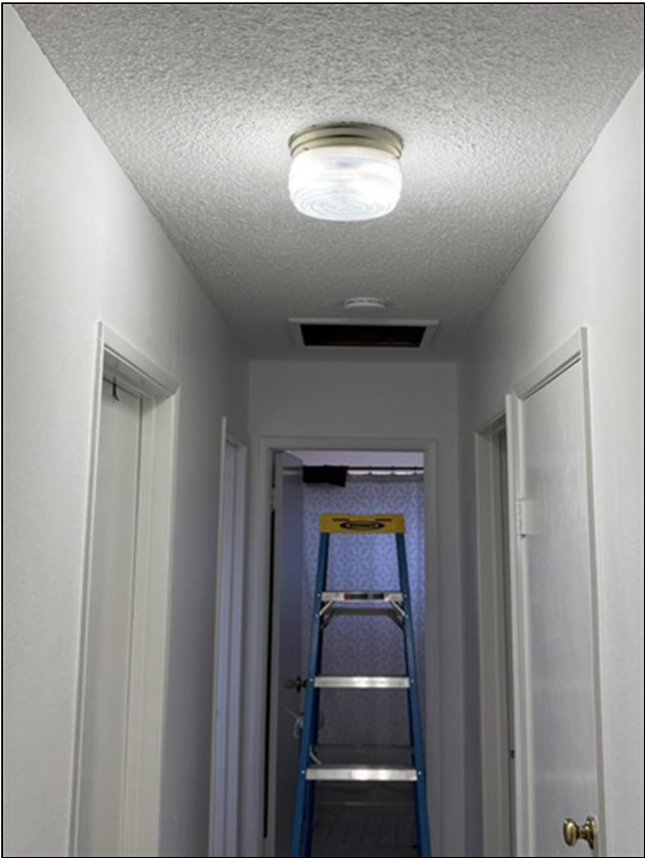
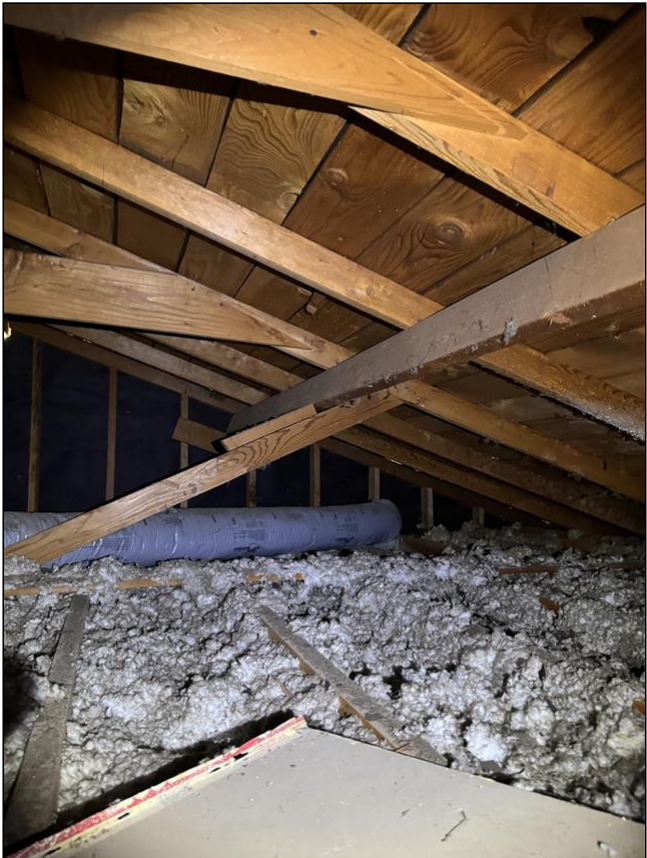
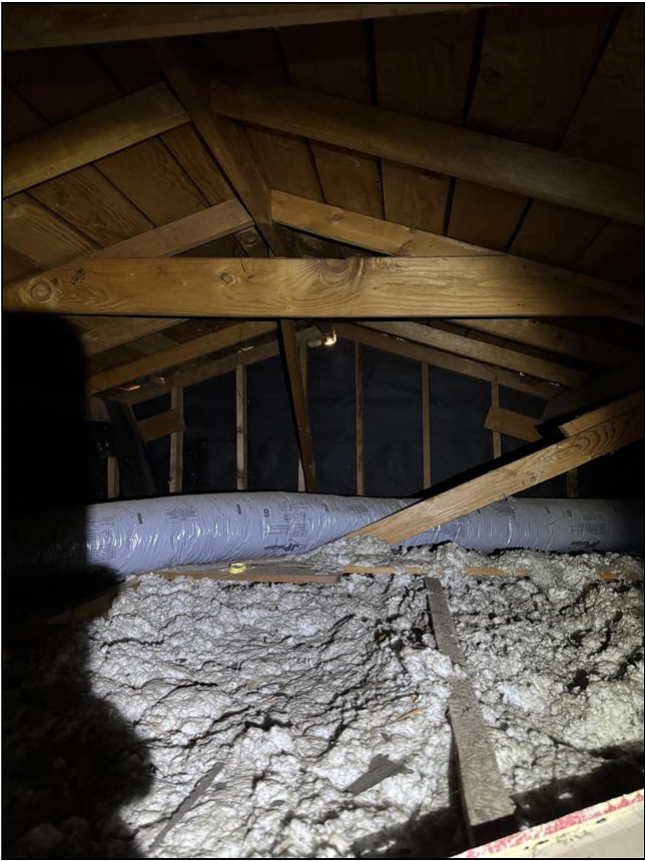
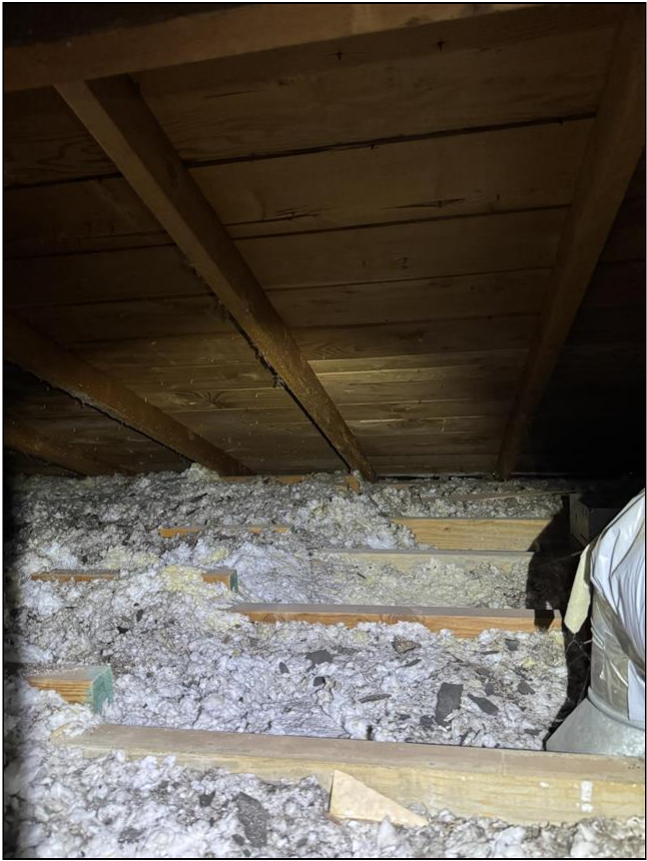
- Though small, the attics access points were both accessible. The insulation material was about 3-5 inches in height and comprised of cotton/fiberglass material.

5.0 Item 1 (Picture) Access

5.0 Item 2 (Picture) Attic 1

5.0 Item 3 (Picture) Attic 2

5.0 Item 4 (Picture) Attic 3
