# Inspection Report

**Joe and Rebecca Blow**

**Property Address:**  
1234 Anywhere Paso  
Paso Robles, CA 93446

**Blue Oak Home and Commercial Inspections**

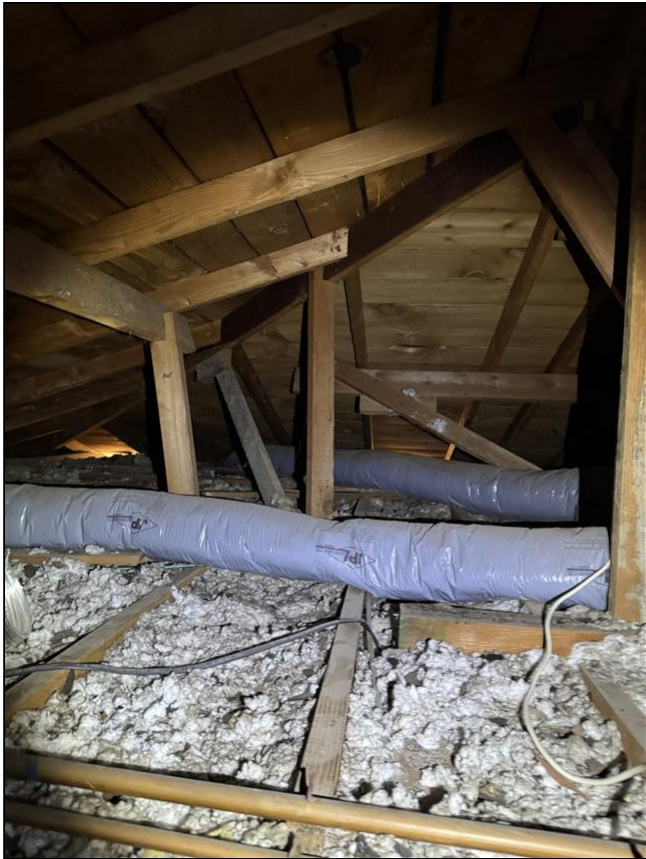
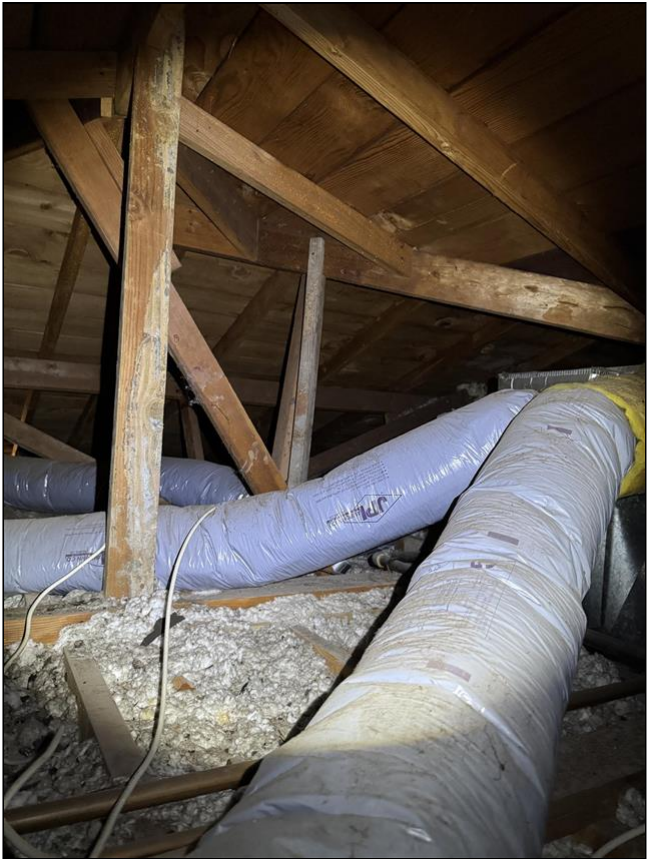
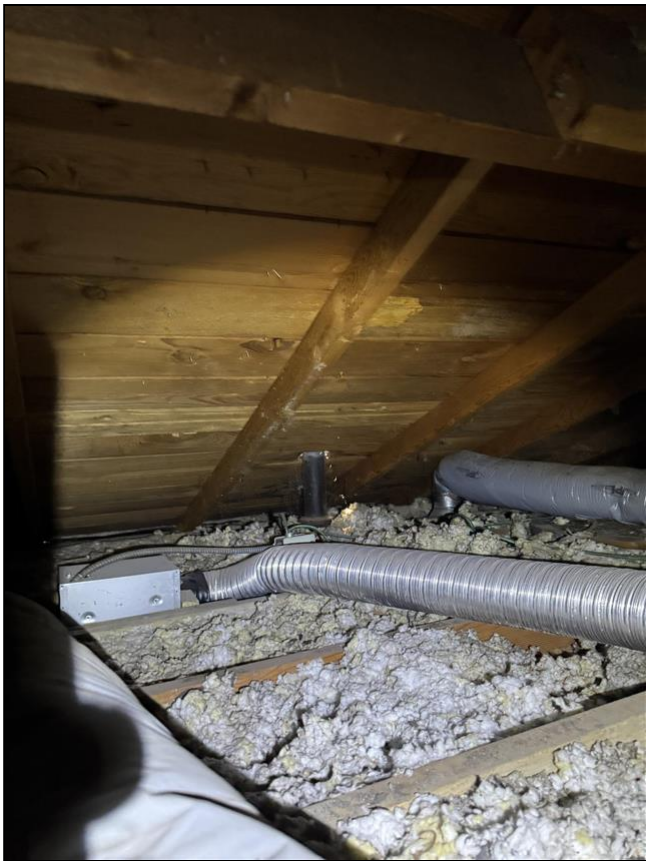
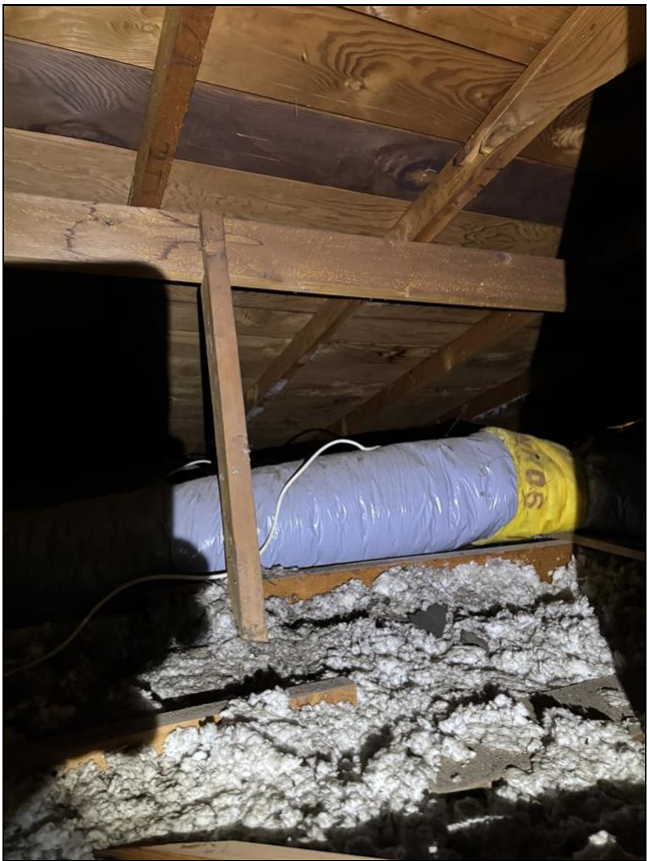
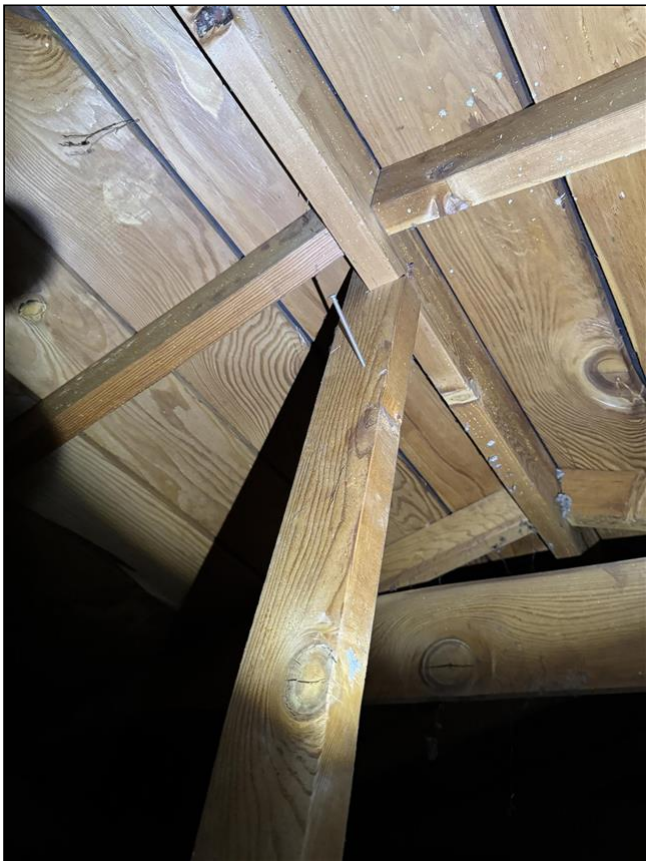
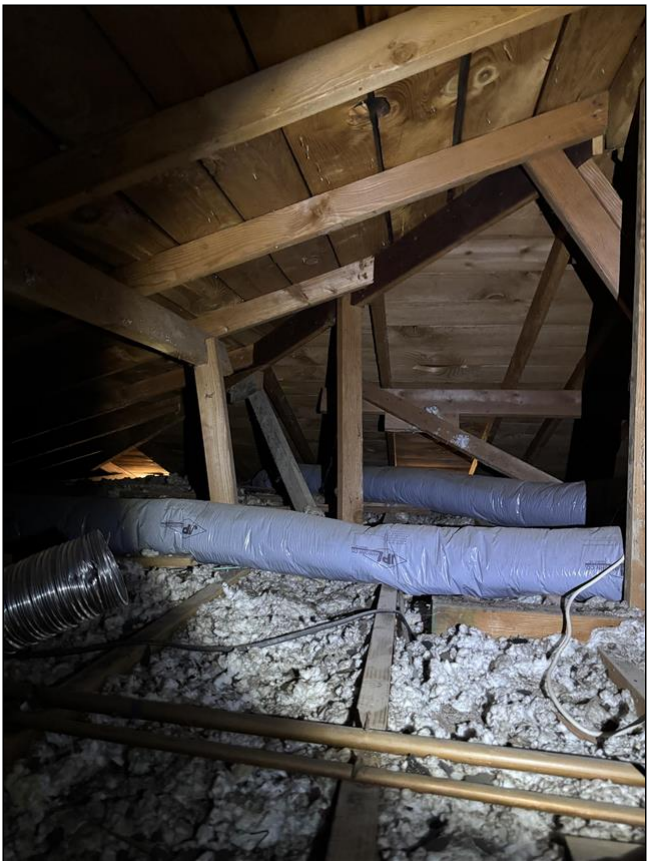
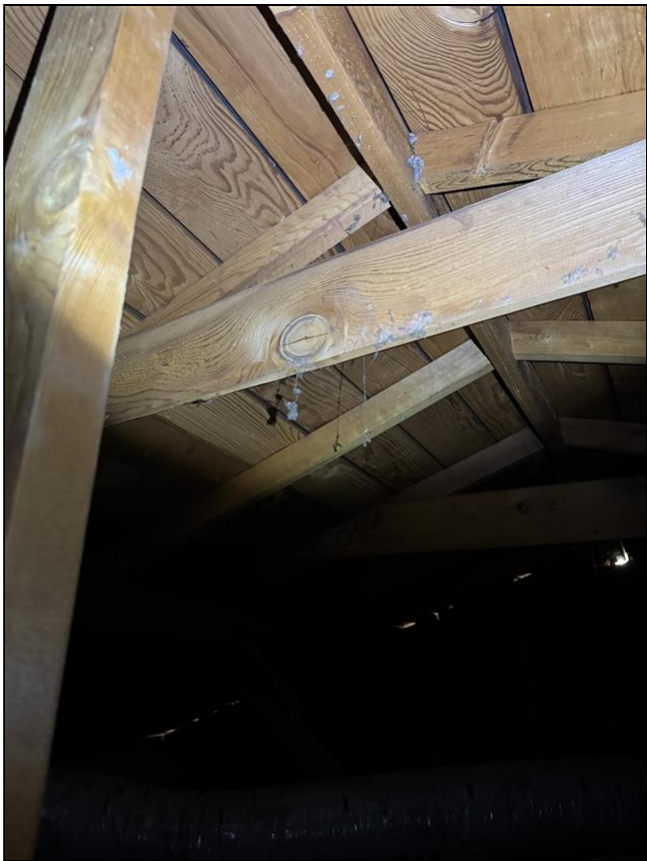
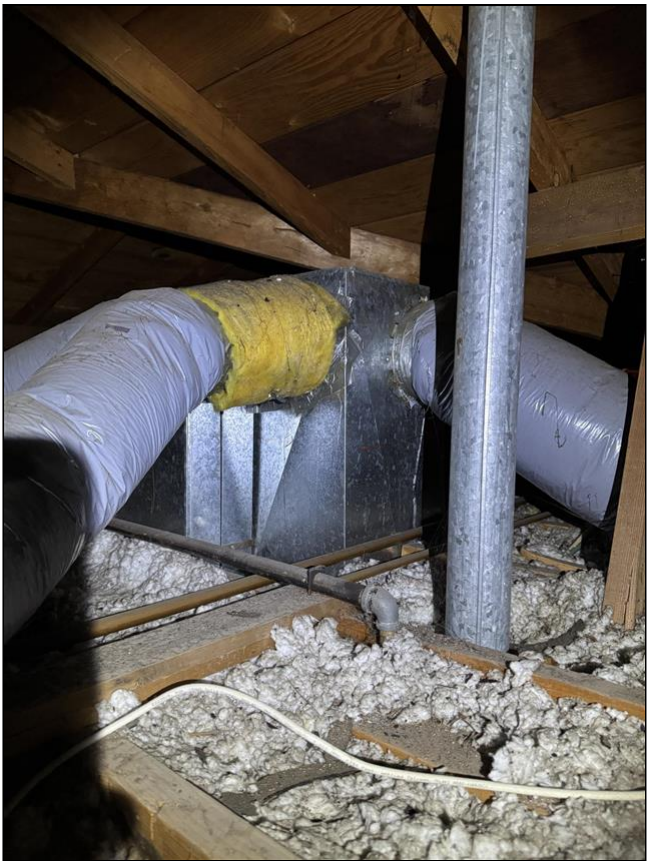
-The Inspector observed no deficiencies in the condition of the conventional roof framing at the time of the inspection. Only some minor discoloration of wood in some areas, but in very good structural condition.

5.1 Item 1 (Picture) Conventional Framing 1

5.1 Item 2 (Picture) Conventional Framing 2

5.1 Item 3 (Picture) Conventional Framing 3

5.1 Item 4 (Picture) Conventional Framing 4

5.1 Item 5 (Picture) Conventional Framing 5

5.1 Item 6 (Picture) Conventional Framing 6

5.1 Item 8 (Picture) Heating System

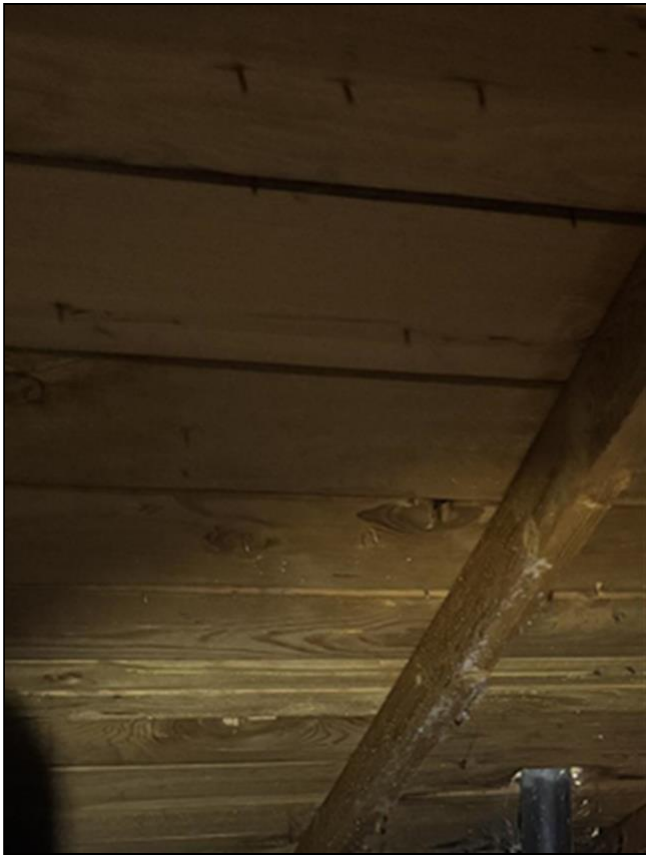
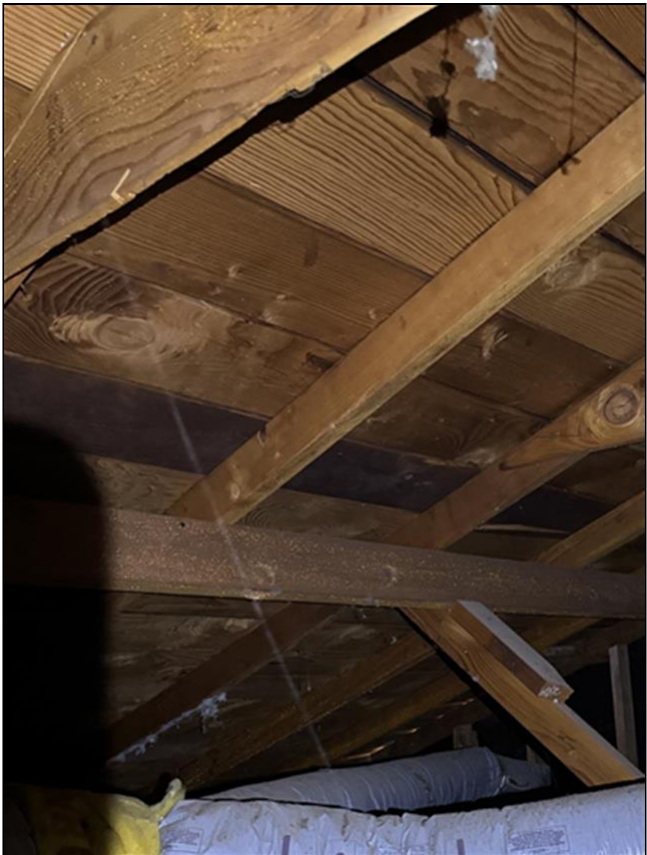
-The Inspector observed no deficiencies in the condition of the roof sheathing at the time of the inspection. 6-8 inch boards composed the roof covering. No sign of leaks were observed.

5.2 Item 1 (Picture) Sheathing 1

5.2 Item 2 (Picture) Sheathing 2

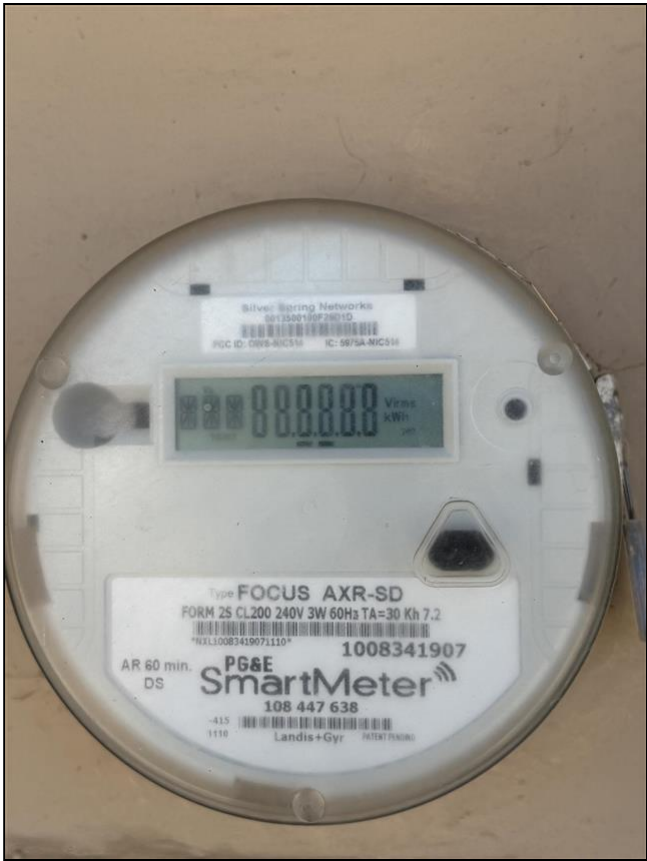
-At the time of the inspection, the Inspector observed few deficiencies in the condition of the electric meter.

6.2 Item 1 (Picture) 200A Meter

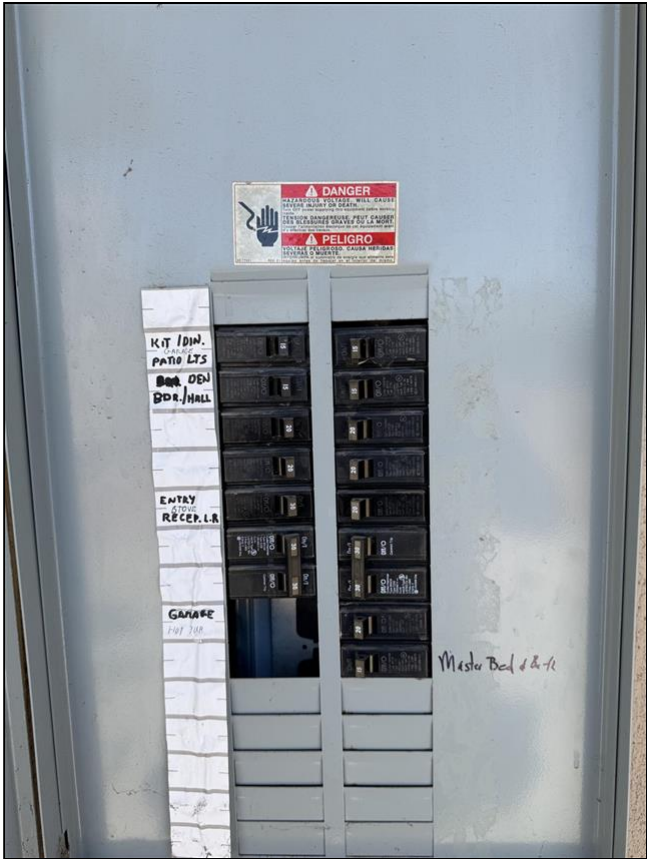
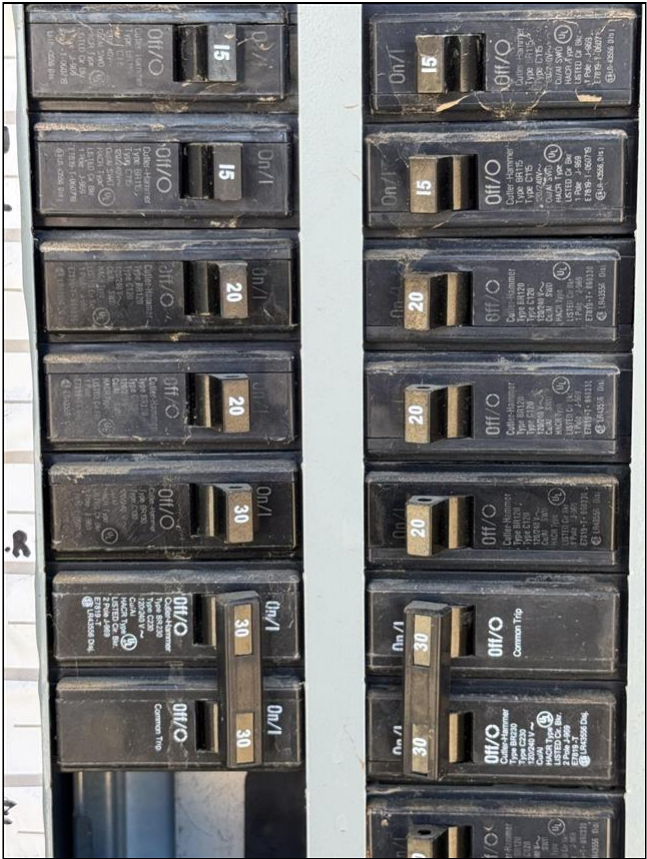
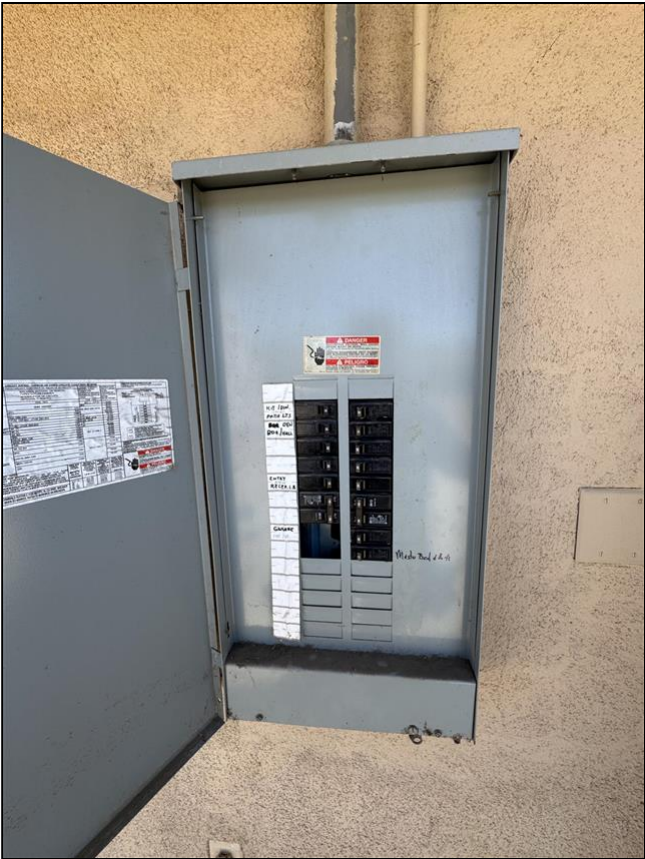
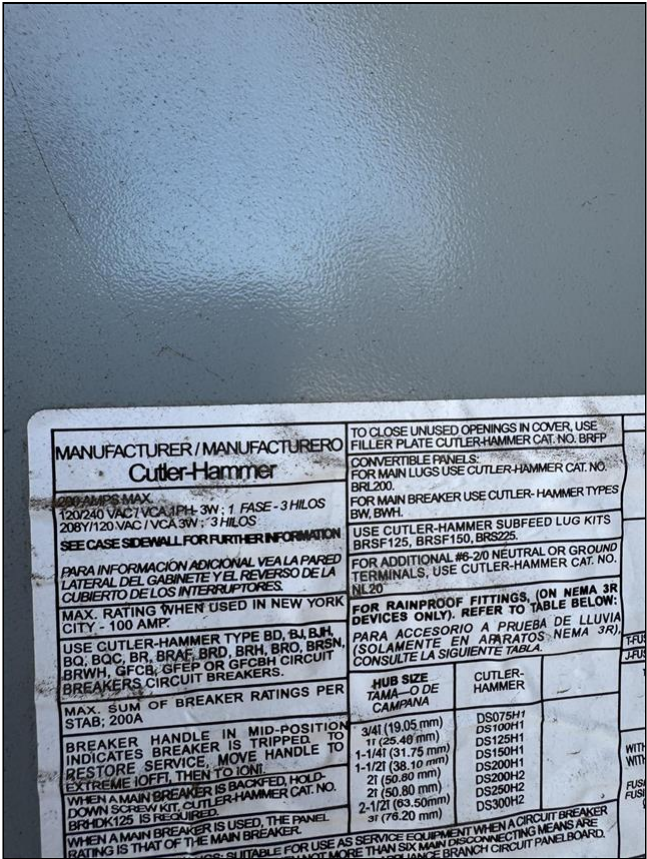
-Service panel was in good working order at the time of inspection, but not fully labeled. It is believed that the main service disconnect switches are #6 & #7 switches on both circuits, but it remains to be determined by a licensed electrician.

6.3 Item 1 (Picture) Service Panel 1

6.3 Item 2 (Picture) Service Panel 2

6.3 Item 3 (Picture) Service Panel 3

6.3 Item 4 (Picture) Service Panel 4

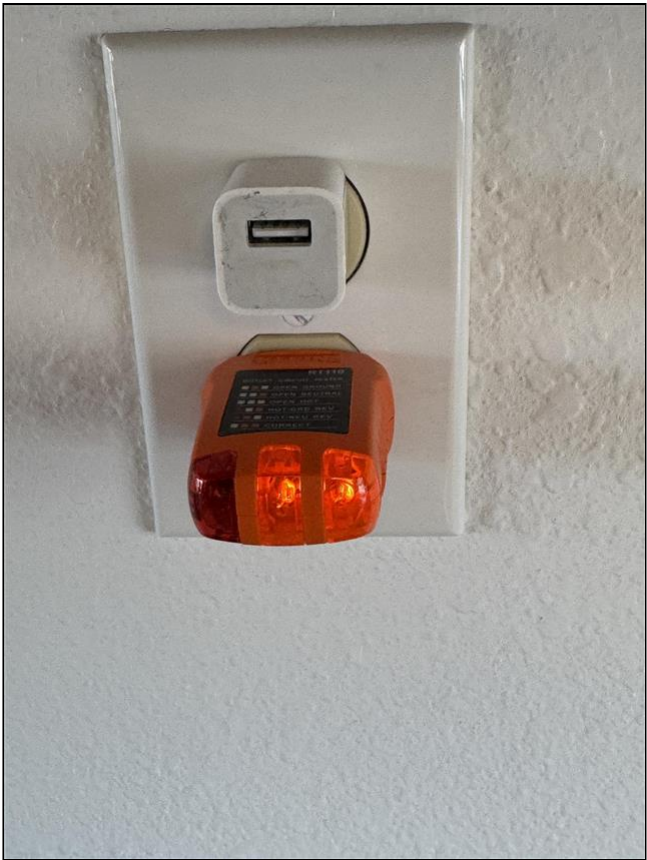
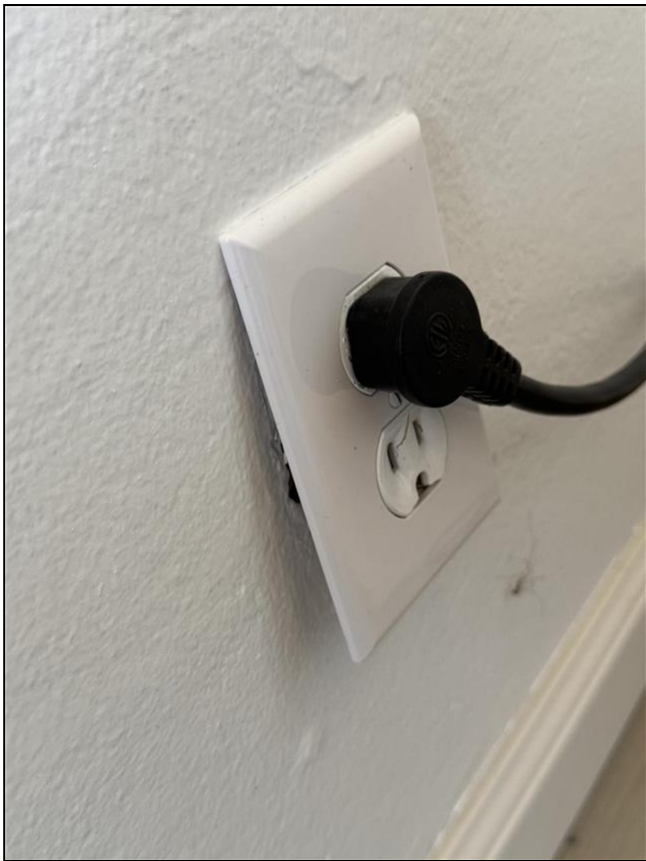
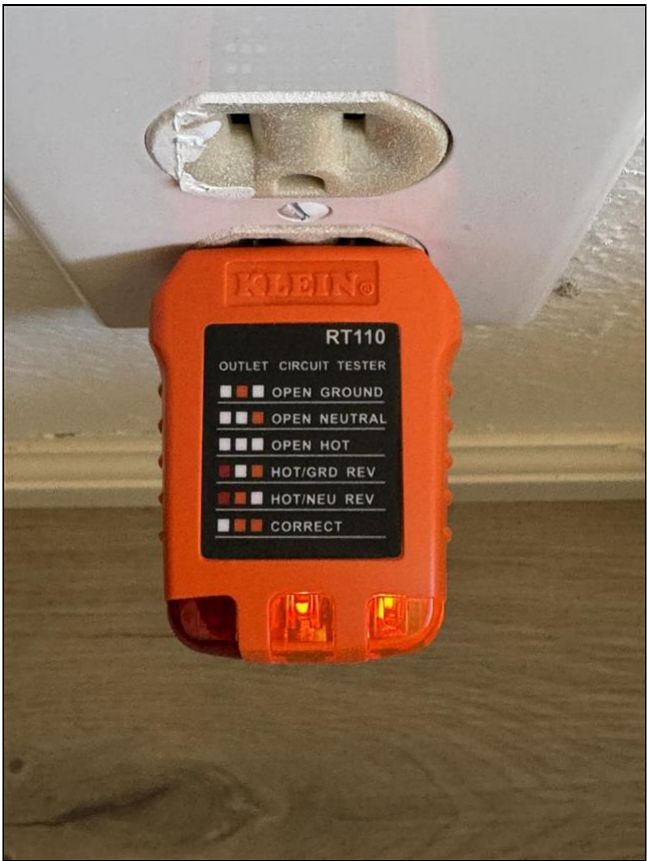
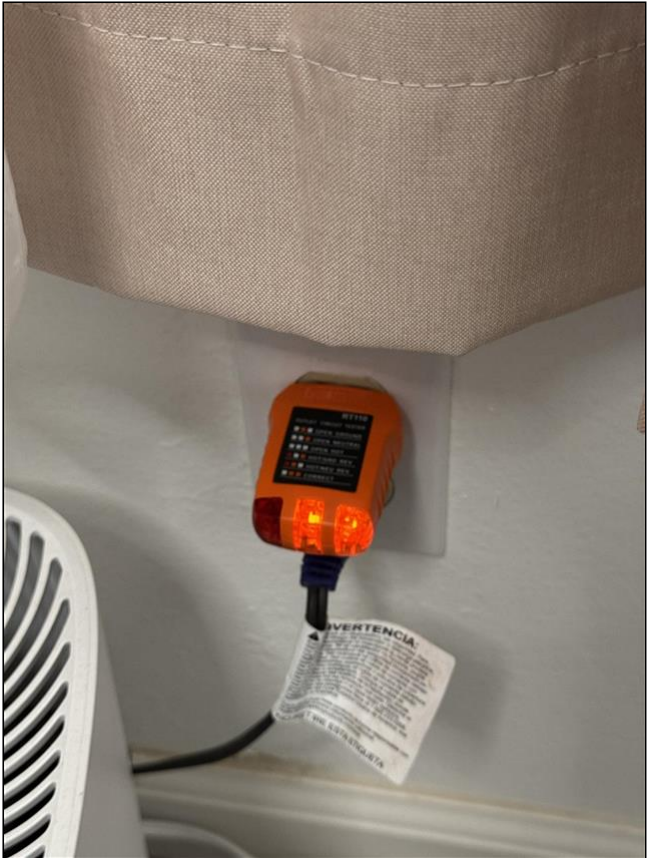
- A representative number of standard receptacle outlets were tested in each room of the house and only 3 deficiencies were found. 1)The corner back receptacle in the kitchen was not working which should be rewired by a licensed electrician if not related to a switch. 2) The entertainment room had a receptacle that is functional but pulling out of the wall. Please have serviced as well. 3) The front bedroom had an old receptacle with no ground and it was also loose. Please have serviced also.

6.4 Item 2 (Picture) Test 1

6.4 Item 3 (Picture) Entertainment Receptacle

6.4 Item 4 (Picture) Test 2

6.4 Item 6 (Picture) Test 3

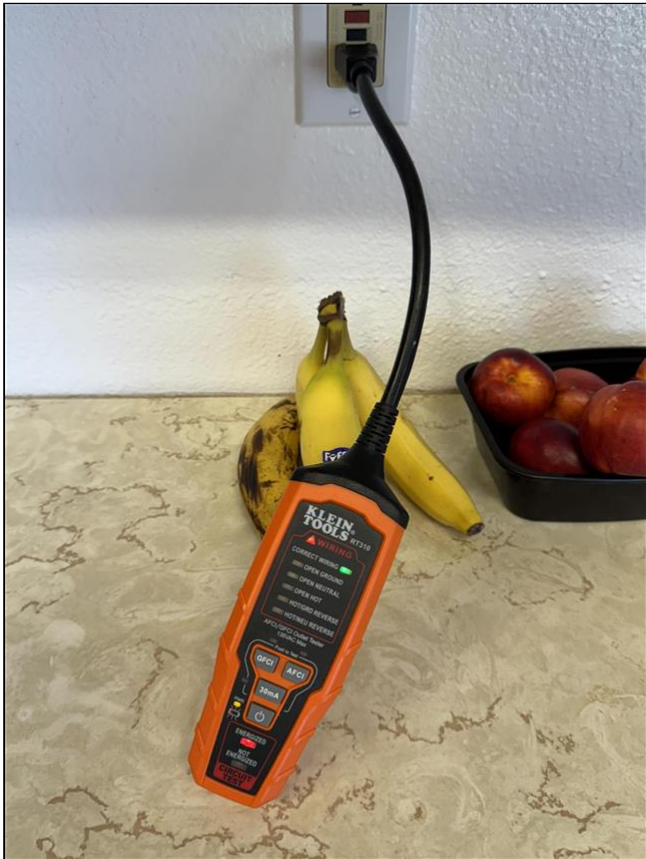
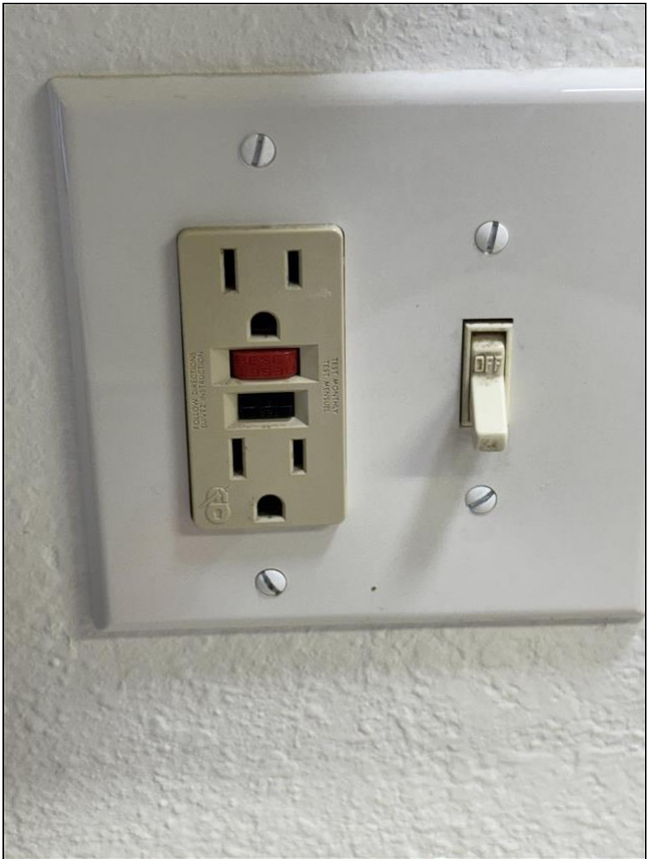
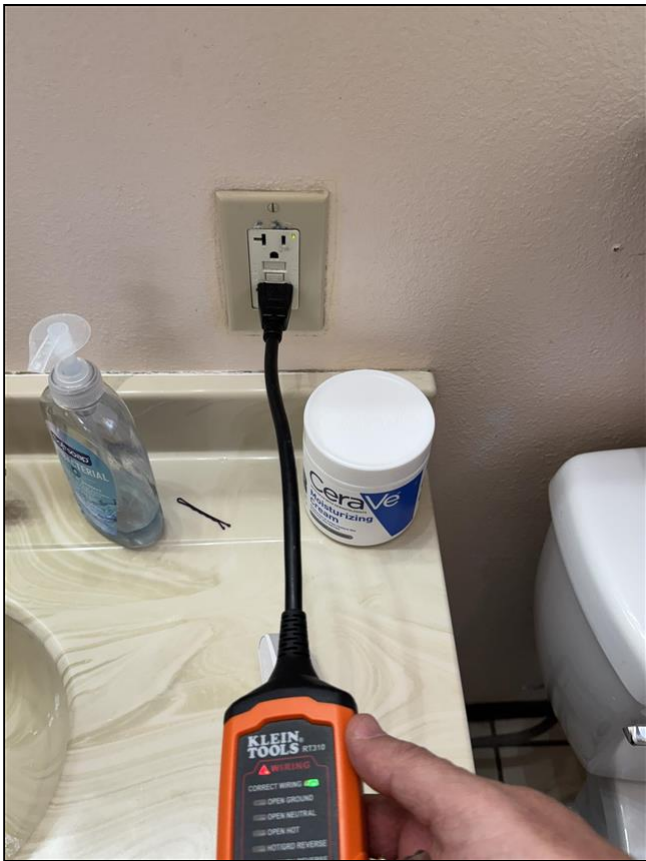
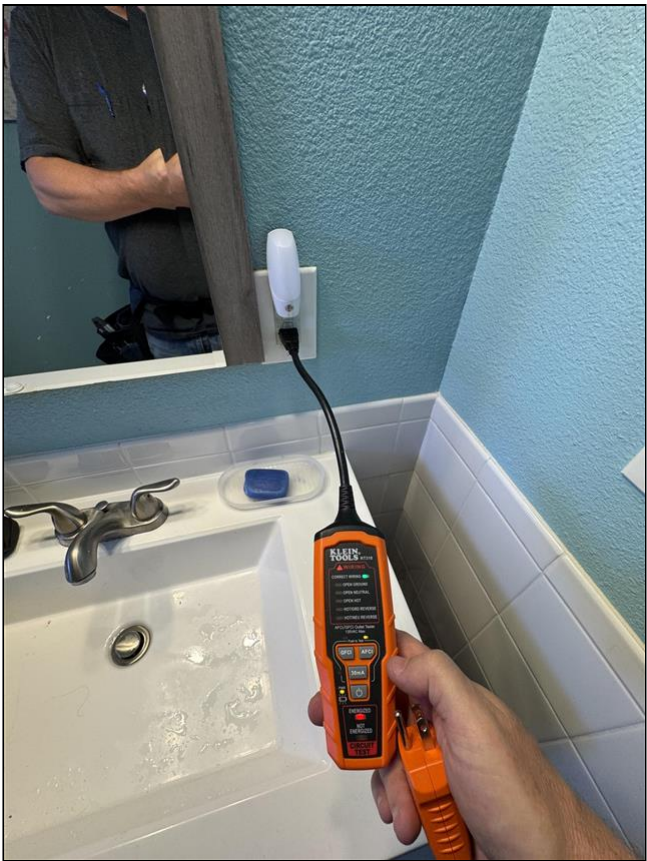
-All GFCI plugs tested well at the time of inspection.

6.5 Item 1 (Picture) GFCI 1

6.5 Item 2 (Picture) GFCI 2

6.5 Item 3 (Picture) GFCI 3

6.5 Item 4 (Picture) GFCI 4

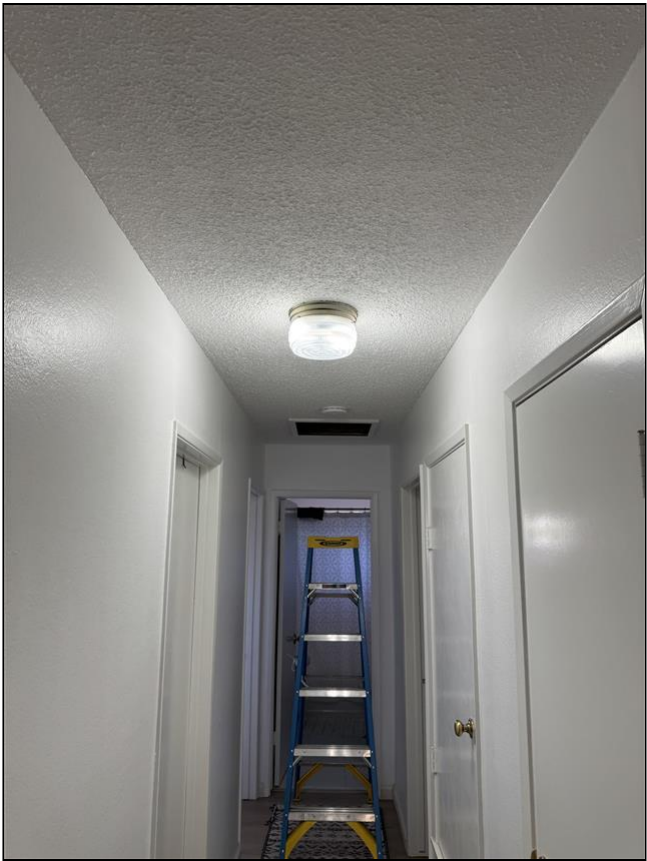
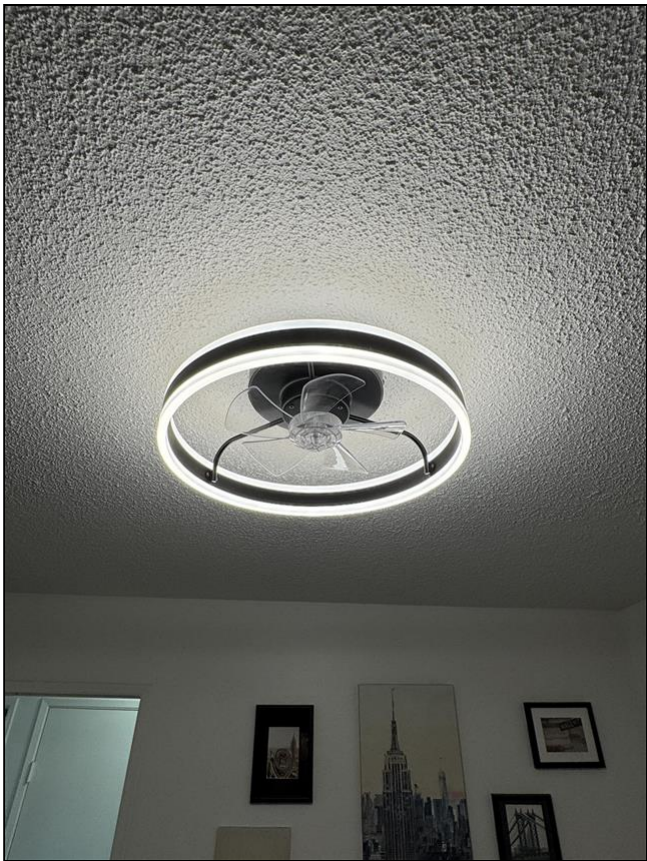
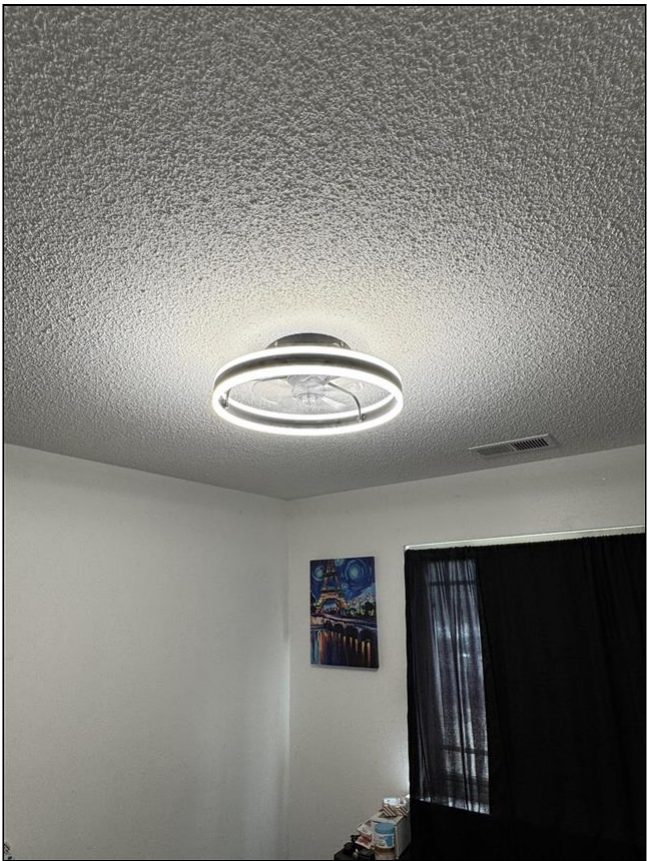
- At the time of inspection, the inspector found few deficiencies in the lighting that was available for inspection in each room and living area. However, there was a fixture in the master bedroom bathroom that should replaced, repaired, or covered. Since there is no vent in the bathroom, the fixture could be re purposed for that. It is recommended to have a licensed electrician perform this task.

6.7 Item 2 (Picture) Hallway Light

6.7 Item 3 (Picture) Bedroom Light and Fan 1

6.7 Item 4 (Picture) Bedroom Light and Fan 2

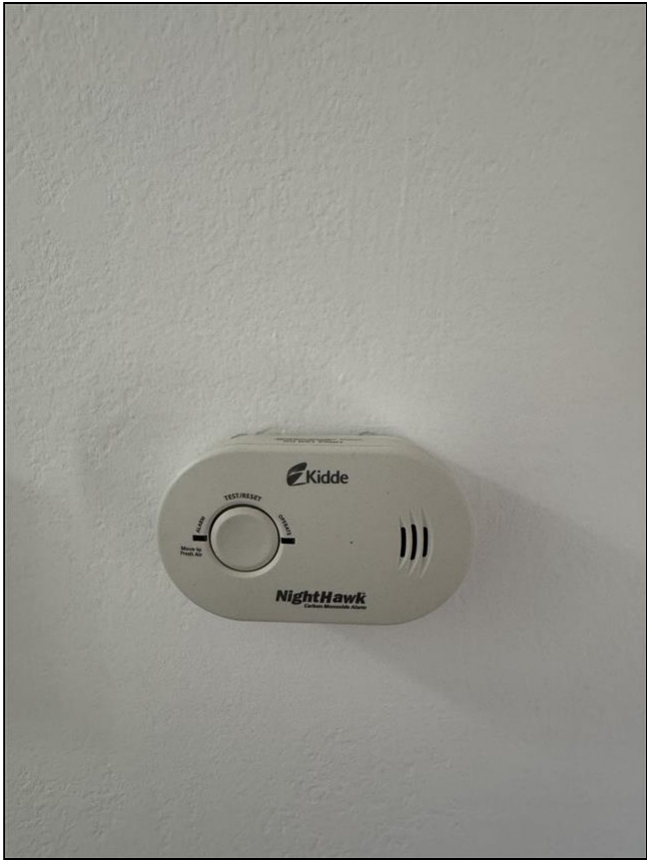
6.9 Item 1 (Picture) CO Detector

-Both CO detectors were functional at the time of inspection.

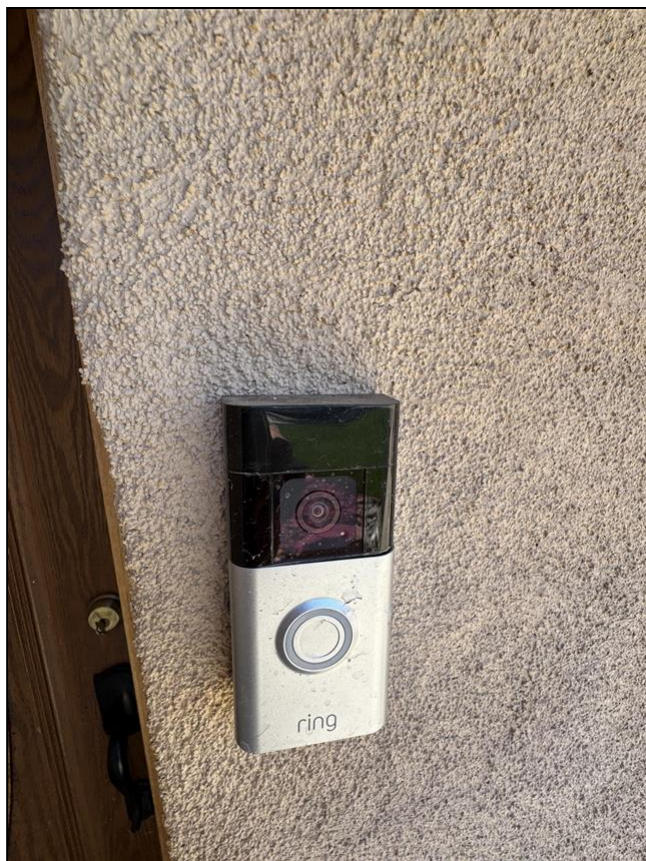
6.10 Item 1 (Picture) Doorbell

-The doorbell responded to the switch at the time of the inspection.

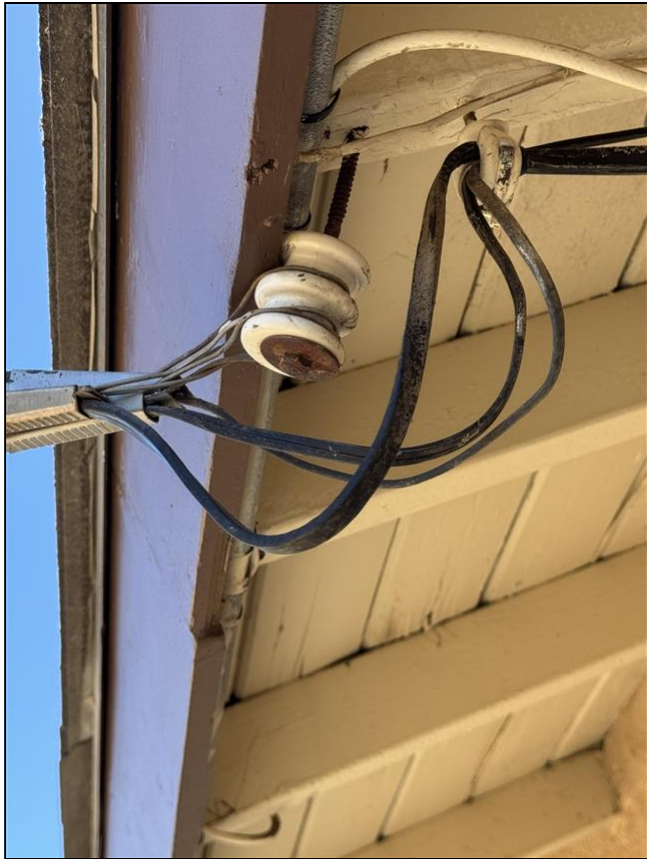
6.11 Item 1 (Picture) Service Drop

-At the time of the inspection, the Inspector observed no deficiencies in the condition of the service drop. Components inspected included the following: the service conductors, splice, drip loop, and point of attachment to the home.

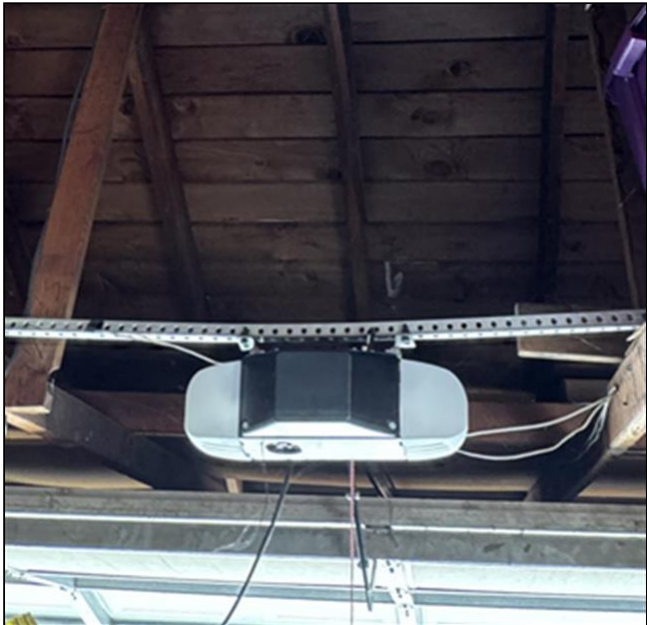
7.0 Item 1 (Picture) Door Opening Garage

-The automatic garage door opener responded to the controls at the time of the inspection including safety sensors.

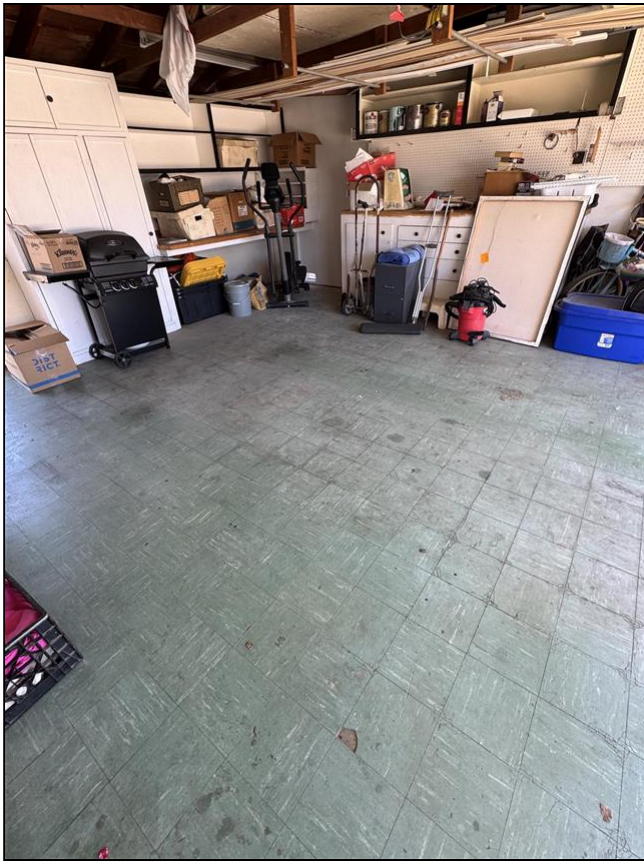
7.1 Item 1 (Picture) Floors

Item 1(Picture) -At the time of the inspection, the Inspector observed few deficiencies in the condition of the garage floor.

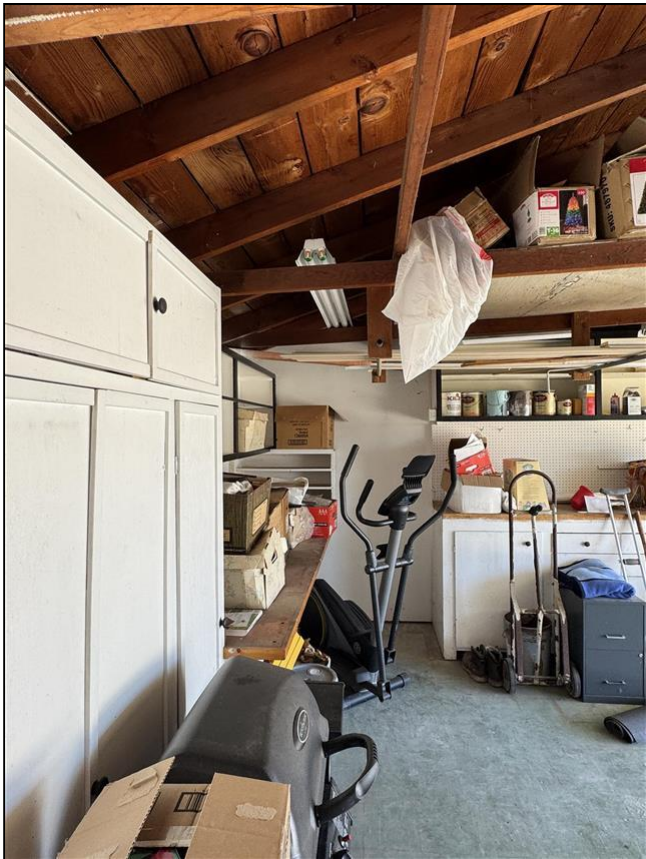
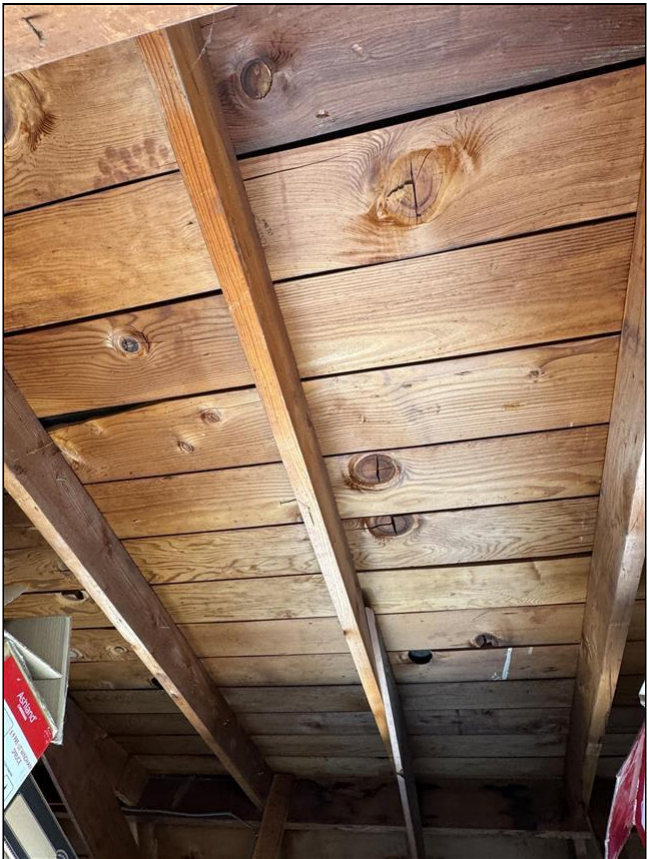
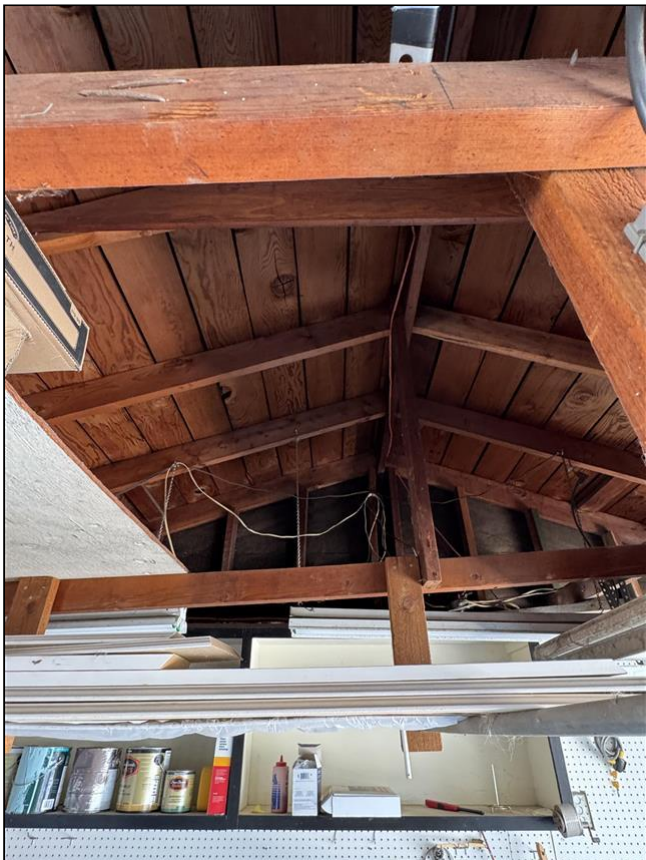
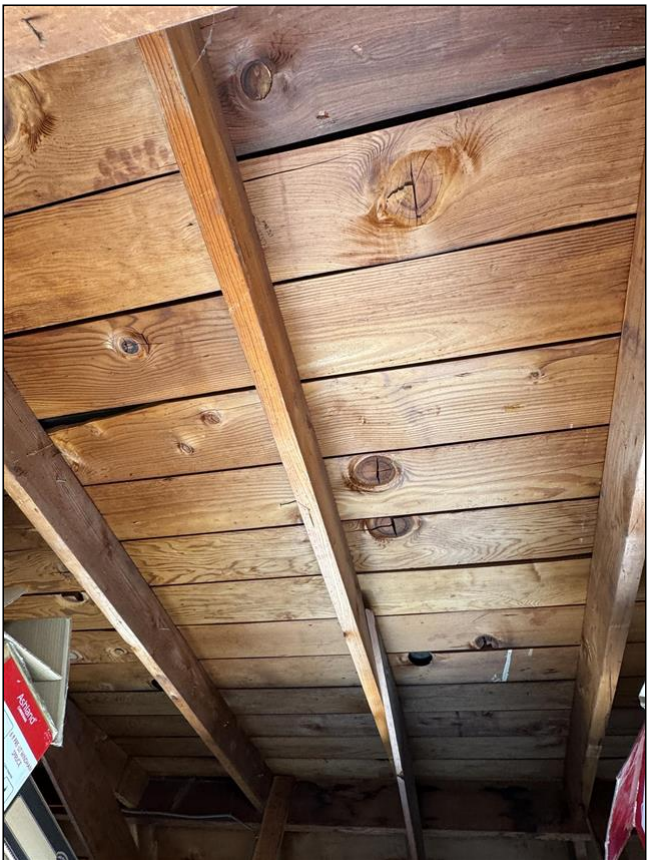
-At the time of the inspection, the Inspector observed few deficiencies in the condition of the garage ceilings.

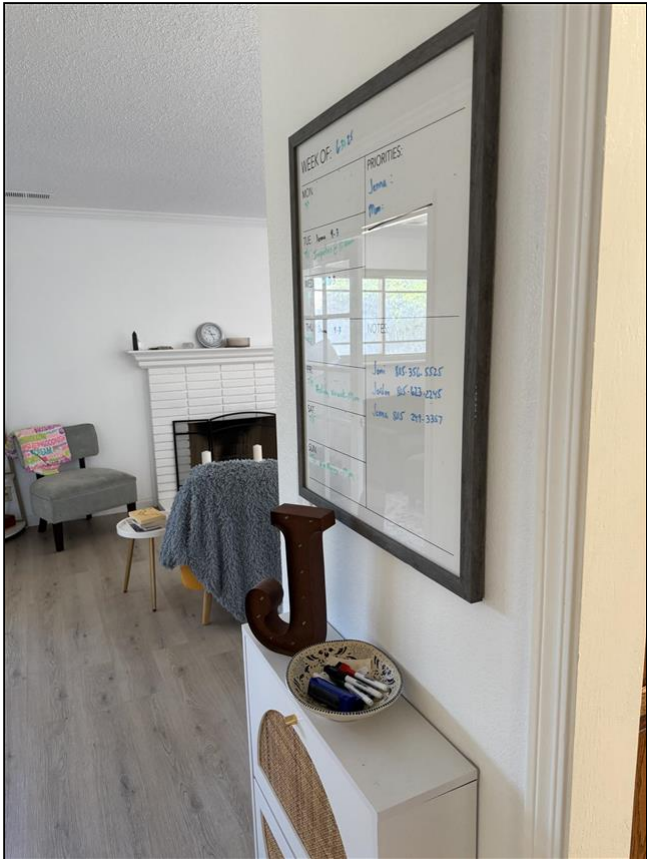
8.0 Item 1 (Picture) Floors

-At the time of the inspection, the Inspector observed no deficiencies in the condition of laminate floors in the home.

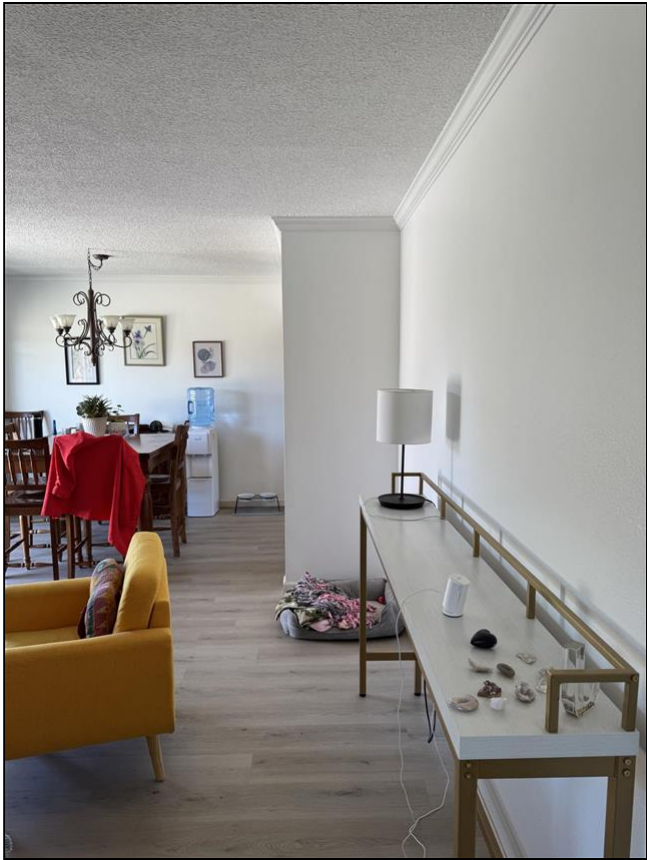
8.1 Item 1 (Picture) Walls

-At the time of the inspection, the Inspector observed few deficiencies in the condition of the home walls.

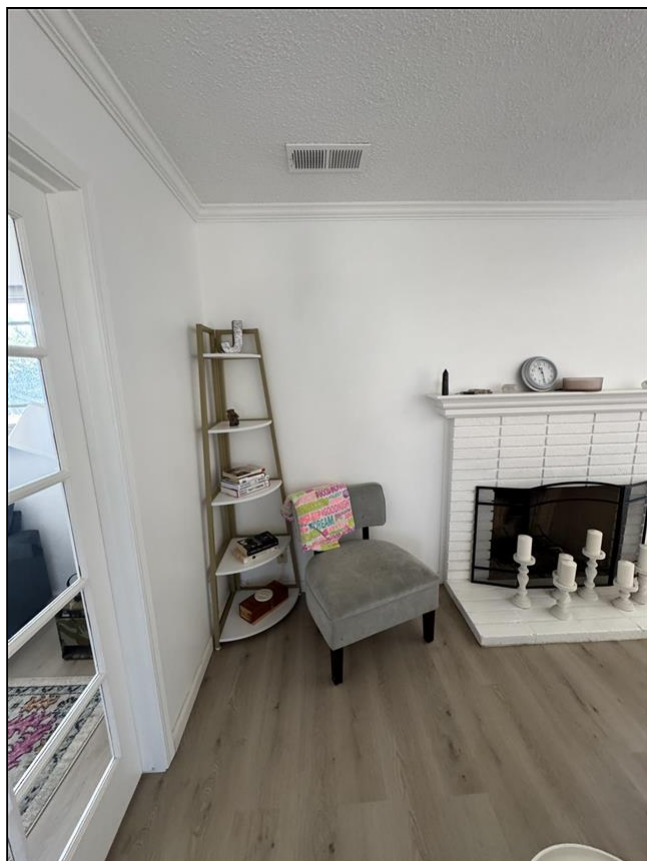
8.2 Item 1 (Picture) Ceilings

- House ceilings were in good condition at the time of inspection.

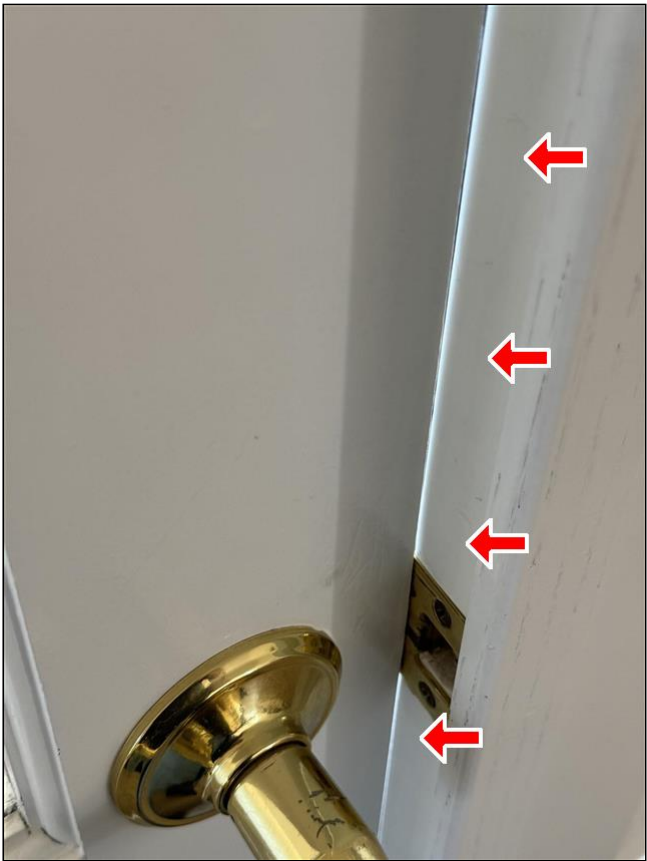
- The interior door to the entertainment area are out of alignment and cannot be closed properly. Also, when they are closed, there is only an upper latch and no lower latch to stabilize the door. It is recommended to have a licensed contractor install a new latch and re-align the doors to close properly.
- The patio door is in good working order.

8.4 Item 2 (Picture) No Closing Properly
