# Inspection Report

**Joe and Rebecca Blow**

**Property Address:**  
1234 Anywhere Paso  
Paso Robles, CA 93446

**Blue Oak Home and Commercial Inspections**

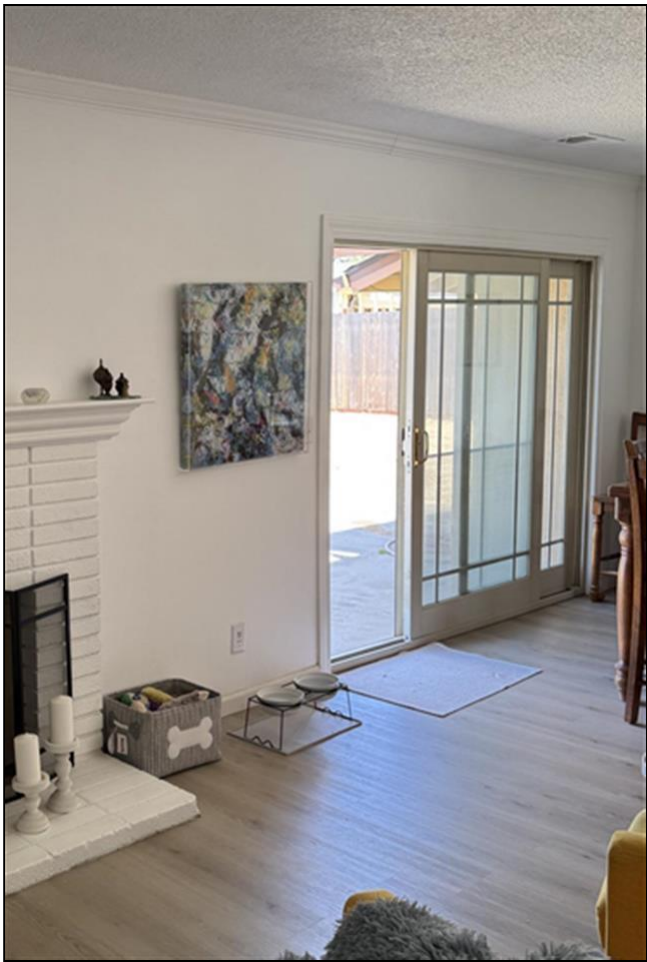
8.4 Item 3 (Picture) Patio Door

- The interior door to the entertainment area are out of alignment and cannot be closed properly. Also, when they are closed, there is only an upper latch and no lower latch to stabilize the door. It is recommended to have a licensed contractor install a new latch and re-align the doors to close properly.
- The patio door is in good working order.

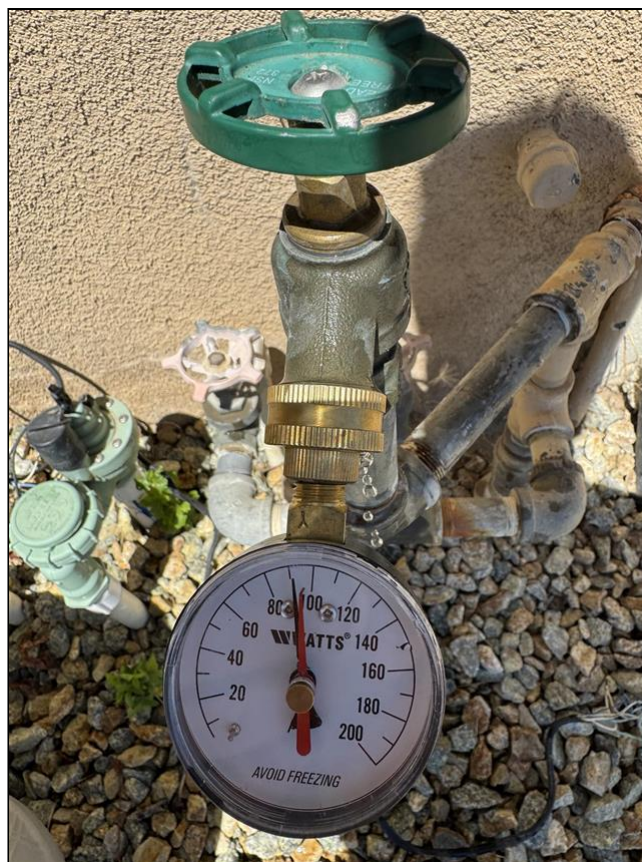
-The front water pressure measured at 90psi, however that is most likely because a pressure regulator was not present (or found). Though 90psi is not prohibitively high, a recommended range is 70-80psi to preserve the pipes over time. Nonetheless, a regulator may be installed for added assurance and reduced pressure fluctuations if that is a problem. Please refer to a licensed plumber for further information.

9.0 Item 2 (Picture) 90psi

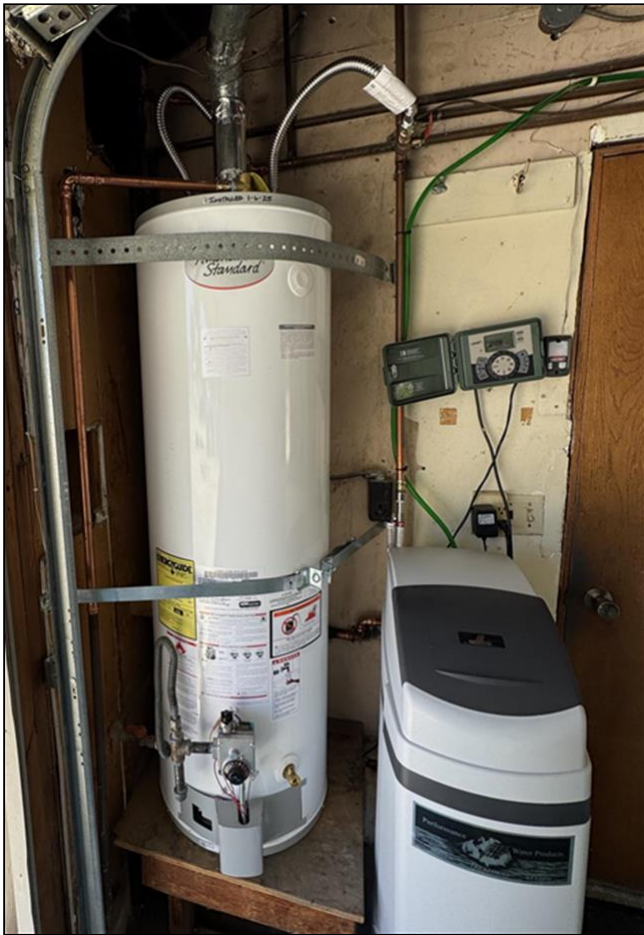
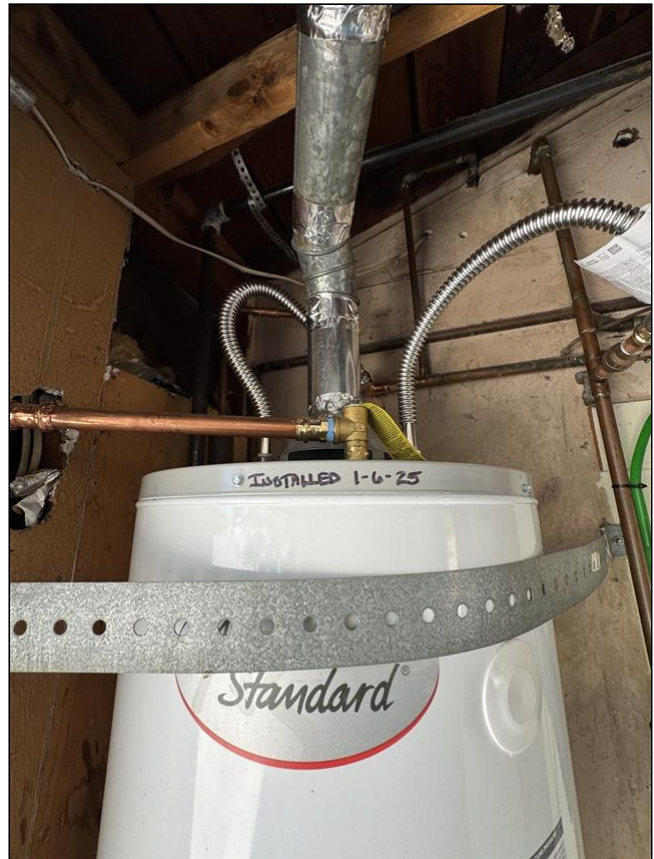
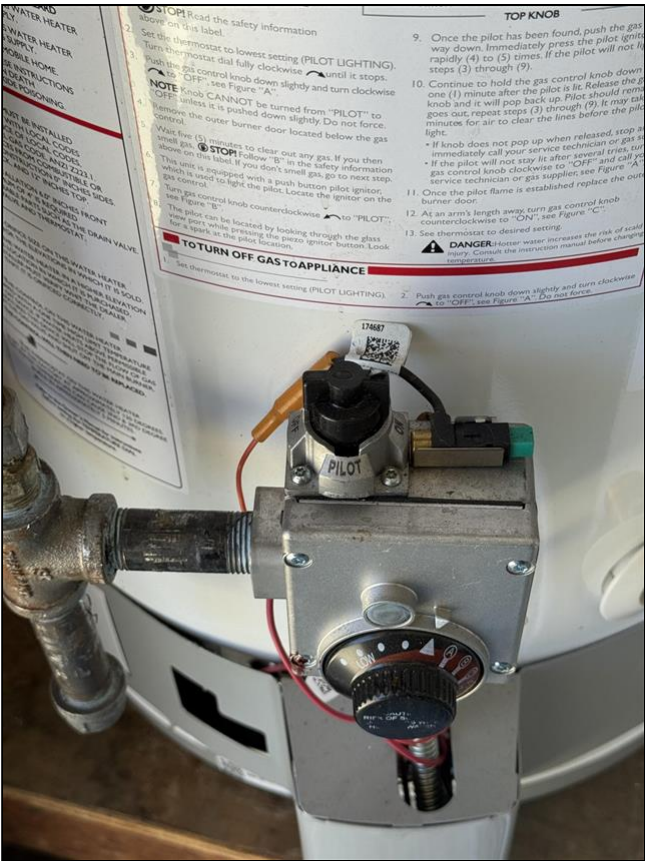
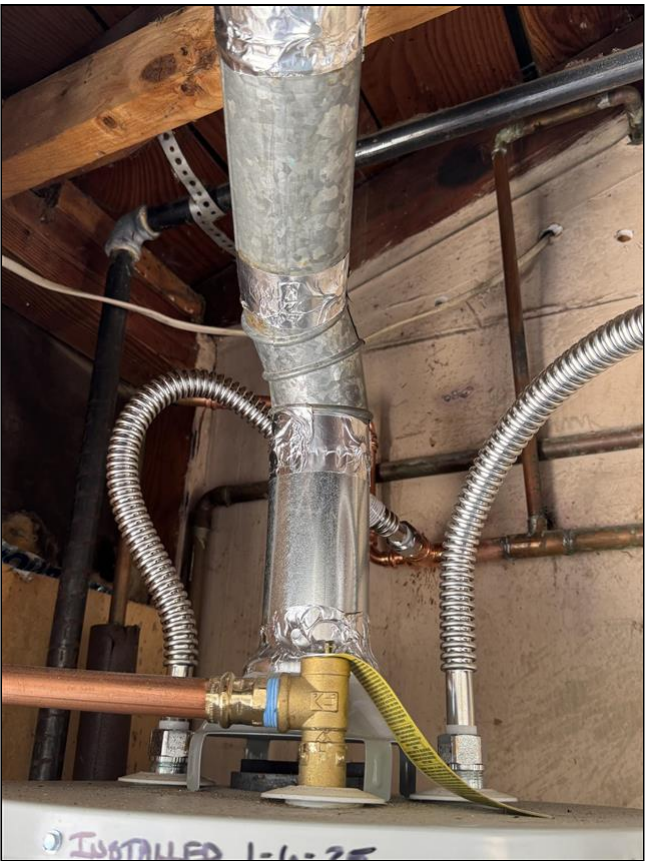
- The water heater was double strapped and appeared in good condition and was well connected and vented at the time of inspection.
- According to the label and markings the water heater was Installed in 2025. The average life span of a water heater is rated at 8-10 years when filled. Therefore, this water heater should be good for another 8-10 years
- The pressure valve and pipes are properly placed and working, but there is no pan underneath the water heater to capture leaking at the bottom. It is recommended to add a pan with the next advised replacement.
- All line and the regulator are in good working condition without leaks.

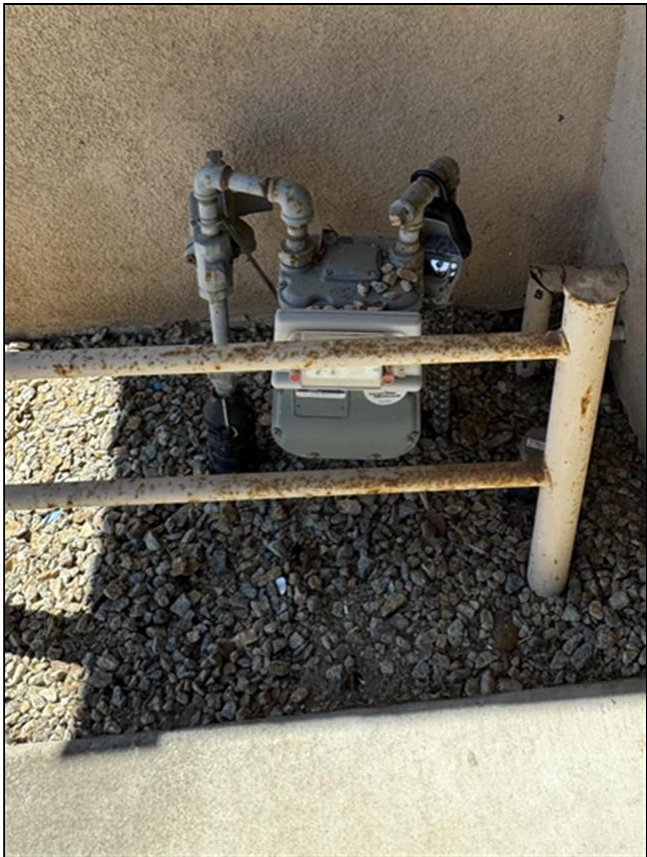
9.4 Item 1 (Picture) Gas Meter and Shut off

-The gas shut-off appeared to be in serviceable condition at the time of the inspection. Shut-offs were not operated, but were visually inspected.

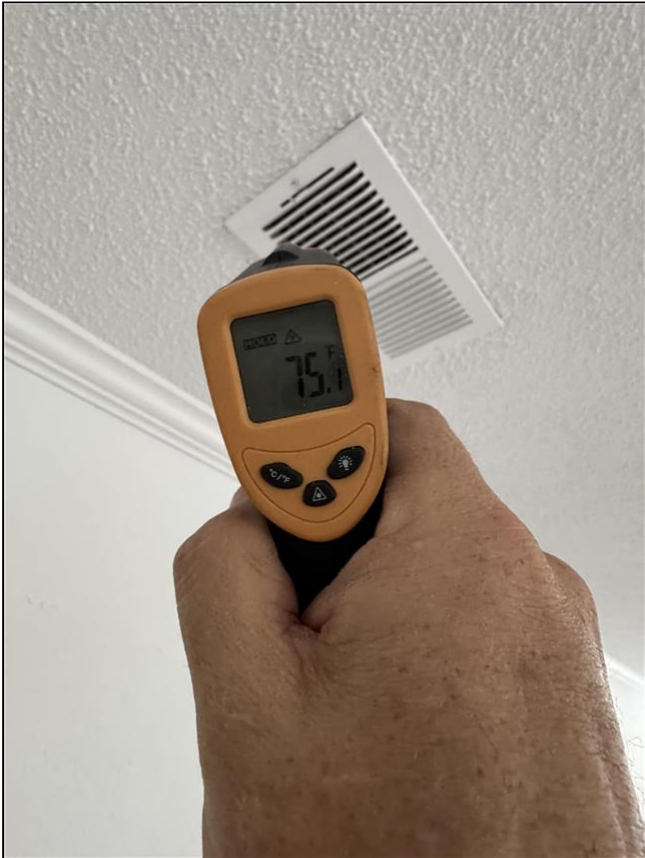
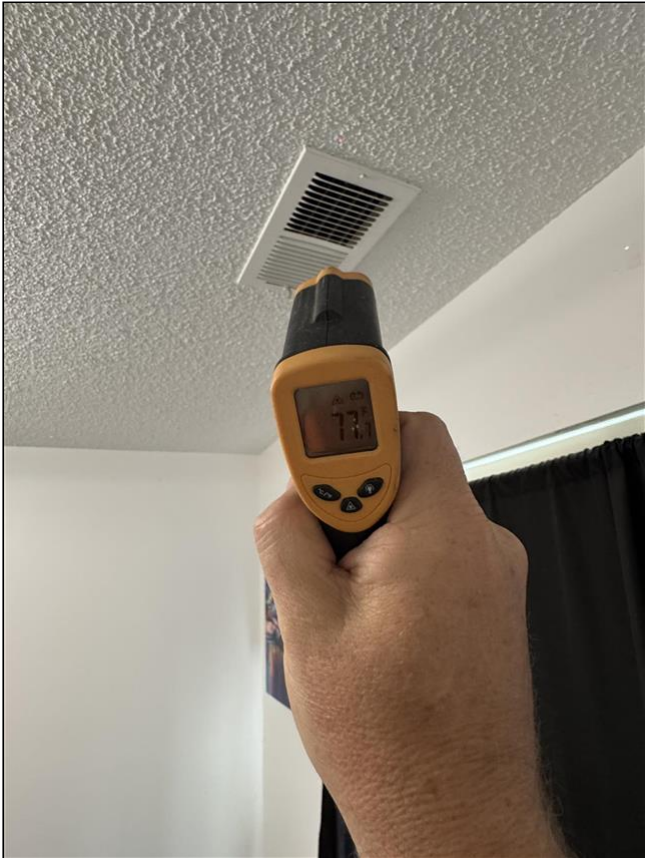
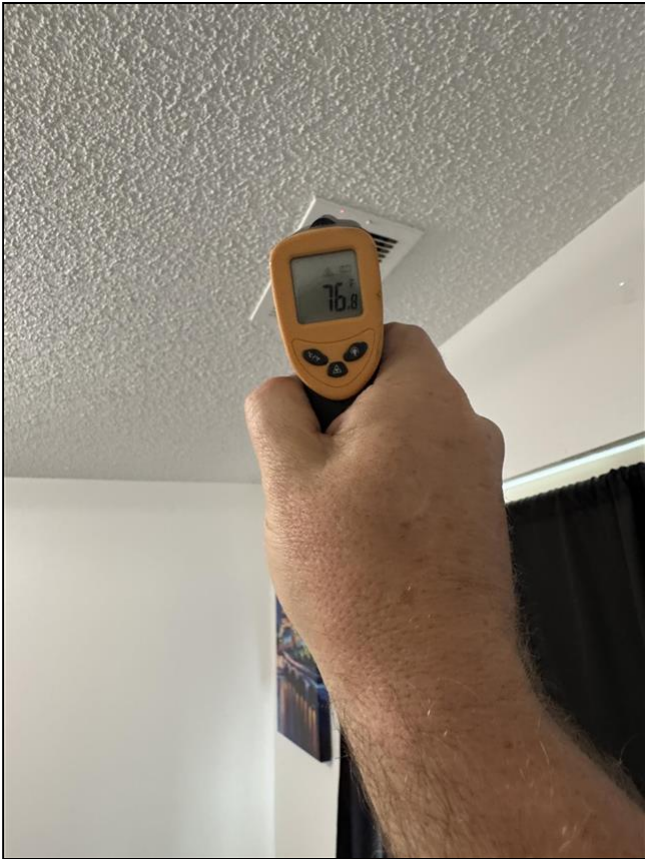
-Heat supplied by furnace to vents in each room. Vents produced positive heating from furnace.

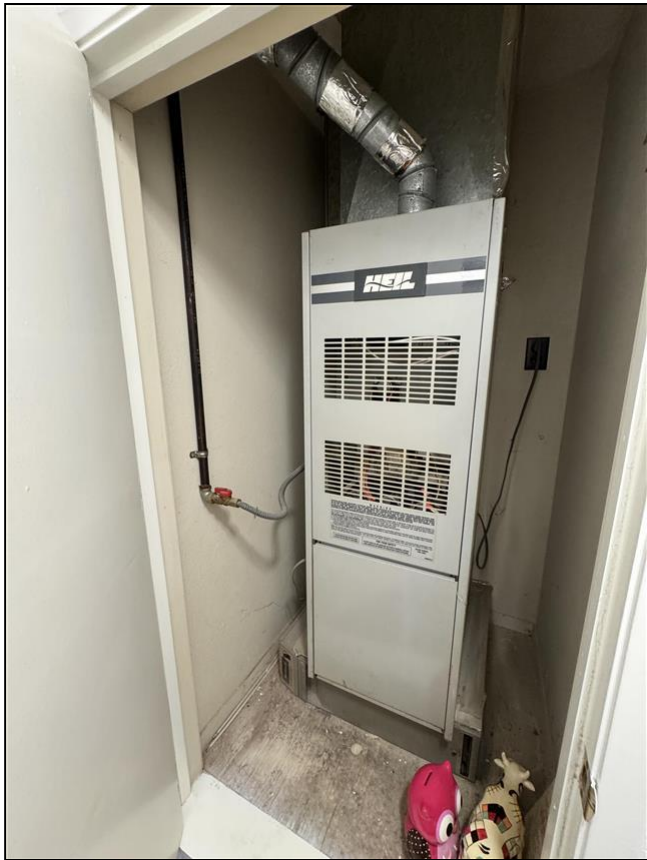
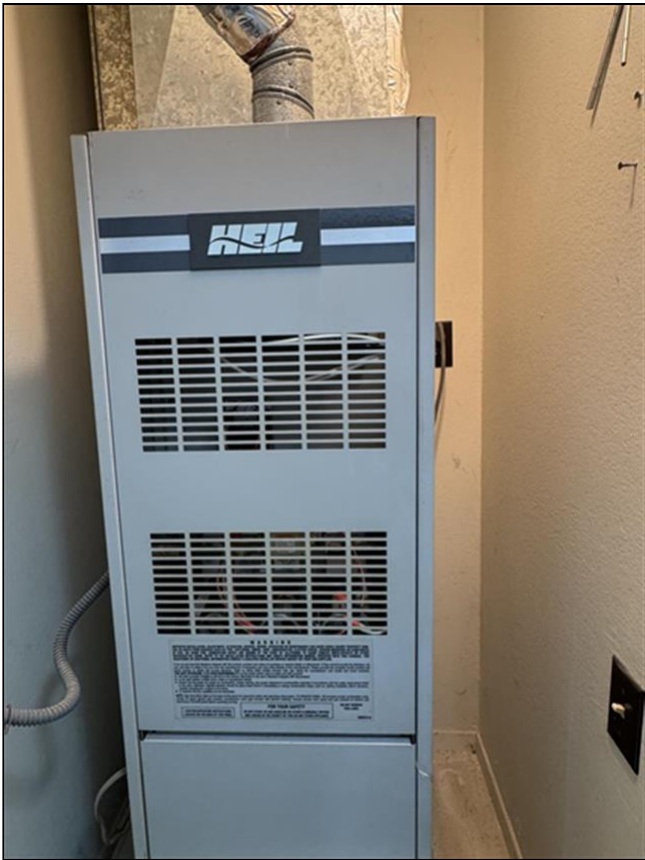
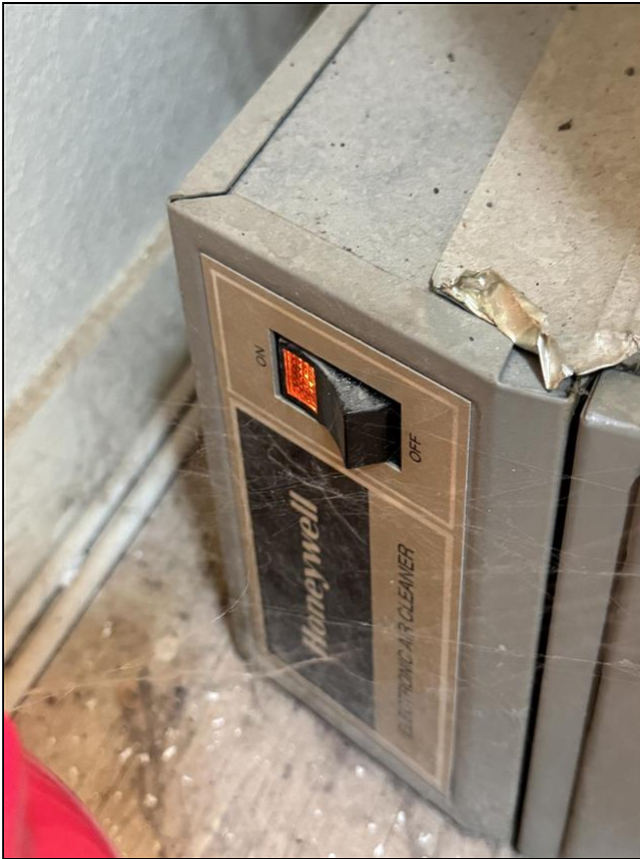
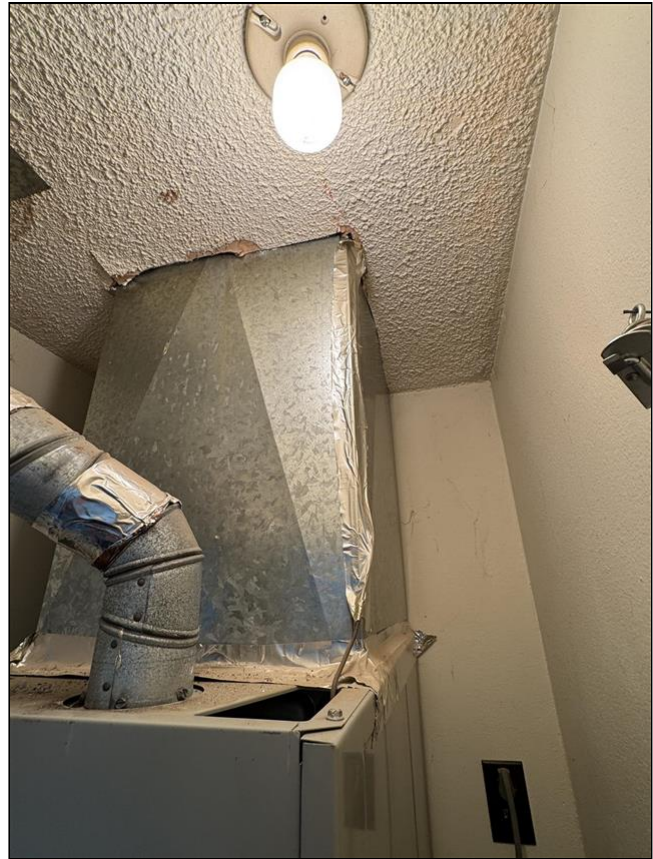
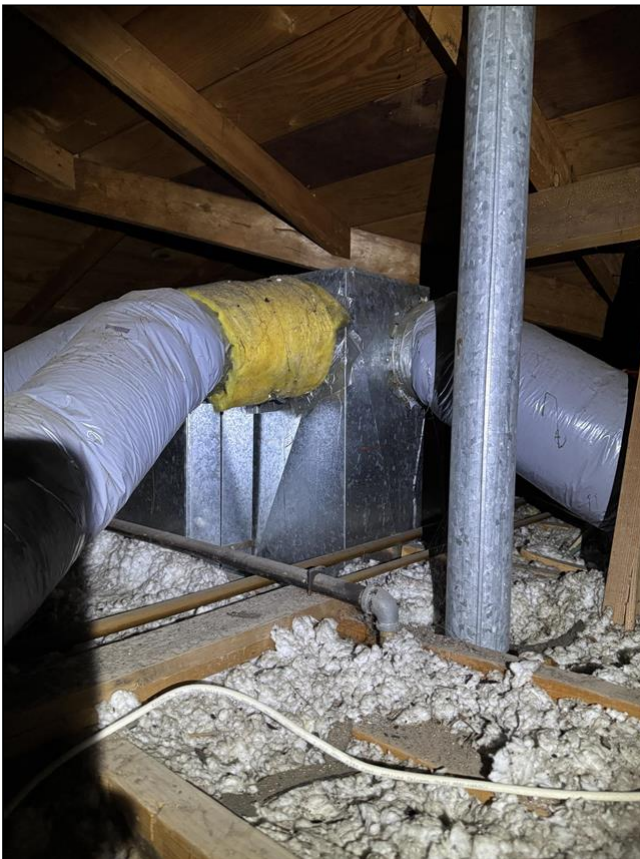
- The furnace was tested at the time of inspection and operated correctly with the thermostat inside the house. The furnace was likely installed at the time of the house build. Heil furnace filters are typically located near the bottom of the furnace unit, either in a slot on the side where the return duct connects. It is recommended to change the filter at least once a year if regularly used. The vent hoses are all insulated in the attic.

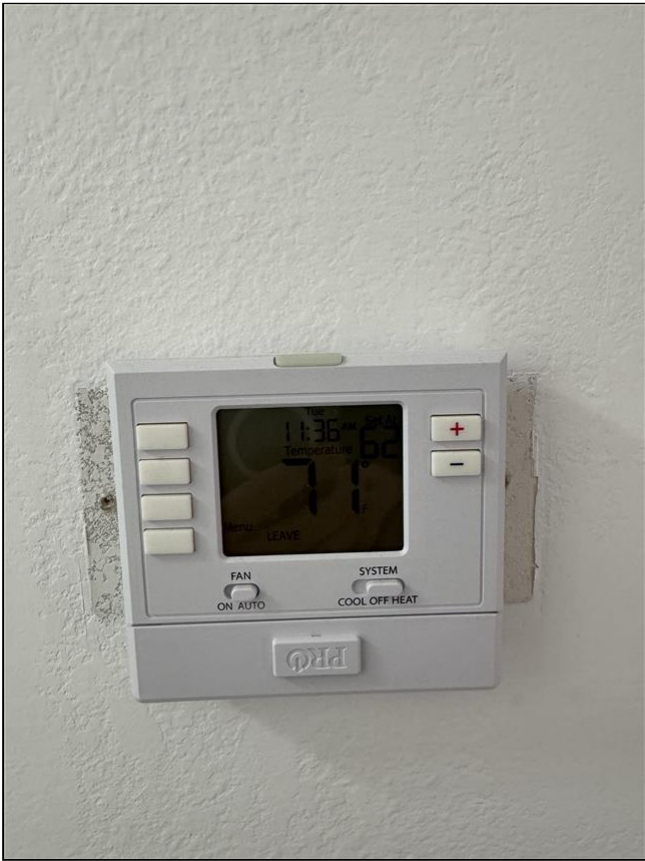
10.2 Item 1 (Picture) Thermostat

-The thermostat for this furnace was located in the hallway and functioned well at time of inspection.

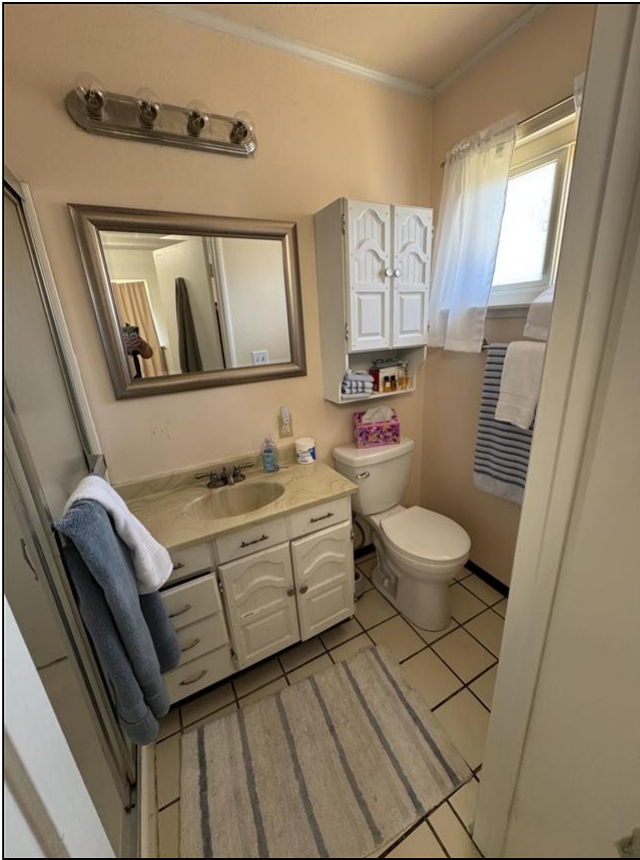
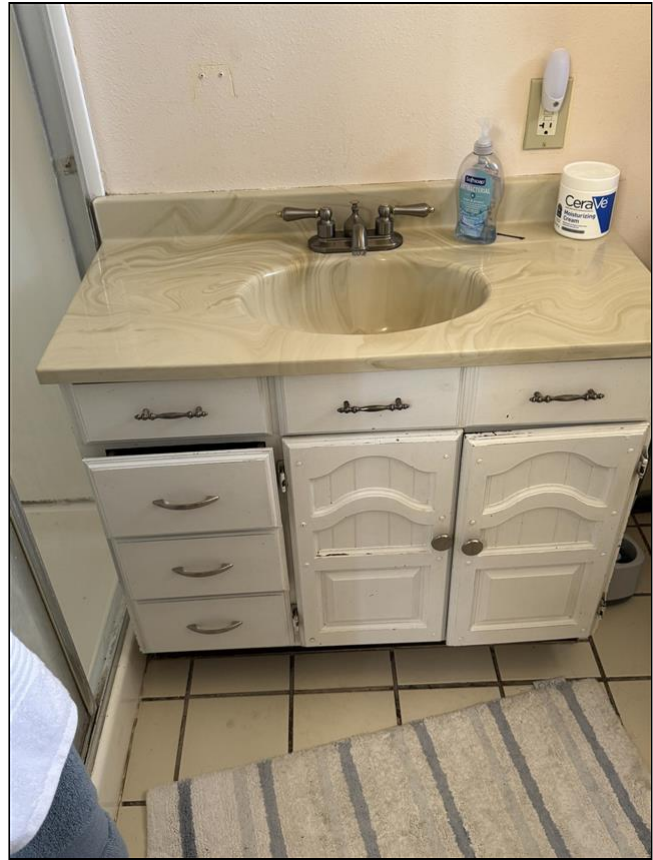
-Bathroom cabinets and sinks were in good condition at the time of inspection.

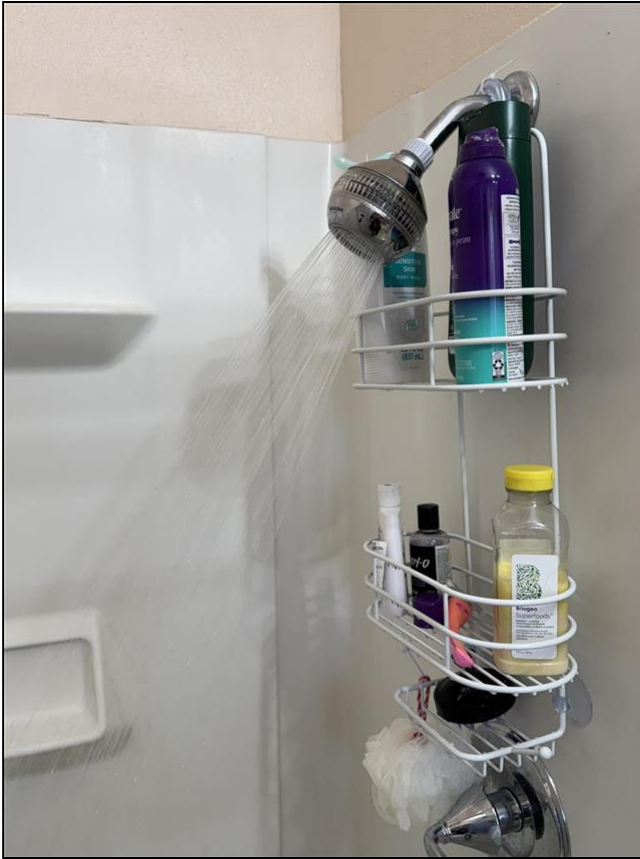
11.7 Item 1 (Picture) Master Shower

-Shower was in good condition and operational at time of inspection. There was mention of a timer configuration in the hallway shower, but I was unable to determine what it was.

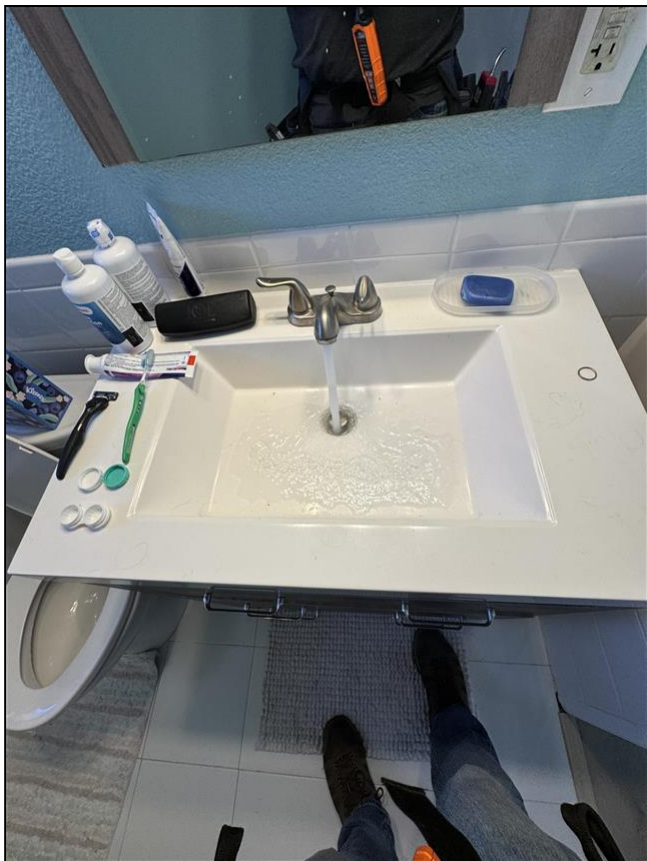
11.8 Item 1 (Picture) Sink 1

- The bathroom sink components and all associated plumbing was in working order at the time of inspection.

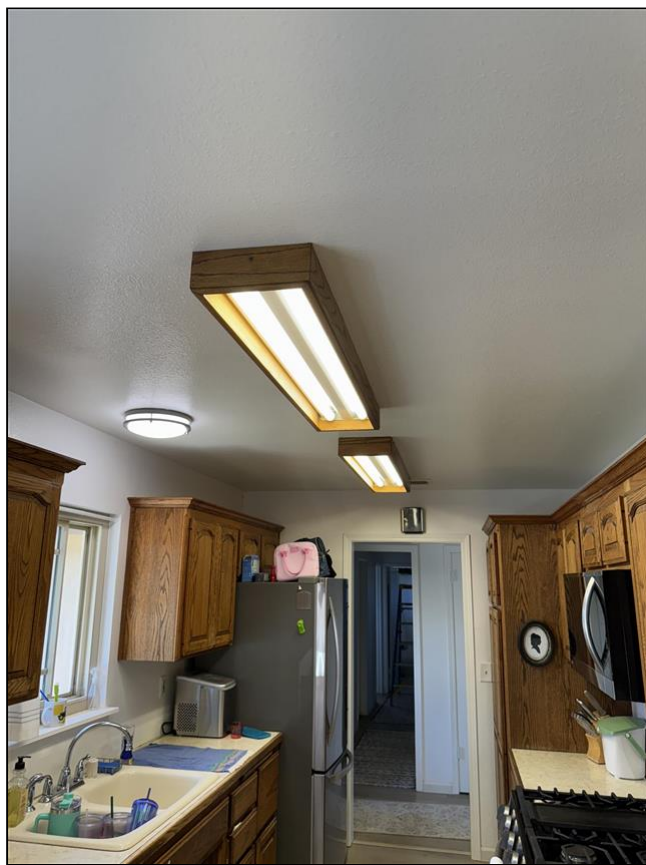
12.3 Item 1 (Picture) Kitchen Light

-At the time of the inspection, the Inspector observed no deficiencies in the condition and operation of the kitchen lights.

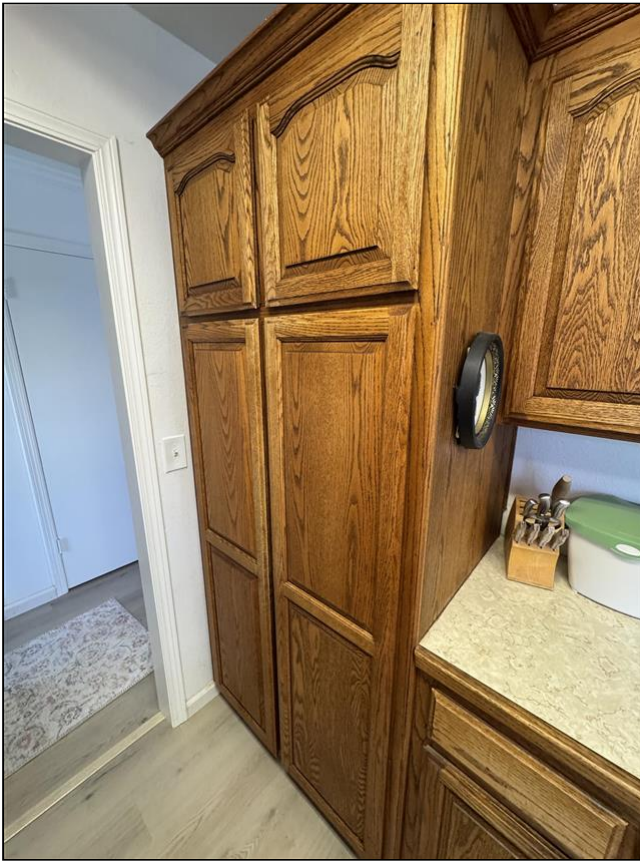
12.4 Item 1 (Picture) Cabinet 1

- Cabinets, sinks ,and fixtures were in good working condition at the time of inspection.
- In addition, the sink was in good working condition as well. No sign of leaks under the sink.

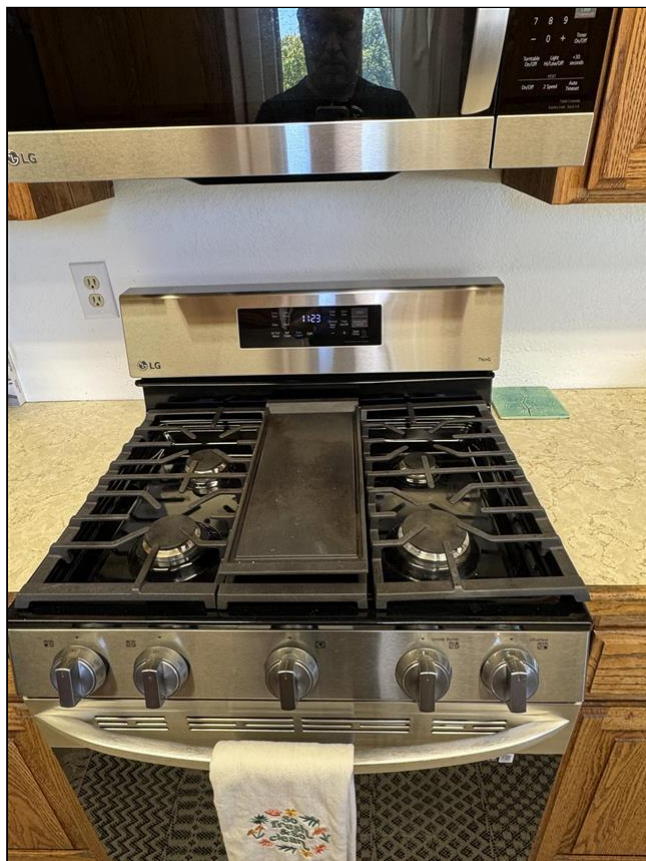
12.5 Item 1 (Picture)

-The Inspector observed no deficiencies during inspection of the range.

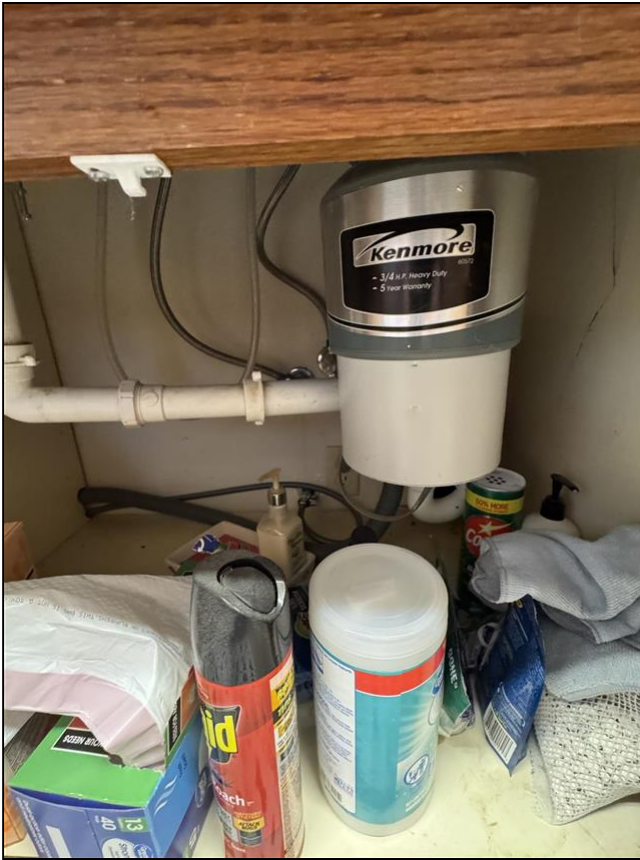
12.6 Item 1 (Picture) Garbage Disposal

-Garbage disposal was in good working order at the time of inspection.

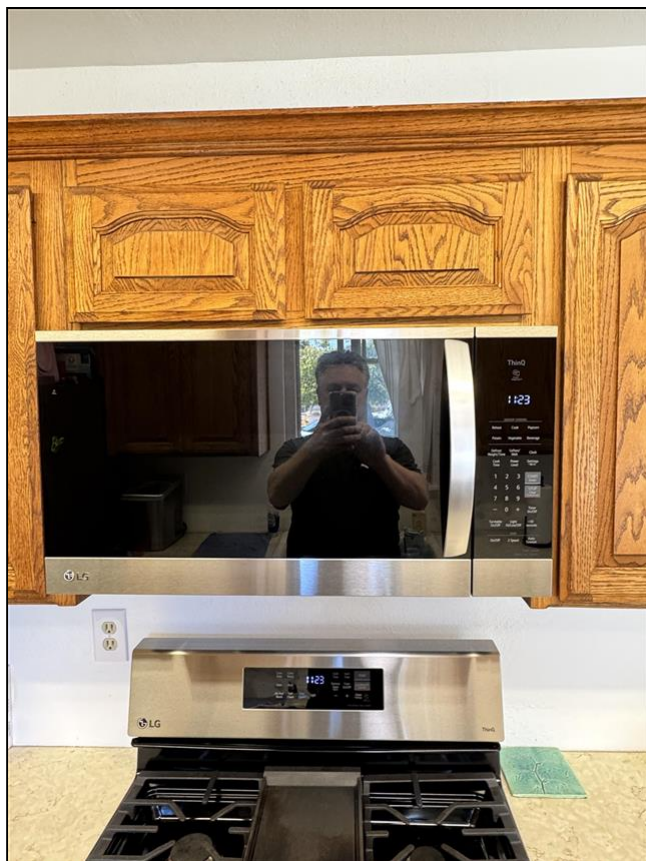
12.7 Item 1 (Picture) Microwave

-The Microwave was in good working order at the time of inspection.

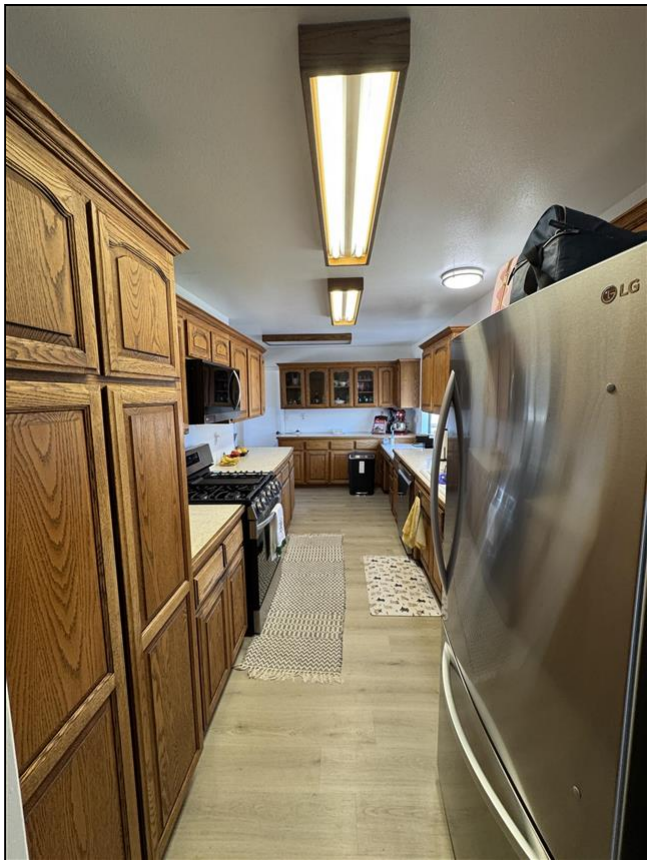
12.8 Item 1 (Picture) Refrigerator

-Refrigerator was in good condition and working order at the time of inspection.

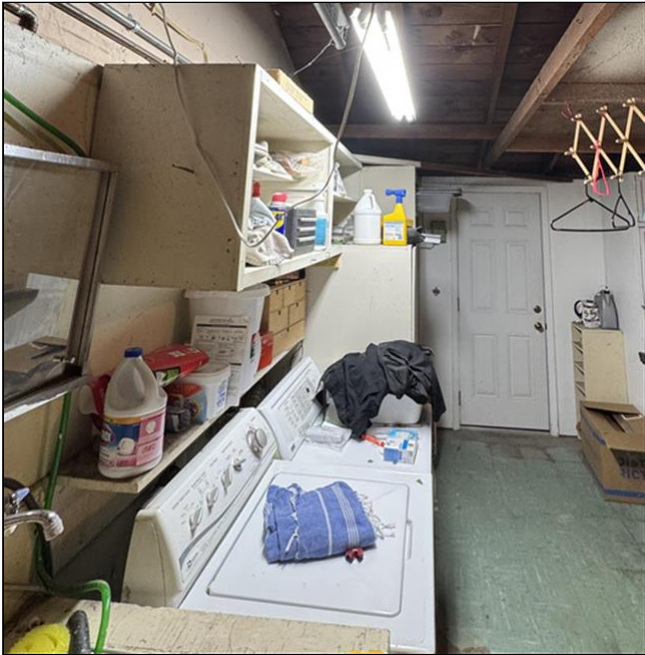
13.0 Item 1 (Picture) Washer and Dryer

**Inspected**  
-All connections including the plumbing and electrical for the washer and dryer were in good working order at the time of inspection. In addition, there was lighting above the machines. These are along the wall in the garage.
